2004 On Site Review Report

2701.YEM

Restoration of Amiriya Madrasa

Rada, Yemen

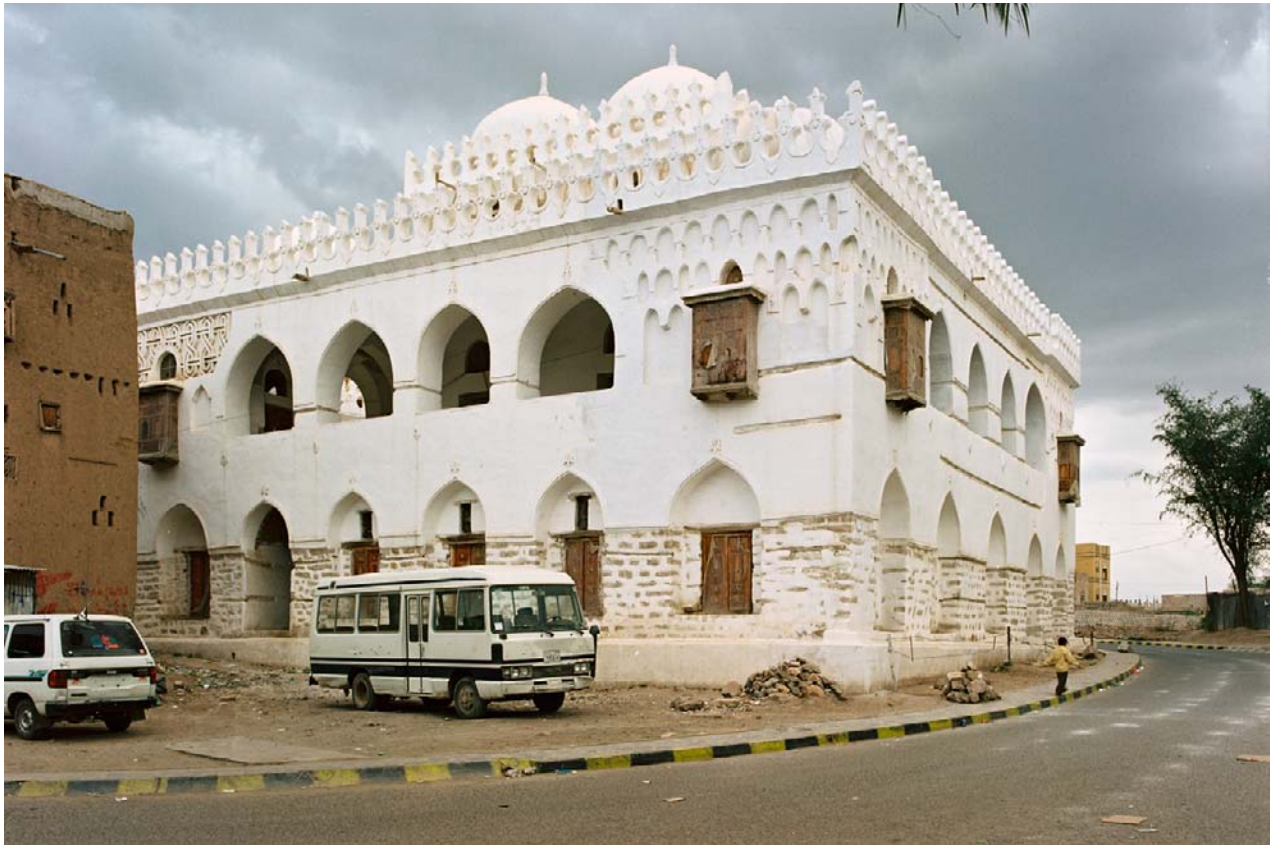
The Amiriya Madrasa following restoration, in 2004.

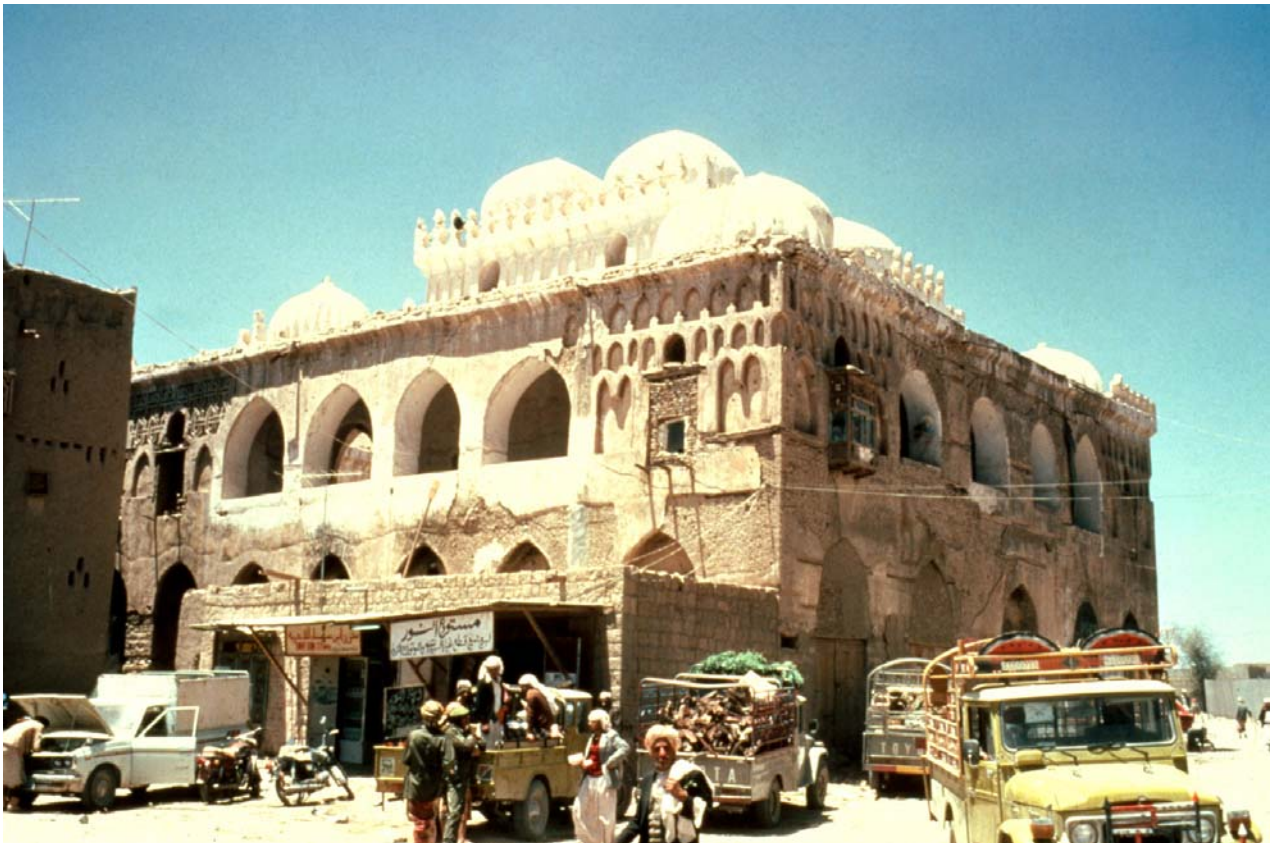
The madrasa was in poor condition prior to the beginning of work in 1982.

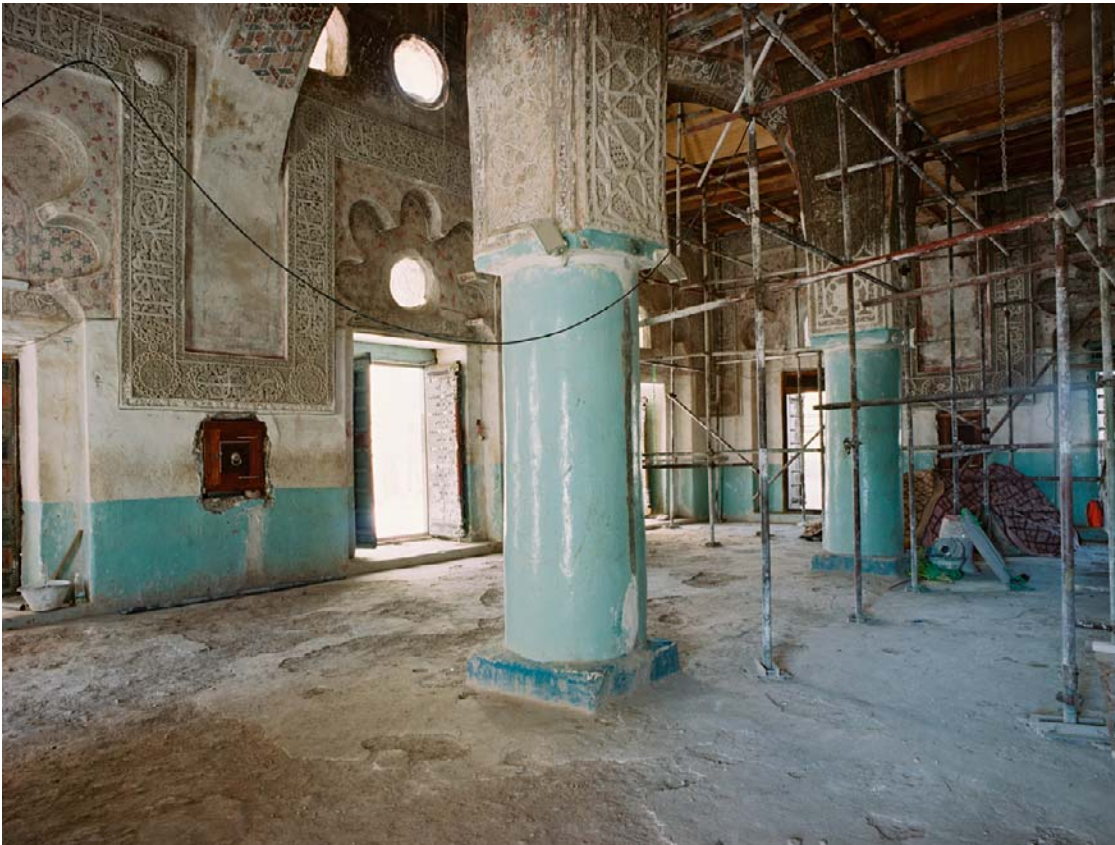
View of the prayer hall during restoration.
