## STRUCTURAL AND EARTHQUAKE RESPONSE ANALYSIS OF THE LITTLE HAGIA SOFHIA MOSQUE

### SUMMARY

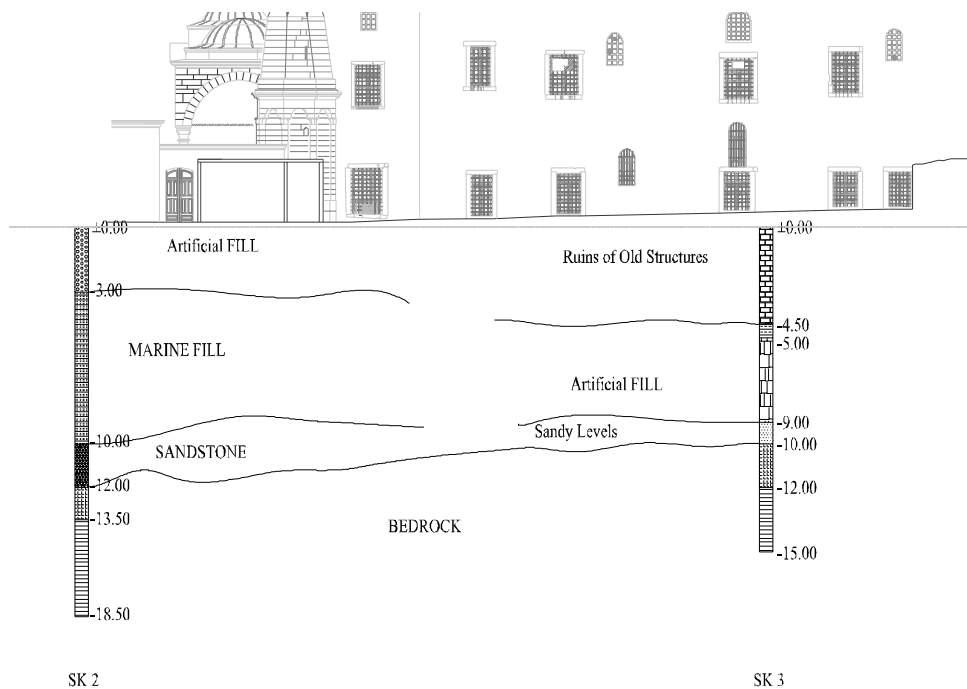
For site investigation three boreholes and six test pits were executed in order to obtain detailed information about the soil profile and the foundations. The locations of boreholes and test pits are shown in Figure 4. Preliminary study revealed that the soil profile at the site has some anomalies [4]. No compressible soil was found in the borehole SK1 that was drilled at the north-west corner of the Mosque. Observations have revealed that there is an artificial fill consisting of remains of some old structures and limestone blocks between the bedrock and the existing ground. Compressible soft silty clay and loose sand layers were encountered in the borehole SK3 that was drilled at the south of the building. By using the findings an idealized soil profile is given in Figure 5. Two test pits were excavated outside of the building, next to the main wall of the Mosque whereas four test pits were excavated inside the Mosque. During excavation of test pits, cut-stones were found beneath the main walls. Cut-stones were also found under the slab and pillars. In other words, it seems that probably the entire structure rests on cut-stones that were placed regularly.

**Figure 5** Soil profiles of the foundations of the building underlying

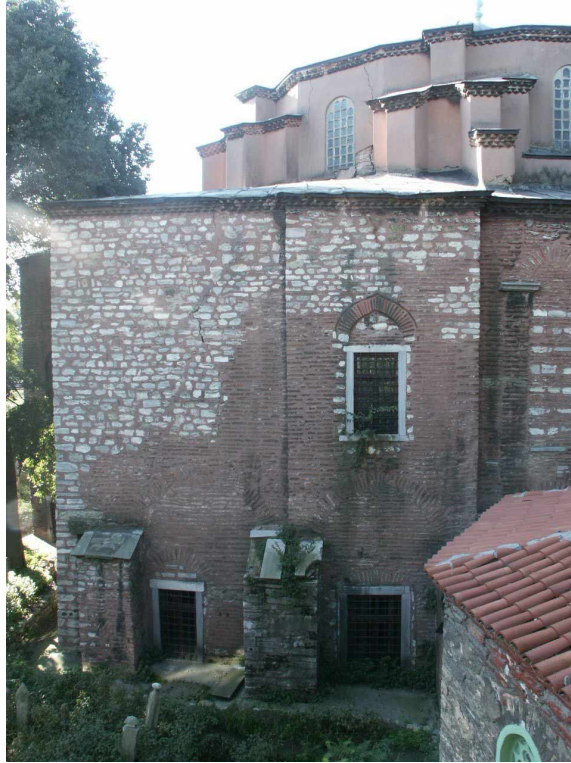
**Figure 6 Damaged, rebuilt and strengthened wall parts of the north-east view**

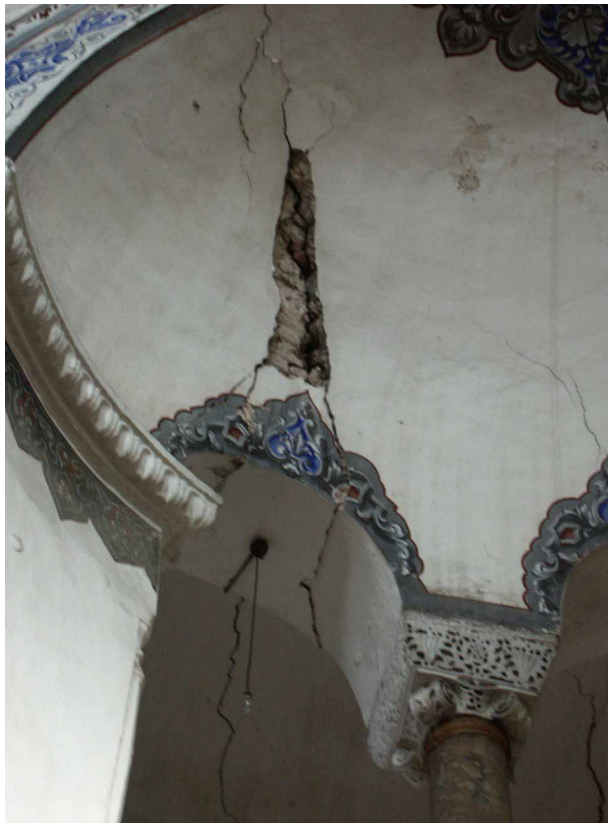
**Figure 7 Interior damages one of the small domes next to the main dome**

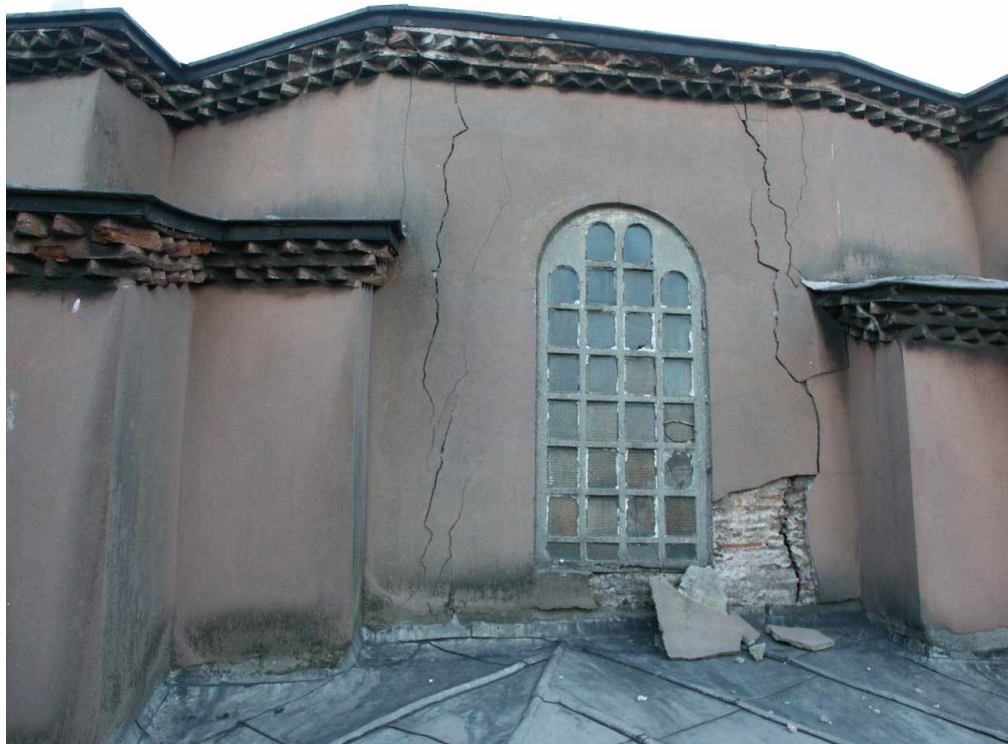
**Figure 8 Crack patterns of the periphery wall of the main dome**

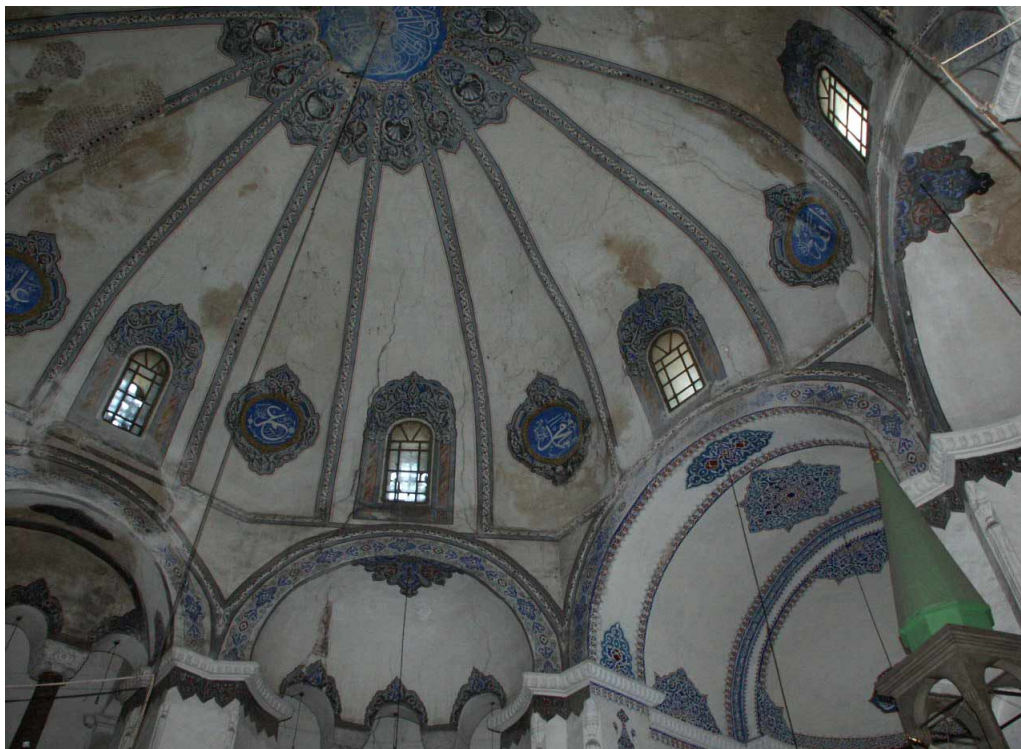
**Figure 9 Interior cracks of the main dome**

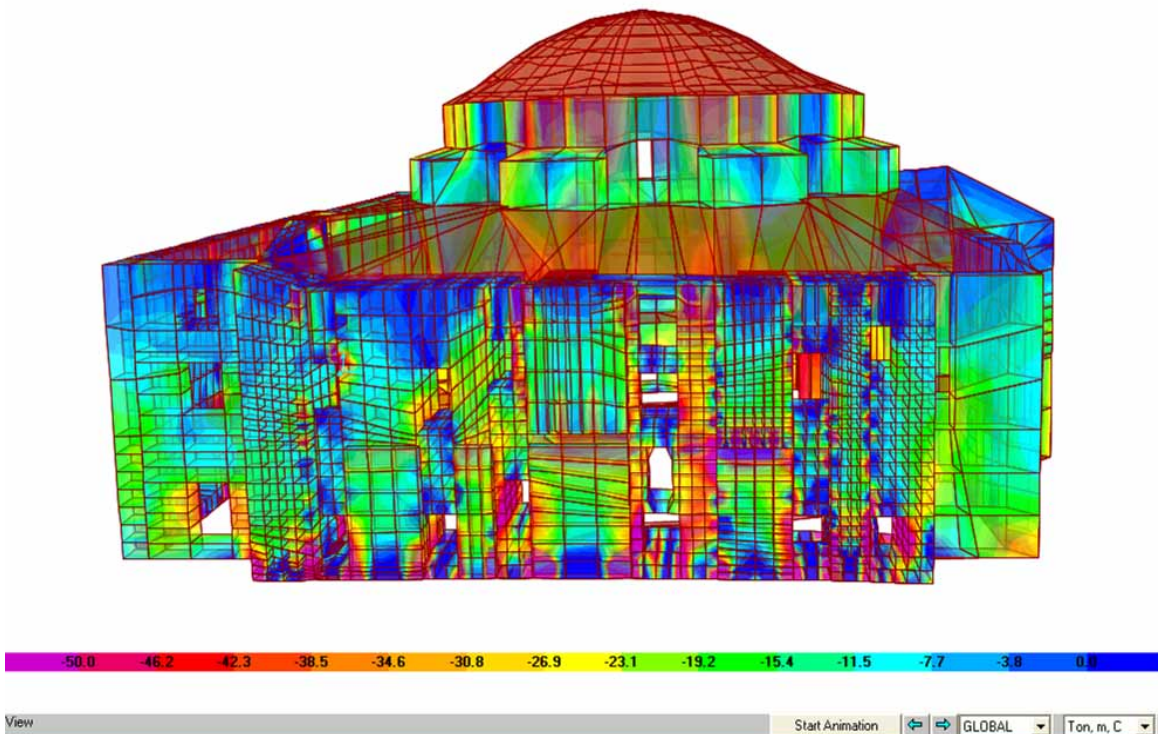
The historical monuments are constructed of brittle materials with large cross-sections of the structural elements. It should be recognized that their earthquake response would be limited to the elastic range of structural behavior. The analysis and the observations of the structure yields transversal earthquake motion are more effective than the longitudinal one (Figure 12). Probably the main reason is the length of the building in the corresponding direction, i.e., the lateral structural behavior of the masonry building to a specific direction depends mainly on its length. The stress distribution shows an increase and a quite different variation at the lower level of the walls, especially around the re-entrant corners of the structure. The maximum normal stress is approximately  $200 \text{ kN/m}^2$  for self-weight of the building and it is  $\pm 150 \text{ kN/m}^2$  for the lateral loading (earthquake). In the combination of the vertical and the lateral loading cases, the maximum normal stresses reach to  $200 \text{ kN/m}^2 \pm 150 \text{ kN/m}^2 = 350 \text{ kN/m}^2$ . These results are obtained under the assumption that the building is supported elastically (Figure 13).

**Figure 13 a Axial stress variation (south) of the structure (in  $t/m^2$ )**

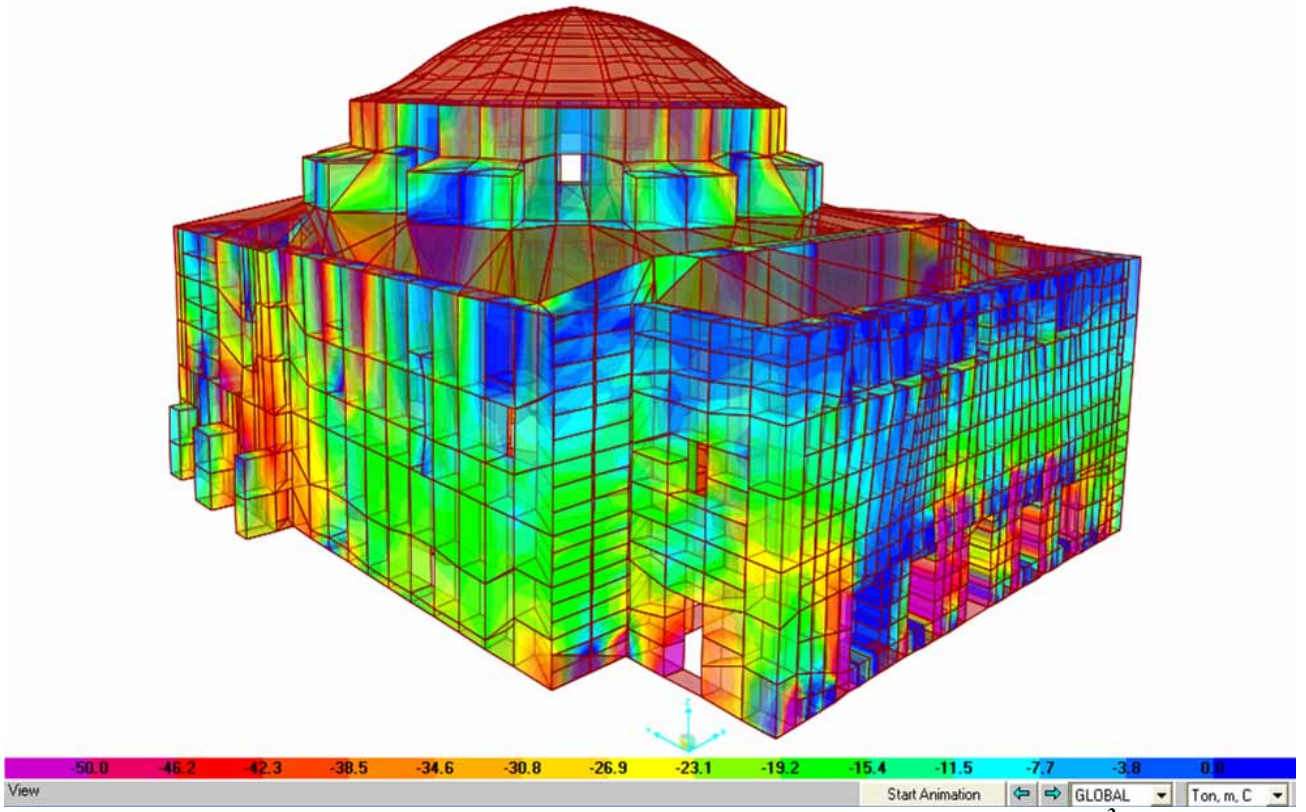
Figure 13b Axial stress variation (north-west) of the structure (in  $t/m^2$ )

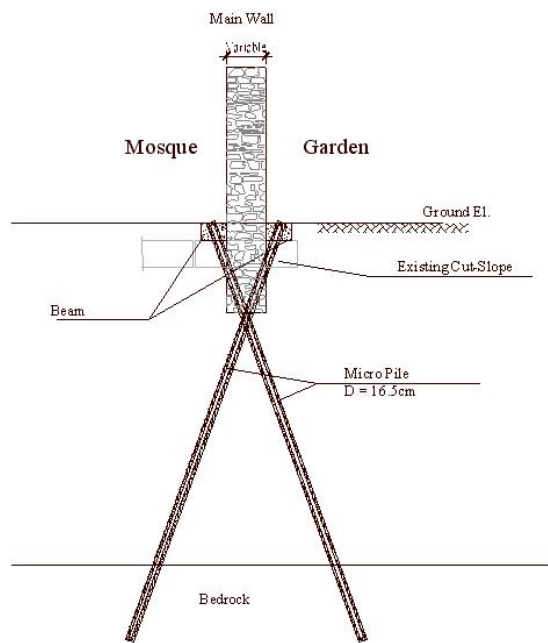
The foundations of the building were constructed over soil layers that exhibit different soil compressibility. West side of the Mosque constructed on loose-compressible soil layers when compared with the east side. As a result, the building has made a differential settlement towards the west. The symmetry of the structure was disturbed by the strengthening works and the functional interferences to the structure done in the past. In return, this has caused uneven loading, eventually lead to an increase in differential settlements. One other observation is tilting of the minaret towards east, to the direction of the Mosque.

Figure 14 Strengthening of the foundation of the building by micro piles (section)

Observations show that the main causes of the structural damages in the present building originate mainly due to poor soil conditions and uneven load distribution. State-of-art reports about retrofitting of historical buildings in literature have been searched and the widely used underpinning method with micro piles has been chosen. Consequently, it is recommended that, in restoration works, a priority should be given to retrofitting of foundations by utilizing widely used underpinning method with micro piles, broadly known as Pali Radices. A typical cross section of retrofitting of main walls is given by Sağlamer [12] in Figure 14. Main points of foundation retrofitting can be summarized as follows:

- Main walls and pillars are to be supported with inclined micro piles with a diameter of  $165 \text{ mm}$ .
- Micro piles are to be connected by a continuous beam on top.

- The beam top elevation shall be below Roman time slab.
- Steel pipe shall be utilized as reinforcement.
- Cement grouting shall be carried out between micro piles as a soil improvement.
