A Study on Restoration of Ayaş Şeyh Muhittin Mosque which is an Example of Ankara Traditional Mosque Architecture

In this study, Şeyh Muhittin Mosque in Ayas district of Ankara is examined in terms of traditional architectural features and the restoration carried out by Ankara Regional Directorate of Foundations in 2018-2019 are discussed. The mosque, which is owned by the General Directorate of Foundations and has no construction inscription, dates back to the 16th century. The mosque has no last congregation space and has a transverse rectangular plan. The walls of the mosque are rubble stone up to the basin level and the walls of the body are built with masonry technique with wooden beams and mud-brick. Traditional materials such as rubble, mudbrick and wood are used extensively in the structure. In the interior of the mosque, wood is used in building elements such as wooden posts and beams of women section, minbar, floor and ceiling coverings. The plaster mihrab has the characteristics of 18th century traditional Ankara mosques. Seyh Muhittin Mosque was examined in terms of traditional architecture and art history, and the data obtained during the last restoration and applied

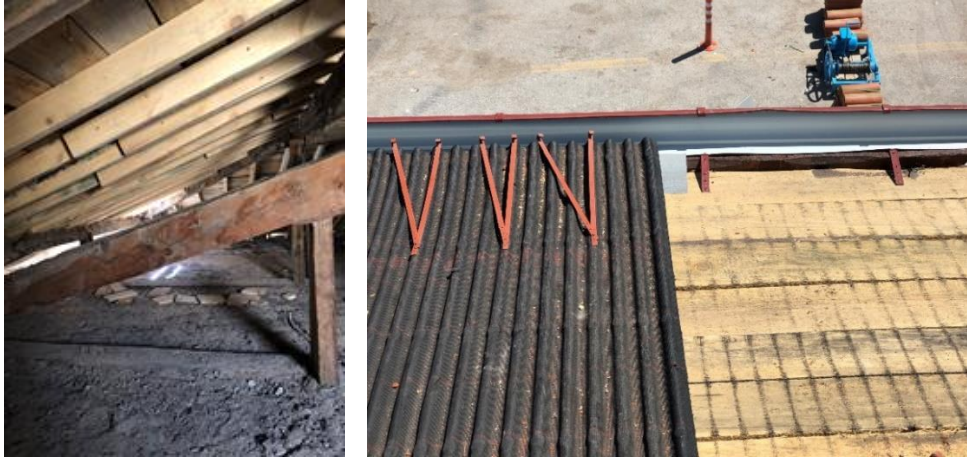
Figure 5. Roof reinforcement and insulation applications [16]

On the roof of the Seyh Muhittin Mosque, the marseille-type roof tiles and decaying wooden cladding boards were removed. The decaying of the carrier pillars and beams in the roof were changed and some of them were reinforced with wooden material. Following the consolidation process, a re-coating board was built and waterproofing was laid and a classical type tile was laid on it (Figure 5).

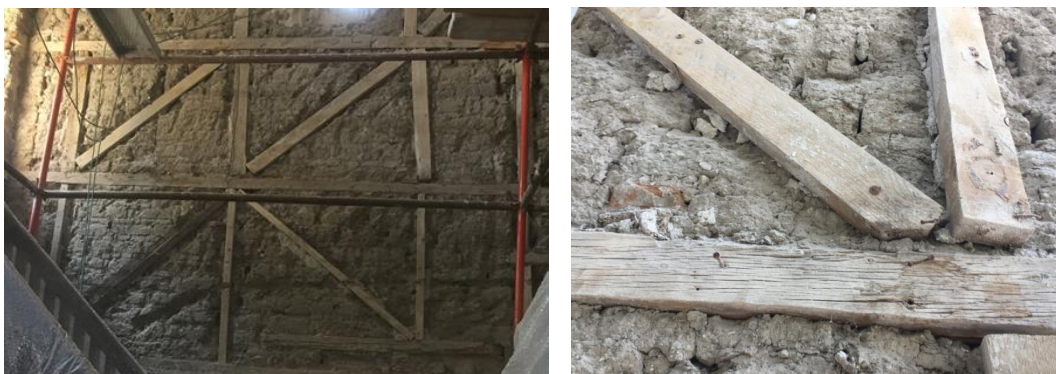
Figure 6. Wood frame irregularities and damage in mud-brick [16]

The survey and restoration project of the mosque was drawn by the Ankara Regional Directorate of Foundations in 2008. In this context, laboratory analysis of materials such as stone, mortar and plaster taken from the building was carried out by the Department of Restoration and Conservation of Ankara University and suggestions were made for the materials to be used in the restoration of the building. In the analyzes, cement based plasters detected on the inner and outer walls of the mosque were scrapped. When the plaster blasting was completed, the thickness of the mudbrick walls was 95-100 cm on the western side and 85-90 cm on the other sides. The structure was built with mudbrick technique of 32x32x8 or 32x16x8 between 10x10 cm or 15x15 cm wooden beams on the rubble stone wall, ranging from 60-80 to the basement level. Among the horizontal beams, there were discontinuous and variable sizes of wooden pillars and irregular nailed 4-5x8-10 cm cross beams corresponding to the wooden beams and beams. But; it was found that the cross frames were not properly connected with the struts and beams, the joining geometries were faulty and their workmanship was very poor (Figure 6). While these cross beams were used on the entire façade of the building, it was not used on the northern interior walls (Figure 7). In order to clarify the determinations, a few of the cross frames were removed and it was determined that the mudbrick surfaces coming under them were carved by intervention to make places for cross woods (Figure 8).

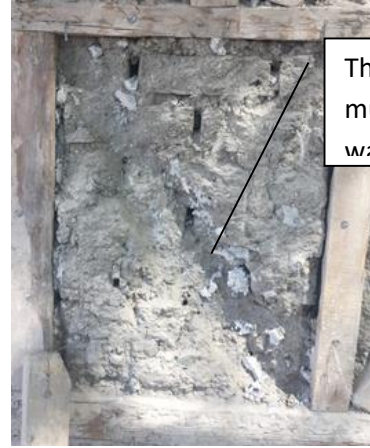
Figure 8. After removal of wooden cross [16]

The shape of the
mudbrick shows that it
was carved

With this evaluation it was concluded that the wall detail was later changed and there were no crosses in the original. In order to eliminate the damages in the structural system of the building, it was decided to remove the rotting pillars and horizontal beams and all the diagonals, and replace the rotting horizontals and replace the verticals. It was decided that the crosses should be canceled and the damaged parts of the mud-brick should be filled with mud mortar or if the destruction was large, it would be completed with mud-brick.

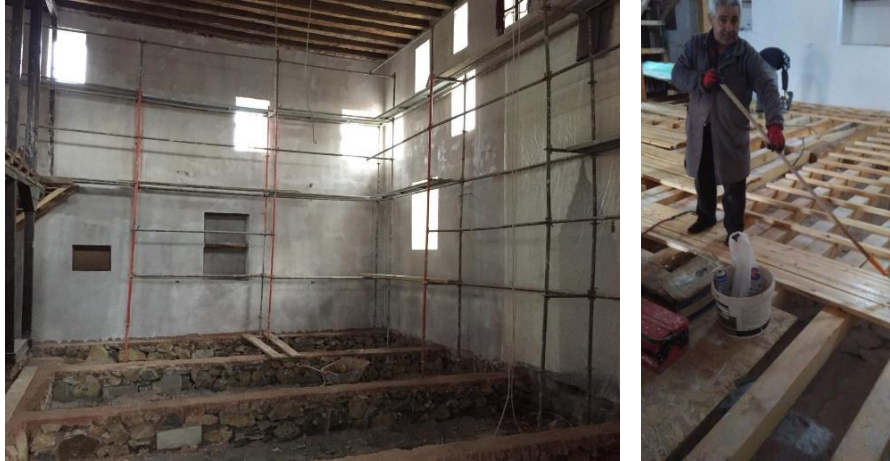
Figure 10. Rubble stone wall and wooden floor beams [16]

In the research conducted under the existing wooden flooring in Seyh Muhittin Mosque, concrete screed was laid under the flooring. For this reason, the wooden floor was dismantled, the concrete screed underneath was broken and the soil filling was removed to allow the floor to breathe. A rubble stone wall of 40 cm height and 250 cm axle spacing was built to fit the wooden beams. Wooden floor beams measuring 15x15 cm were installed on these walls and the floor ground was reinforced (Figure 10).

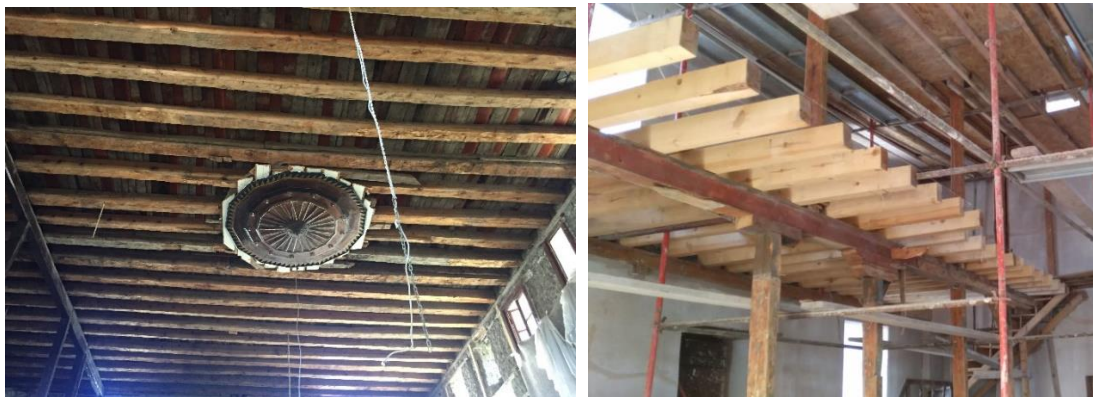
Figure 11. Wooden ceiling beams of main prayer area and women's section [16]

The rotten wooden ceiling coverings of the mosque were removed and the wooden beams and the wooden ceiling core where the ceiling was mounted were preserved. The sections where the wooden ceiling beams were damaged were consolidated (Figure 11) and the bearing system was reinforced. Later, wooden ceiling coverings and laths were rebuilt in accordance with the original. After dismantling the floor covering and ceiling covering of the women's section, the beams bearing the floor layer, the floor covering and the ceiling covering of the women's section were renewed.

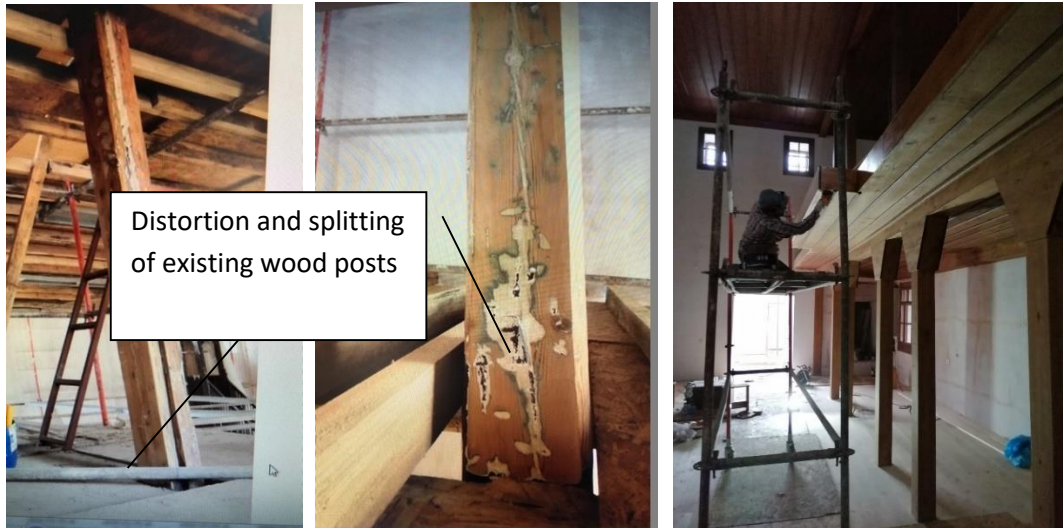
Figure 12. Distortion and splitting of existing wood posts and new posts and ceiling [16]

In the approved restoration project, it is envisaged to clean the oil paint in the protected wood productions in the main prayer area (protected ceiling hub, pillars bearing the ceiling beam and minbar). In this direction, oil paints were cleaned on wooden posts and human interventions such as nailing, hanging, and also cracking and worming were observed depending on time (Figure 12). According to the decision of the Conservation Board, these posts were renewed.

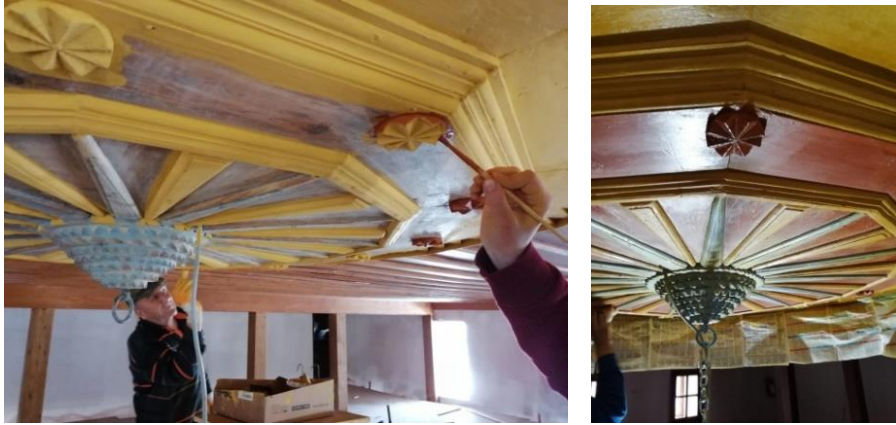
Figure 14. Wood ceiling hub orche paint application [16]

In the cleaning of the wooden ceiling hub (Figure 14) and the wooden minbar, which is envisaged to be protected according to the approved project, two layers of brown oil paint and two layers of green oil paint have been identified as very thick oil paint layers. As a result of the removal of these layers with paint remover and scalpel, green, yellow and orange ochre was seen at the bottom. In addition, cypress and carnation patterns were found in the minbar (Figure 15). According to the decision of the Conservation Board, after the oil paint cleaning was completed on the wooden ceiling hub, it was completed with orche paint suitable for the original tone and shellac polish was applied on it. The chasings on the wooden minbar were completed in accordance with the original and shellac polish was applied on it.

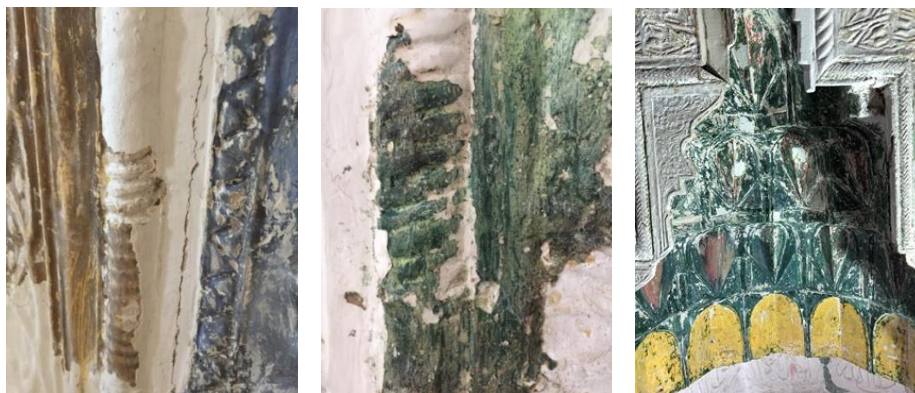
Figure 16. Mihrab cleaning works [16]

In the approved restoration project; It is envisaged that the paint layers applied in layers over time prevent the perception of the plaster mihrab motifs to a great extent, and therefore, paint cleaning is performed with suitable methods in order to reveal the original surface. In this direction, firstly mechanical cleaning has started in plaster mihrab. During the cleaning of the paint, different colors of ochre paint were found in the lower layers (Figure 16). For this reason, the cleaning activities were carried out more precisely, paint cleaning was continued with paint remover and scalpel and orche paint was determined in most of the mihrab. After the cleaning works were completed, the fractures and cavities in the mihrab were consolidated by injection (Figure 17). Afterwards, completion and revitalization was done with orche.

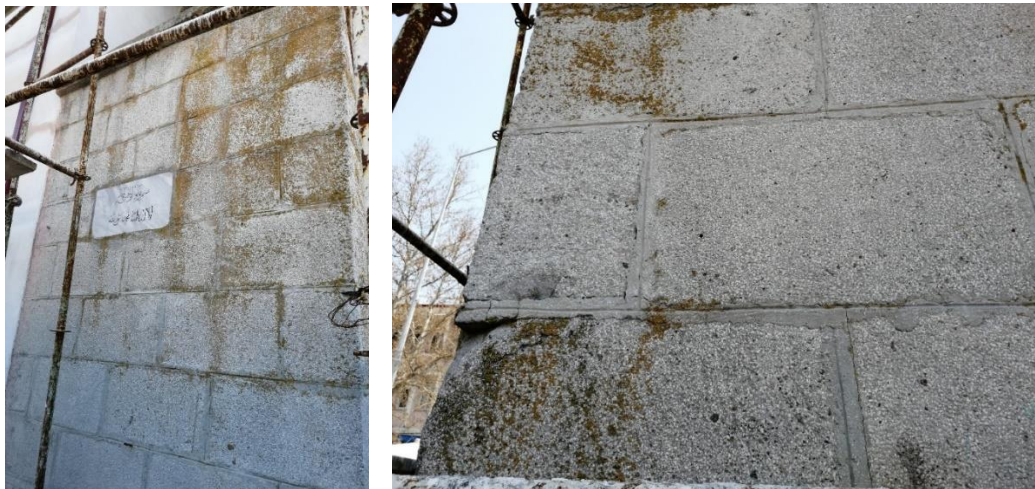
Figure 18. Algae and cement residues on the surface of the minaret [16]

Dirt layer and algae have formed over time on the surface of the non-original stone imitation reinforced concrete minaret. In addition, cement residues from previous repairs were identified on the surface of the minaret (Figure 18). In the scope of the restoration, the remains of ossified mortar on the surface of the minaret, which provided adherence with the structure, local fillings made with cement-based unreinforced mortar, and cement slurries flowing on the facade were cleaned with small hand tools without damaging the wall surface and the surface was washed with arabic soap and water (Figure 19).

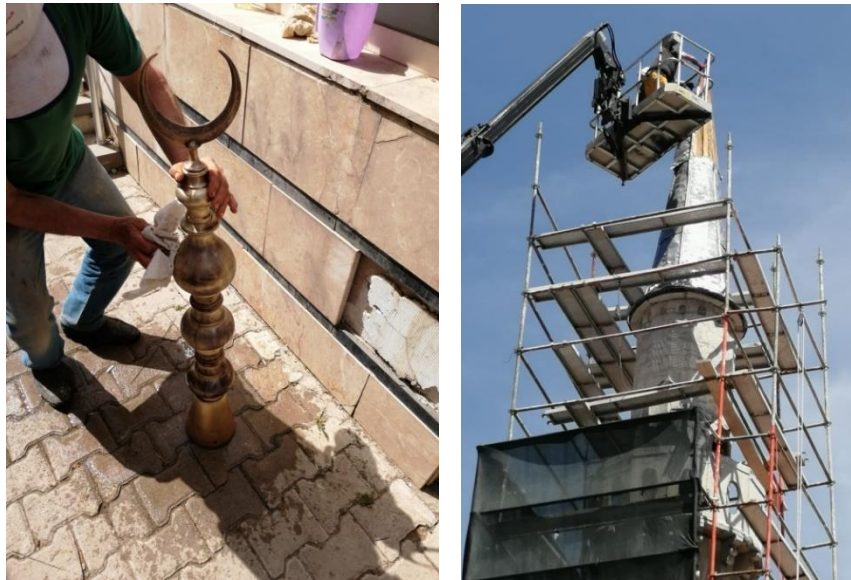
Figure 20. Lead coating in minaret cone and cleaning of finial [16]

The metal coating in the minaret cone was removed and the stability of the wooden coating under the cone was checked and the wood was impregnated and reinforced. Then the lead was coated on the cone. The copper finial in the cone was removed and cleaned and assembled in place by applying protection (Figure 20).
