AGA KHAN CULTURAL SERVICES - AFGHANISTAN

FINAL NARRATIVE REPORT

RESTORATION OF DEHDADI MOSQUE, BALKH

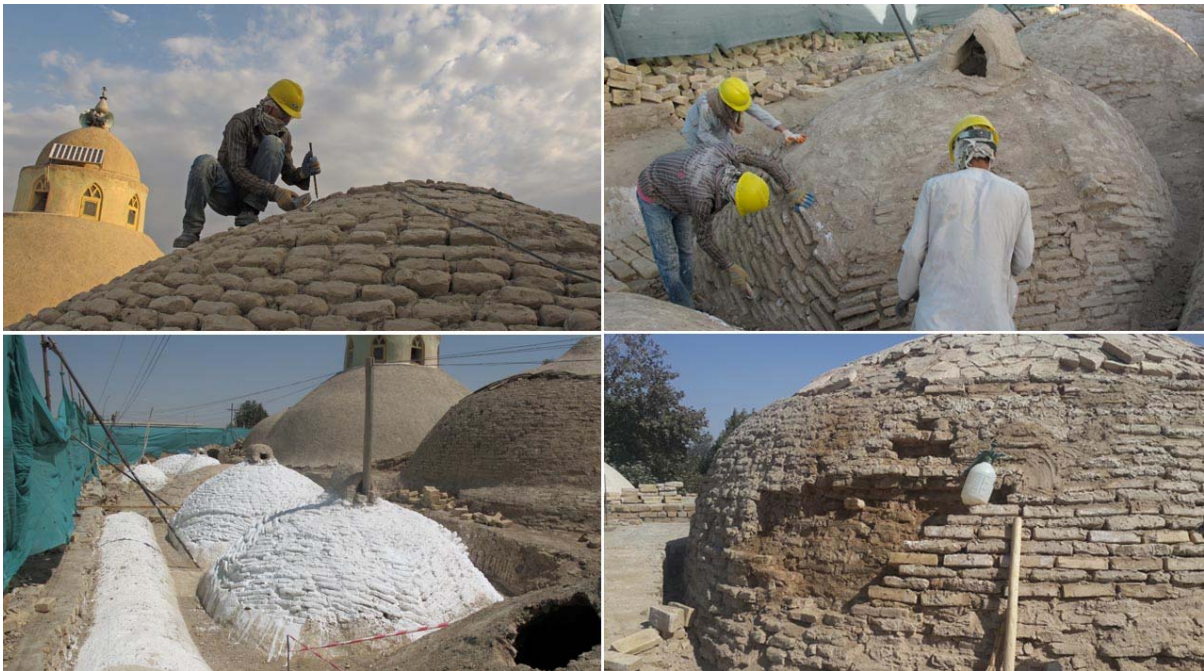
While most of the domes were built from a composite of adobe bricks (unbaked) and baked bricks using mud-mortar, it was discovered that three of the main western domes were built only using unbaked adobe bricks. It was not a coincidence that these domes all suffered extensive cracking and structural problems. Based on standard conservation techniques, masons undertook to stitch the damaged domes using locally produced adobe bricks and a mud-mortar. Once the stitching of the domes was complete, the domes were strengthened further by retrofitting glass fiber

mesh material to built a “belt” around the sections of the structure where the most tensile forces would converge. The glass fiber mesh was laid in a thick mix of composite gypsum mortar. In total an area of more than 300 square meters was consolidated in the manner described above.

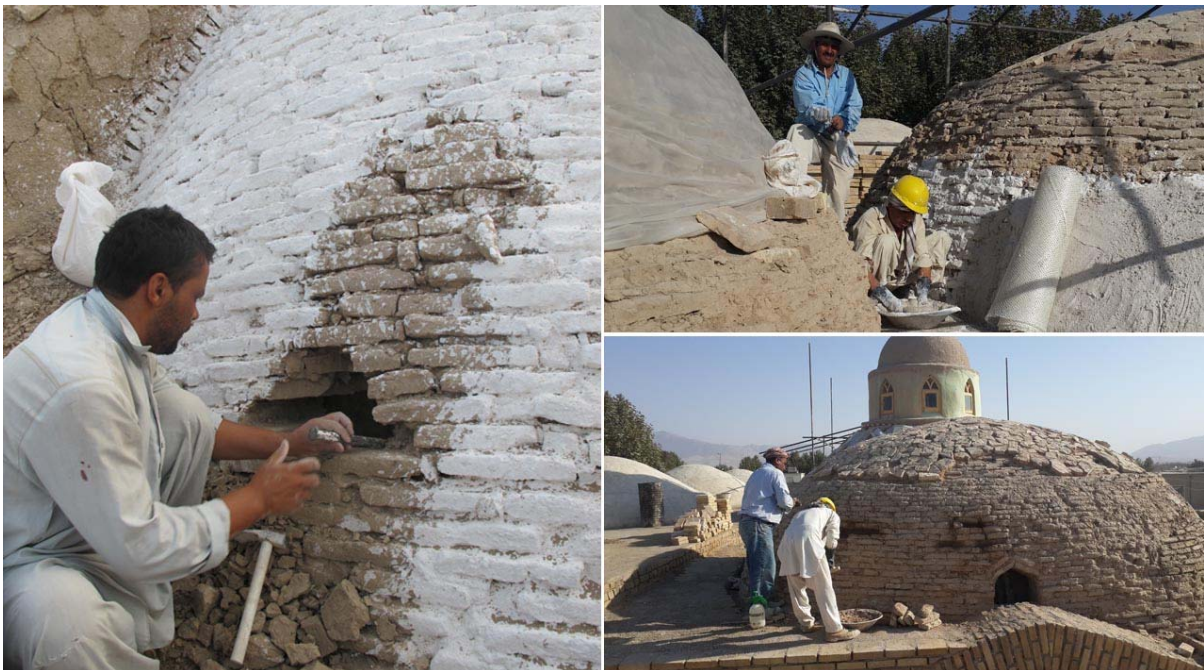
As the masonry construction of the roof was built using unbaked mud-brick (adobe) material, it was not possible to directly apply suitable water-proofing materials (lime concrete). In order to ensure that the roof could be permanently protected from water build-up and penetration, it was decided that a secondary light-weight baked brick dome, essentially constituting a “shell”, would be constructed above the existing mud-brick masonry domes. The thin masonry shell built above the original mud-brick domes would also enable the design of a cavity between the two structures. Vents designed into the new masonry shell will enable air to circulate in the cavity, leading to the rapid evaporation of water that may penetrate the baked brick shell in the future. The new baked brick masonry shell was built using 23cm x 23cm bricks and lime mortar and constructed at a distance of 20cm above the original mud-brick domes. In total 59 cubic meters of new brick masonry was used in the construction of

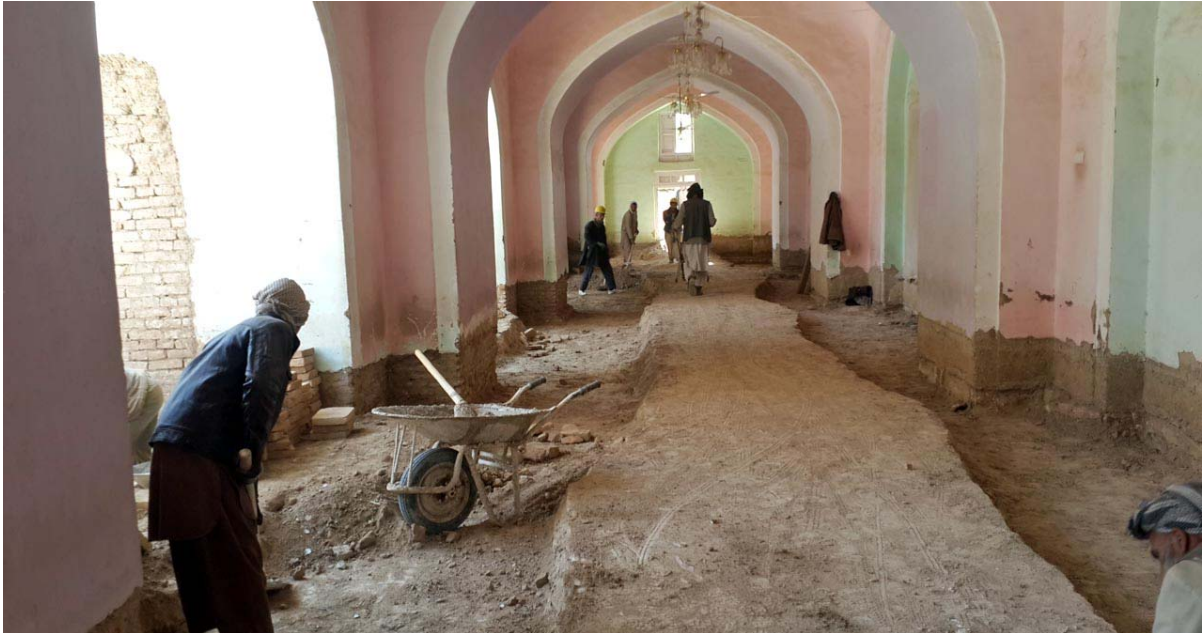
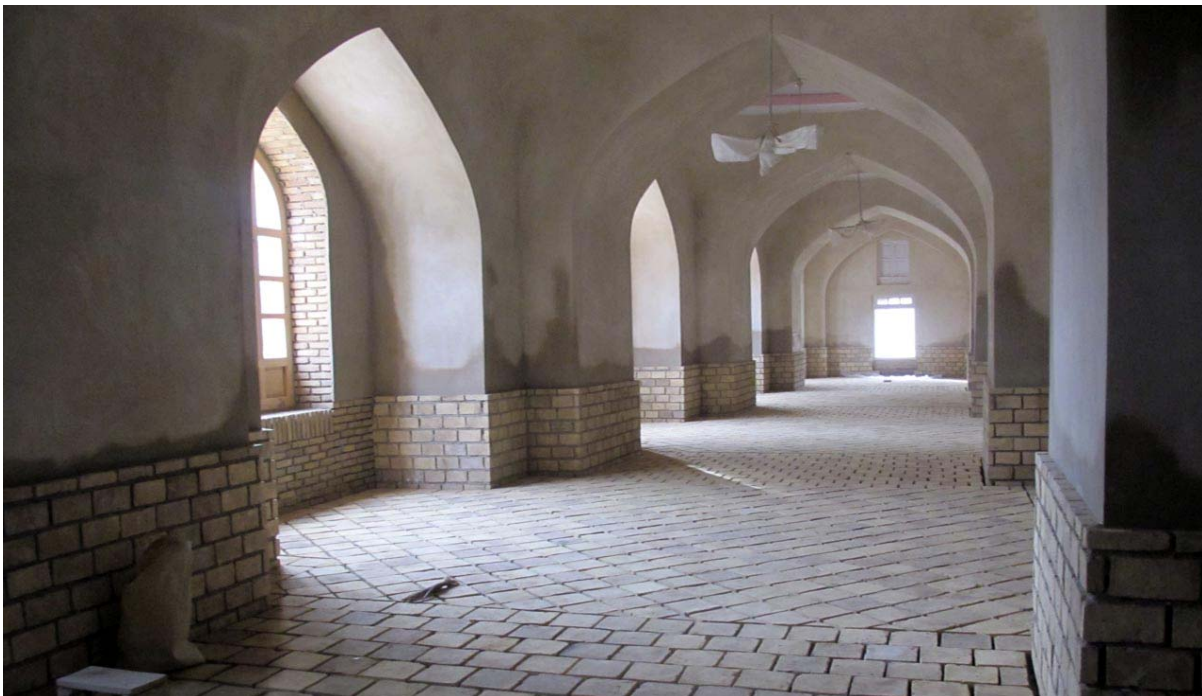
As a result of rising damp within the building, more than 216 square meters of plaster had become eroded and in places detached from the masonry walls. Once the internal level of the flooring had been restored to the original levels and the masonry walls had been left to dry, these sections of plaster were carefully removed and re-plastered with gypsum. A section of the wall – up to 80cm above the level of the flooring – was refinished with durable baked bricks in order to prevent future damage

to the plasterwork as the damp walls continued to dry. Sections of the walls in smaller rooms (*Chelle Khana*) flanking the Mosque were re-plastered using traditional mud-straw plaster.

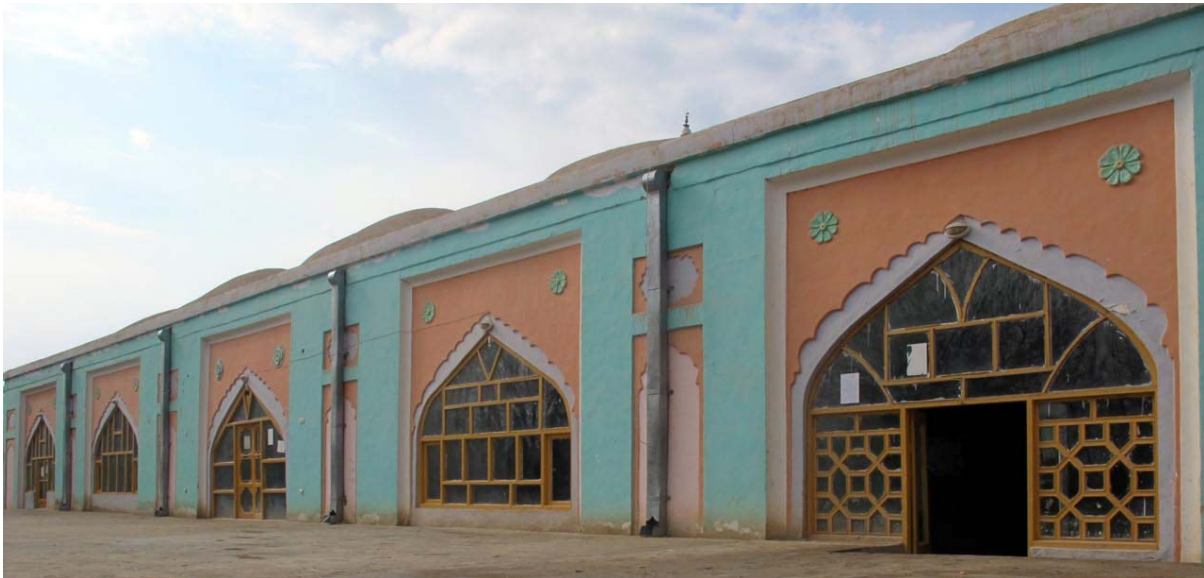
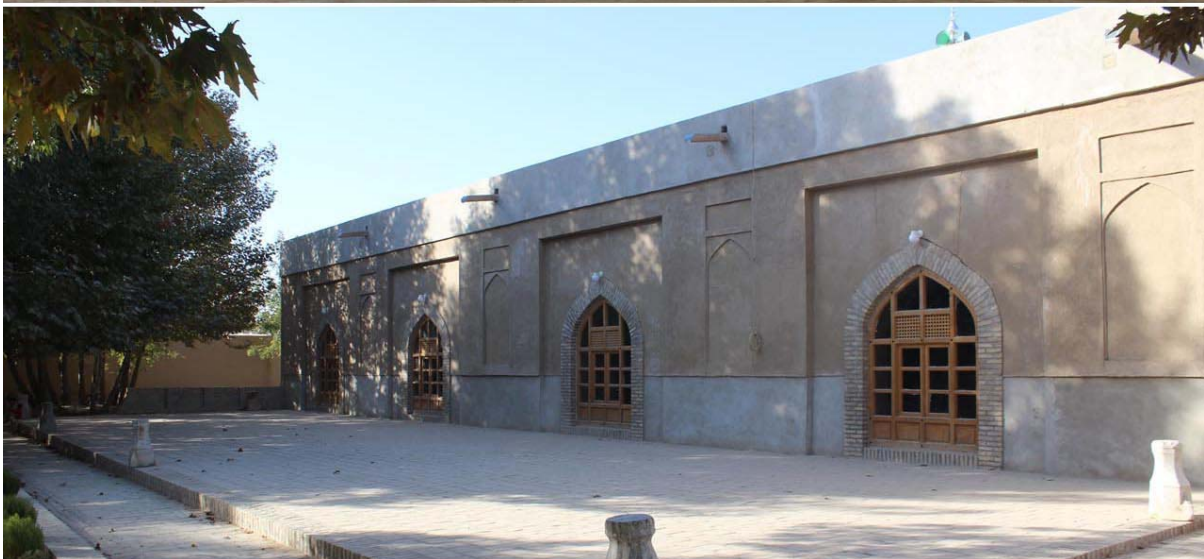
Plaster finish was used to cover over serious structural problems and settlement in the arches of the main elevation of the building. The deformed or broken arches could not be repaired without lowering the load bearing wall located above the arches. As this was not possible, an innovative solution was found whereby new arches were built beneath the existing arches in order to help support the damaged structure and transfer lateral forces and weight. Once these secondary support arches had been constructed, the original arches were consolidated in place through the injection of gypsum grout into large cracks. More than 15.8 cubic meters of new baked brick masonry was laid with lime mortar in order to build the support arches.

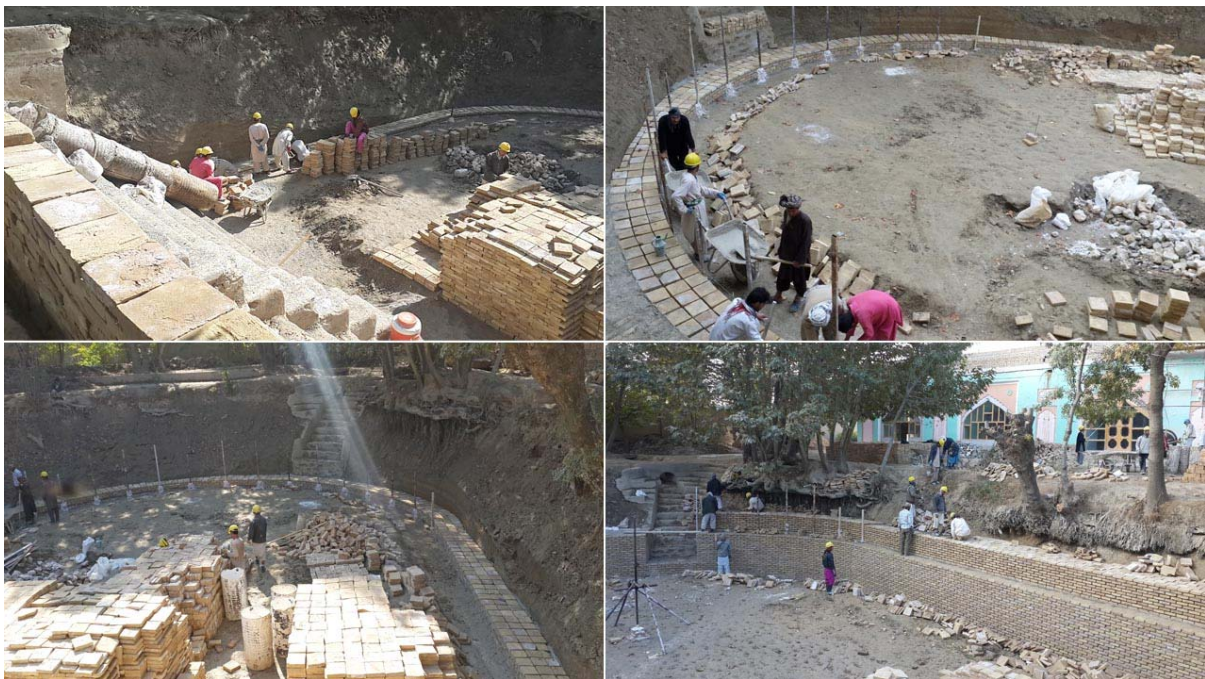
When consolidation works commenced, the only section of the reservoir that contained traces of its historic construction was a section of baked brick staircase on the northern edge of the pond that descended into the water. The remaining 71 meter long perimeter of the reservoir was made of irregular earth banks. The precarious condition of the reservoir presented further dangers for young children and worshippers who frequented the Mosque or collected water.

In order to prepare the reservoir for consolidation works, it was drained of all water using mechanical water pumps and more than 255 cubic meters of sludge and water born vegetation was removed by hand.
