SHAHJAHANI MOSQUE CONSERVATION

Baghe Babur, Kabul

Completion Report

Ratish Nanda, Conservation Architect
January 2005

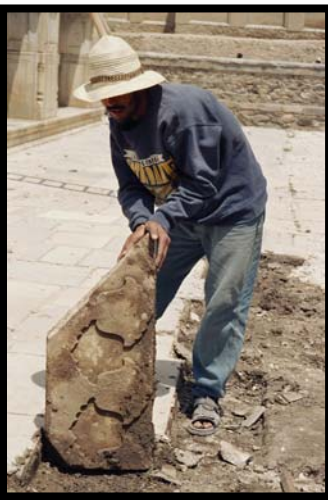
Original parapet piece reused in the plinth, discovered during recent surface archaeology investigations

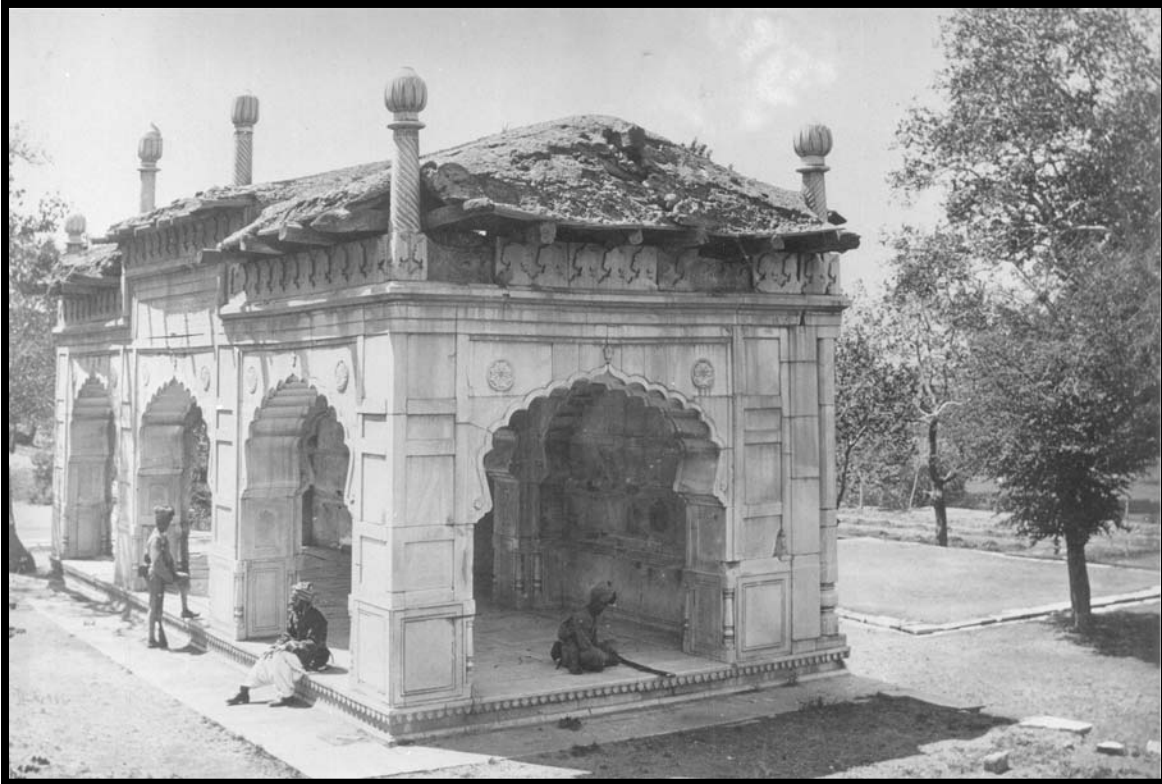
The first documented roof addition, possibly to prevent water seepage, 19th century.

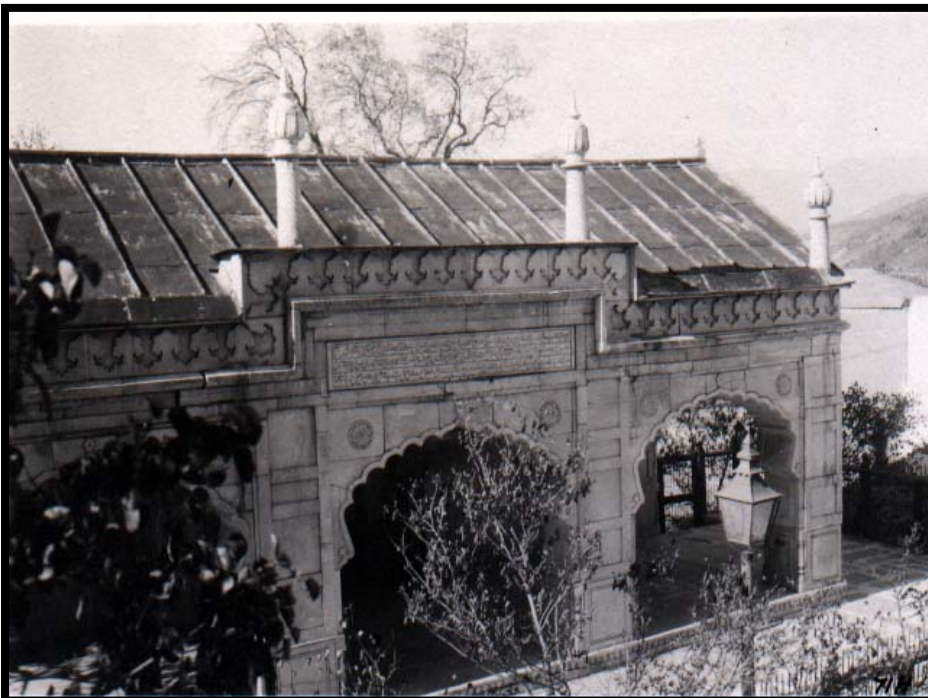
The second documented alteration/addition to the roof.

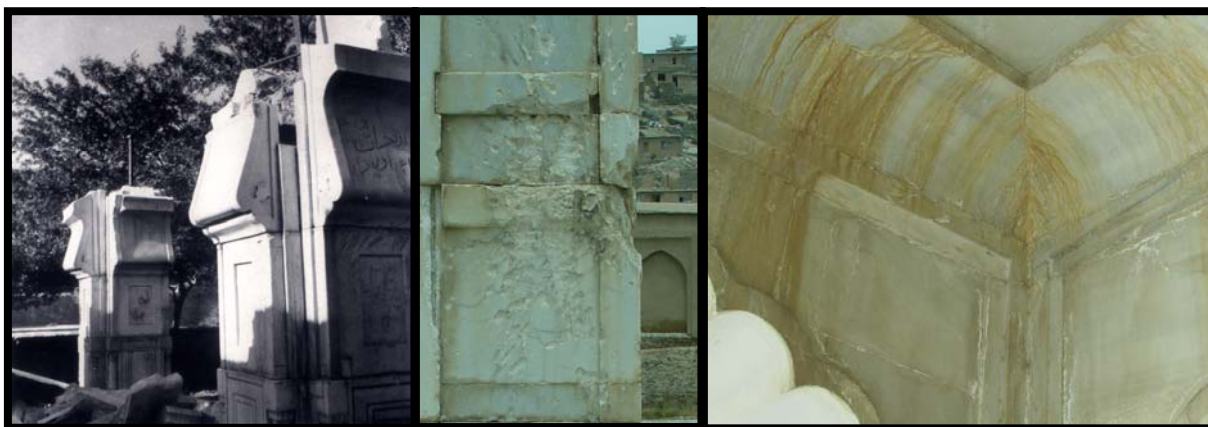
The mosque was found in a state of deterioration; a variety of factors combined to cause decay and the three principal reasons were:

- ❖ Inappropriate materials used during the 1964-66 restoration (concrete, bottom left picture).
- ❖ War damage, mostly accidental and caused due to the crossfire (bottom centre picture).
- ❖ Neglect of the building and its surroundings (ferrous run off due to water seepage).

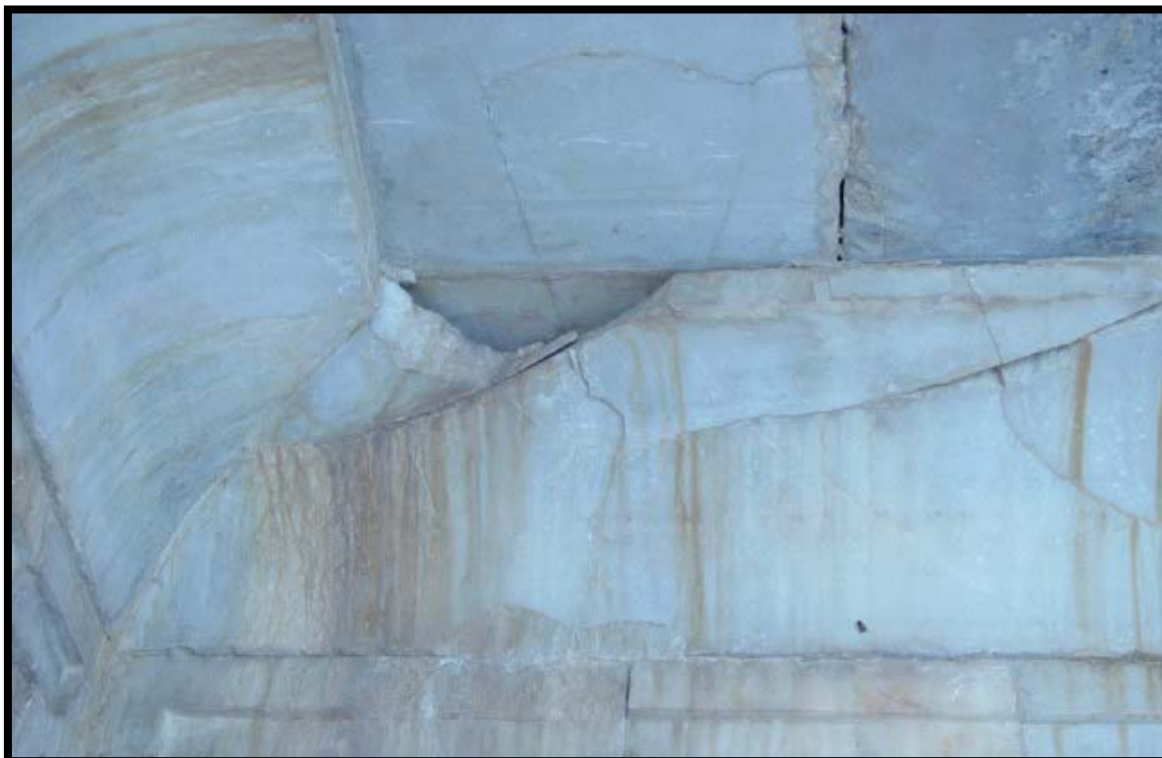
In the central bay one of the marble slabs, 3000 mm+ long, 400 mm wide and over 150 mm thick on average was supported on the west cornice with an overlap of only 25 mm. Though the slab was supported on the adjacent stone with a minor lap joint it nevertheless resulted in cracking in the 2 m cornice stone (see picture below) causing it to split.

Following documentation of the marble plates it became evident that replacing the damaged west cornice of the central bay would not be sufficient as with the limited overlap and high point load the new cornice was likely to crack in a similar fashion. The marble plate was temporarily supported using jacks and a brick masonry pier, 1m square in plan and built in mud mortar. This temporary support allowed the damaged cornice to be removed and be replaced with a new cornice stone 1.2 m long prepared in carefully selected marble from the quarries in the Wardak region and using only hand tools in order to encourage traditional craft techniques. Once the new cornice stone was in place, in order to avoid a recurrence of the damage and to provide extra support to the marble plate, an additional ‘T’ shaped marble stone was placed over it. Extending 100 + mm over the cornice with a chamfered edge, this stone was used to support the marble plate. Though visible from below, it is a repair meant to stabilise¹⁶ the roof structure with a minimal intervention¹⁷ and that too with the same material- marble, prepared using traditional tools and techniques¹⁸.

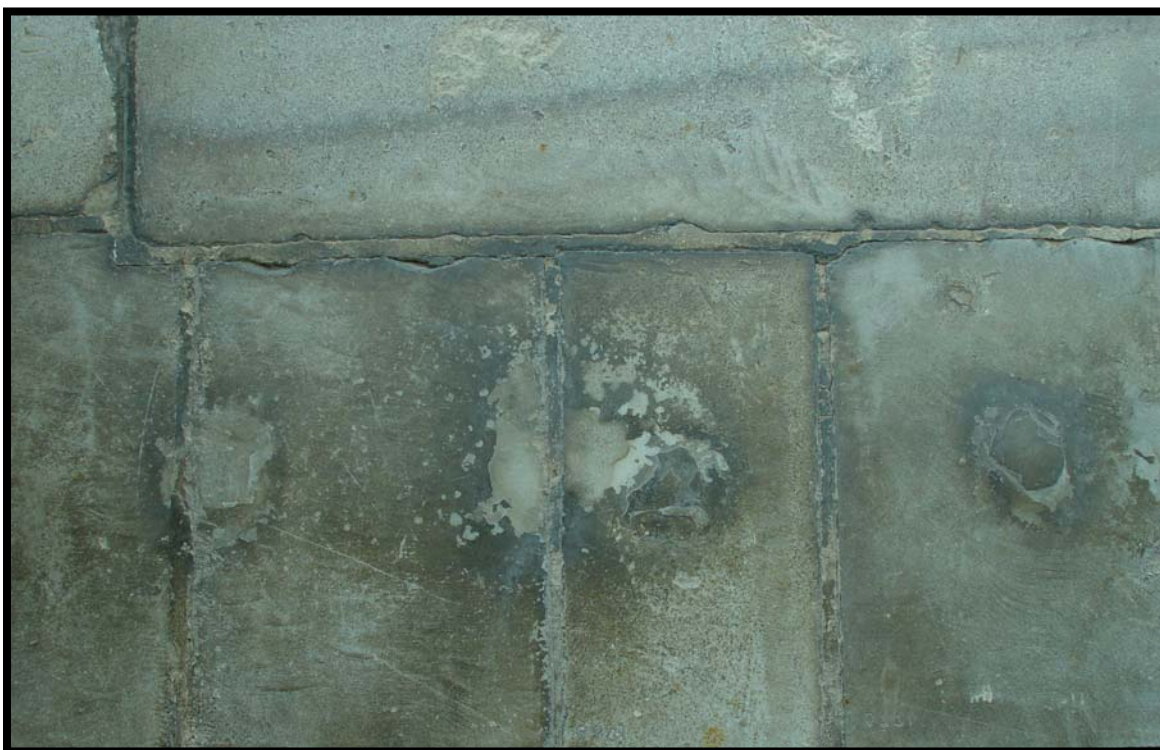
accumulation on the roof and subsequent penetration. A water channel to the east of the mosque feeding the upper water reservoir has been leaking for several years causing water accumulation in the grounds adjacent to the mosque. With the surroundings of the mosque paved with stone over cement concrete the water accumulates under the mosque causing rise of damp and deterioration (picture below) of the flooring.

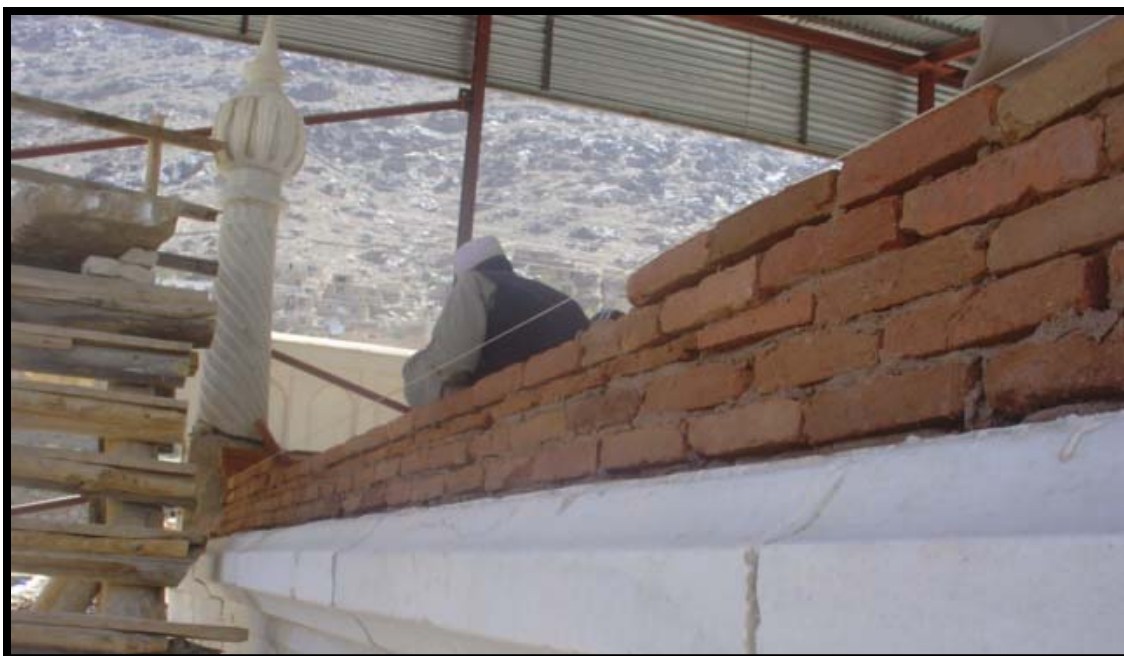
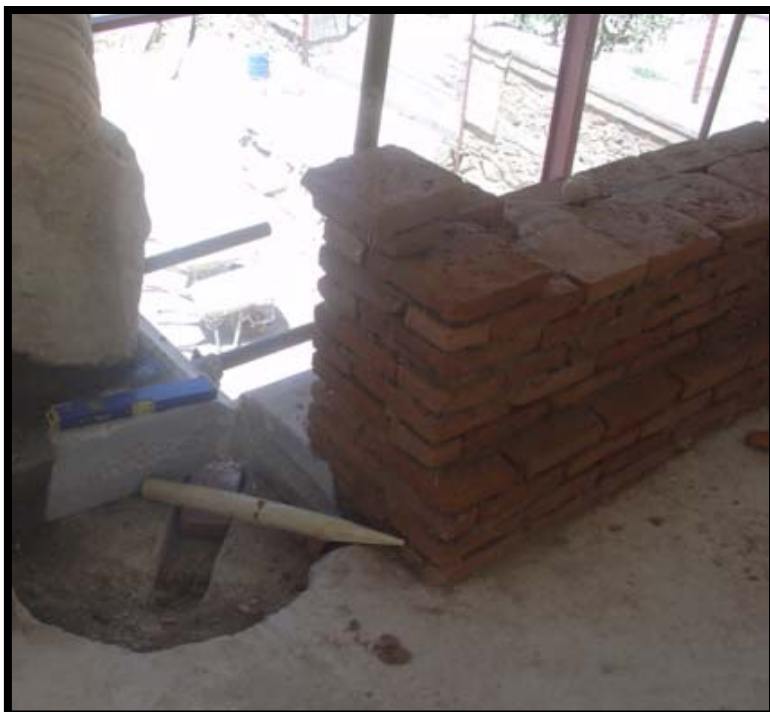
The parapet of the mosque was rebuilt during the 1960's reconstruction in rubble masonry with cement mortar. The poor masonry was causing water seepage into the masonry leading to salt formation on the marble facing of the walls in the mosque. Also, the marble facing of the parapet was partly missing and was in a state of collapse in several parts.

The parapet was carefully dismantled with each of the stones in the facing carefully numbered prior to being dismantled. The parapet was then rebuilt in brick masonry with lime mortar.
