AGA KHAN TRUST FOR CULTURE

Historic Cities Programme

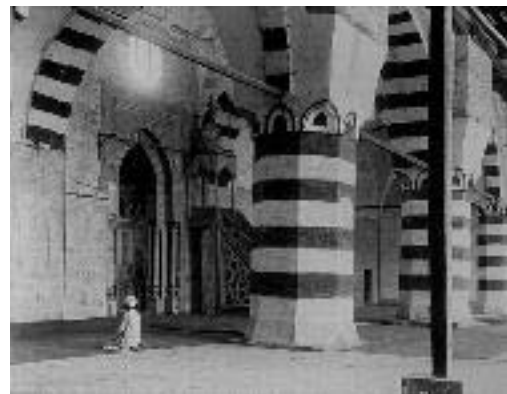
The brick one-bay dome above the mihrab is carried on four plain squinches built of brick. Similar squinches are also used to carry the brick dome over the mausoleum of Kuchuk, but with a pendentive underneath each squinch. By the time this foundation was built, the use of plain squinches in the transitional zones of domes instead of muqarnas pendentives or squinches was old-fashioned. The blue Iznik tiles on the qibla wall were installed in 1652-64 by Ibrahim Agha, who seized and redecorated the mosque. They were imported either from Istanbul or from Damascus.

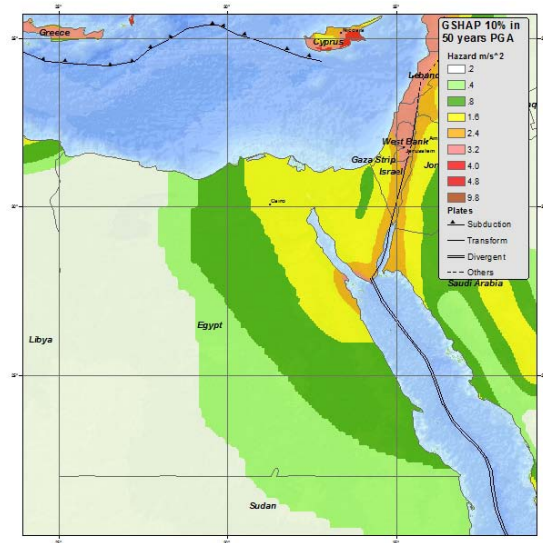
Map of Egypt Seismic zones

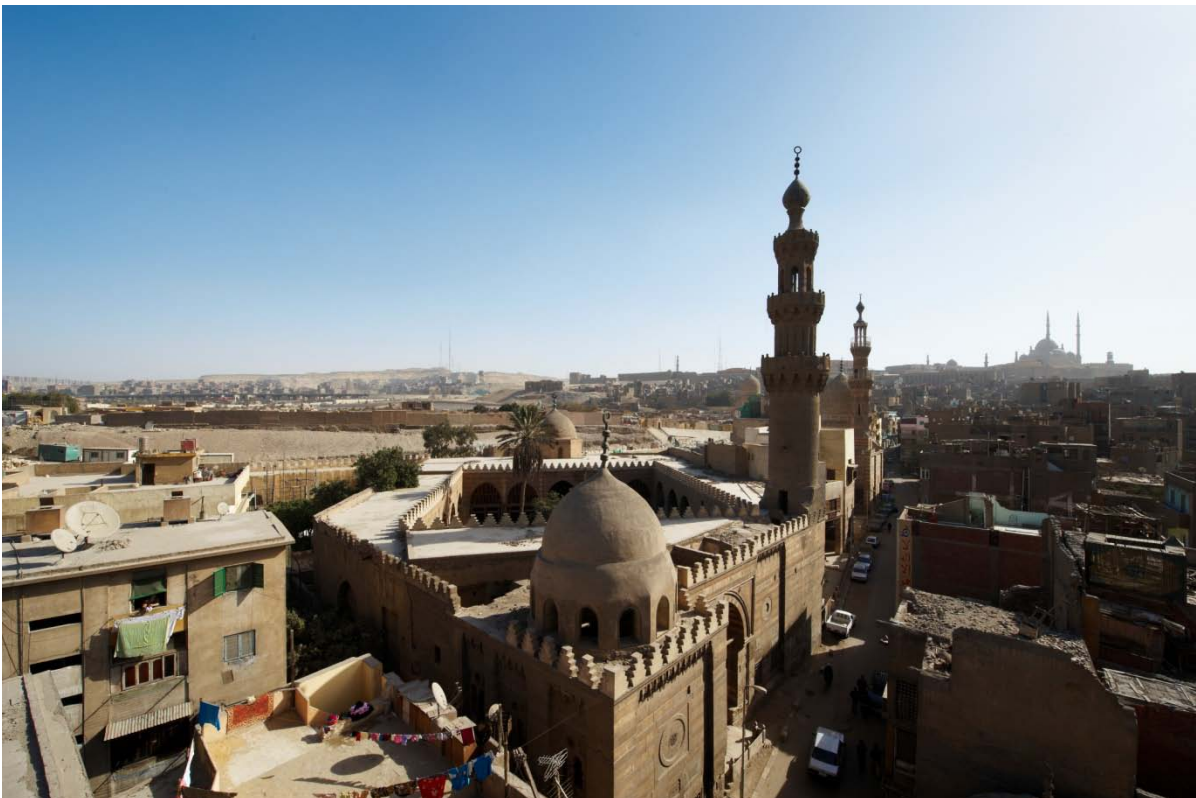
General view of the building from the North-East, including Kujuk mausoleum in the foreground, the minaret (of which the top fragment was reconstructed in 1924) and in the background the mosque's courtyard and cupola over the covered prayer area. The building is aligned on darb al-Ahmar Street leading to the Citadel, centre of sultanate power.

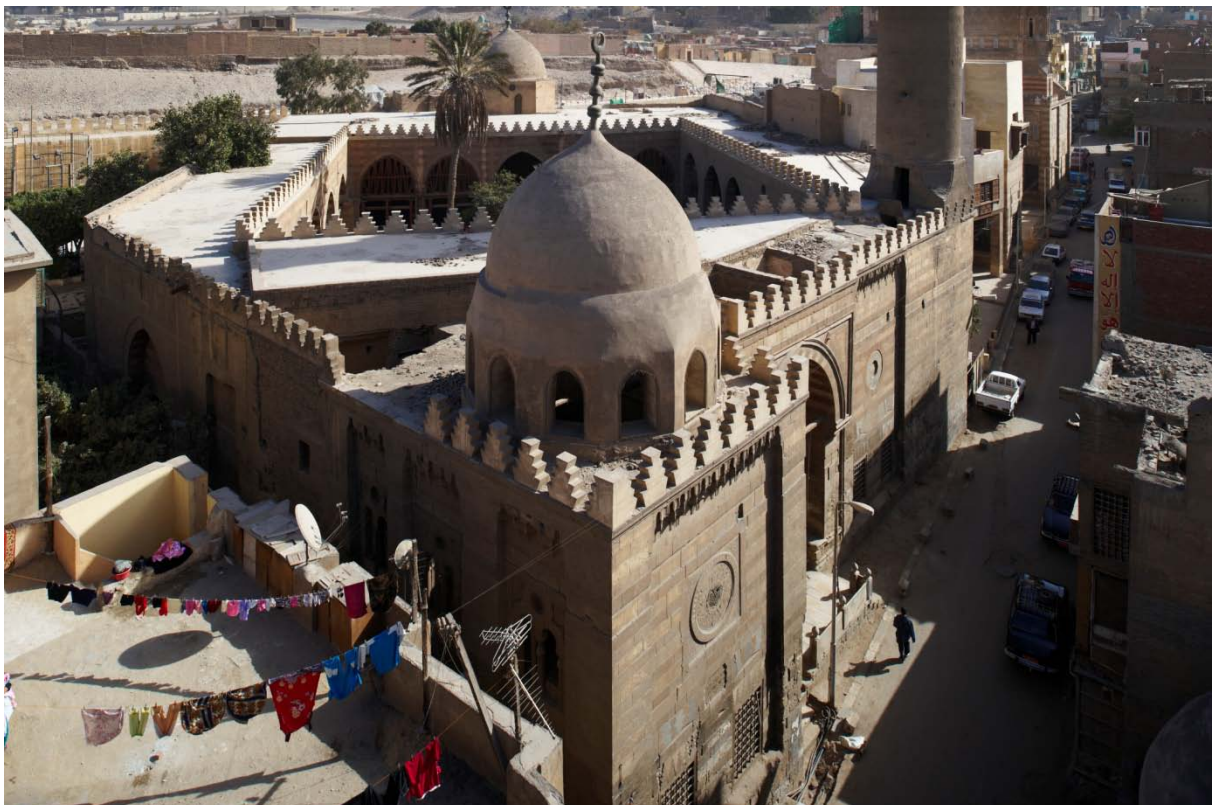
(Bottom) General view of Kujuk mausoleum cupola and of the roofs. The connection between the stone octagonal base of the cupola and the brick semi spherical dome is not perfectly mastered externally. The crenellations are clearly resulting from the Comité intervention. All elevations are covered with the aggregated dust forming a 8-10mm crust that is typical of Cairo's polluted environment.

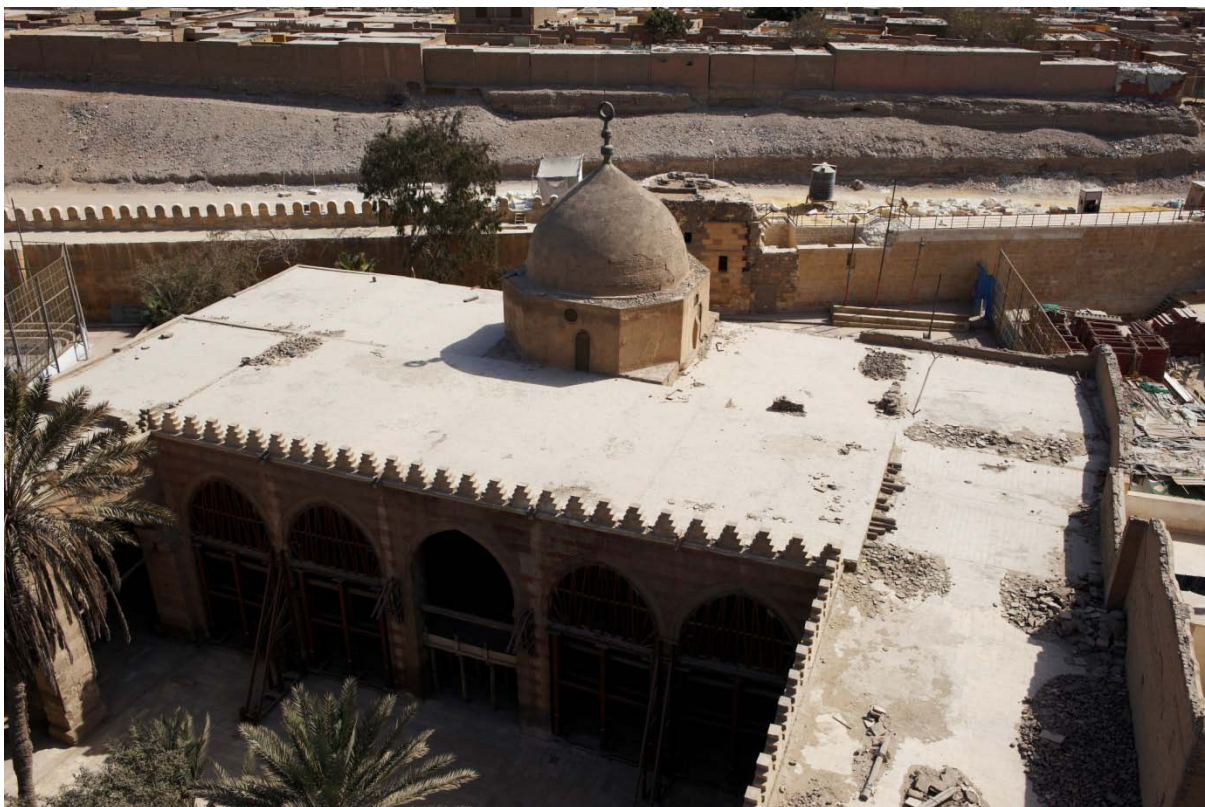
(Top) General view of the roofs covering the prayer area: roofing system is made by parts and not fully leveled to ensure proper rain water drainage. Decayed materials accumulate in several areas.

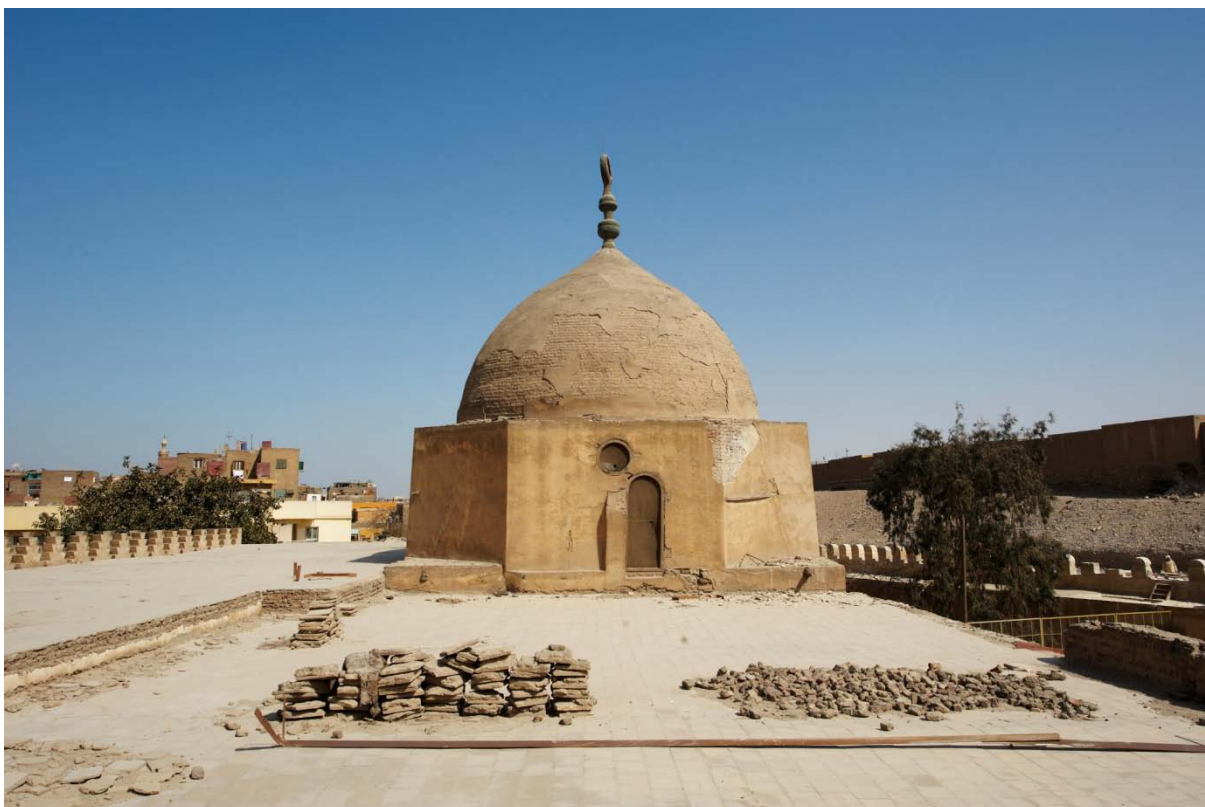
(Bottom) View of the roof covering the prayer space and of the dome at its centre: the roofing and insulation systems are not continuous, roofing tiles are decayed leaving the sand visible. The dome masonry has been subject to significant interventions: the joint between the roof and dome does not appear to be water tight, some windows in the drum were blocked by masonry, the brick cupola is cracked, large areas of plaster are missing

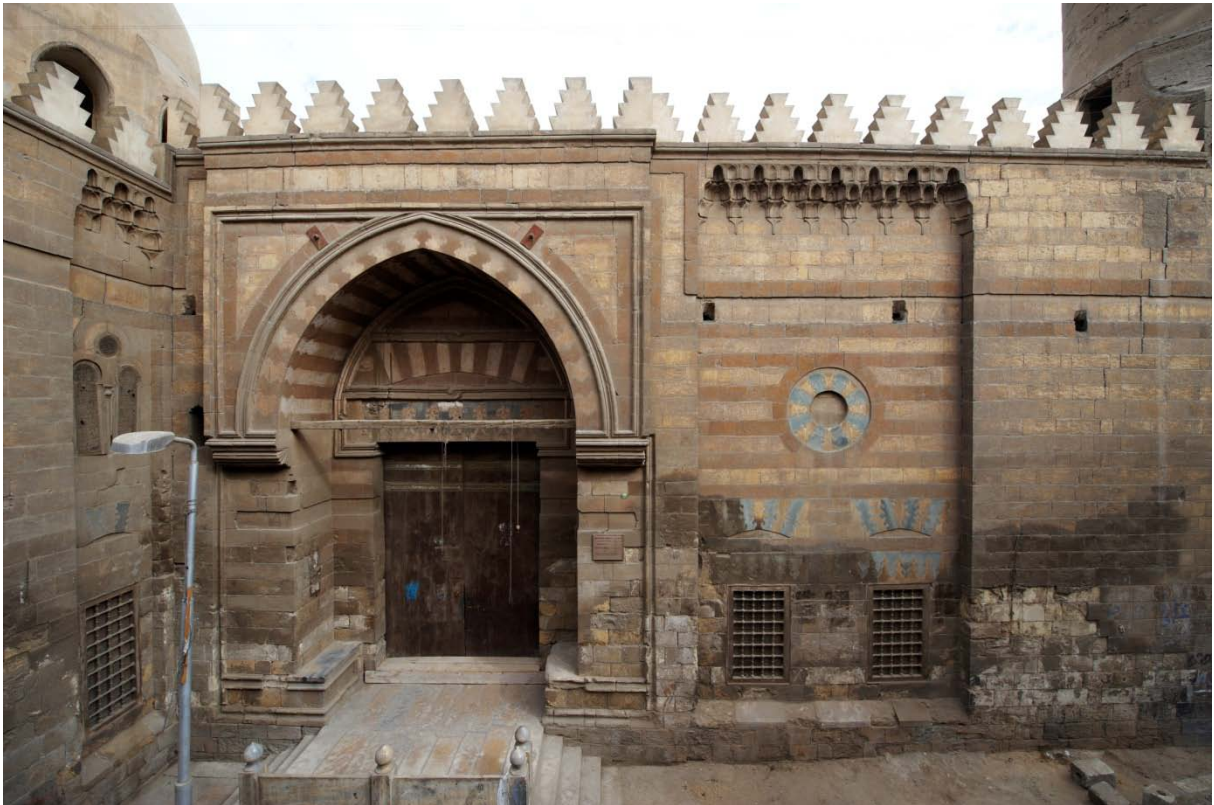
(Top) The Mosque's entrance portal and main façade lining Darb al Ahmar Street. The general damage pattern of the Mosque's elevations is marked by a line of salt migration from the ground up to 2-3 m, creating decay to the stone veneer (desquamation) and on the mortar joints (powdering). Cause of this moisture damage appears to be a combination of the Cairene habit of watering the streets, garbage deposits at the foot of the facades and leakage of the underground main potable water pipes.

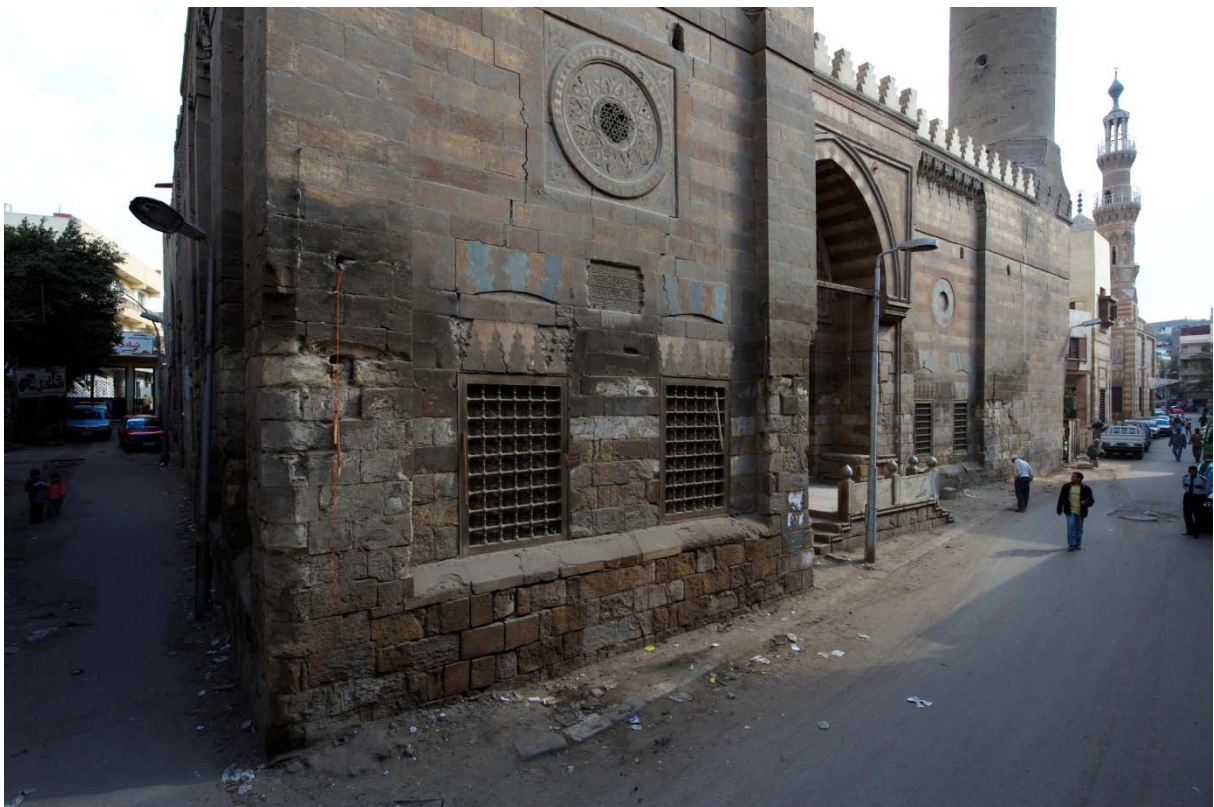
(Bottom) Elevations of the Kujuk mausoleum. A similar damage pattern is visible, made more significant in the building's edge. The lower portion of walls has lost its pointing mortar and all stones are either covered by thick soluble salt crusts or cracked and desquamated.

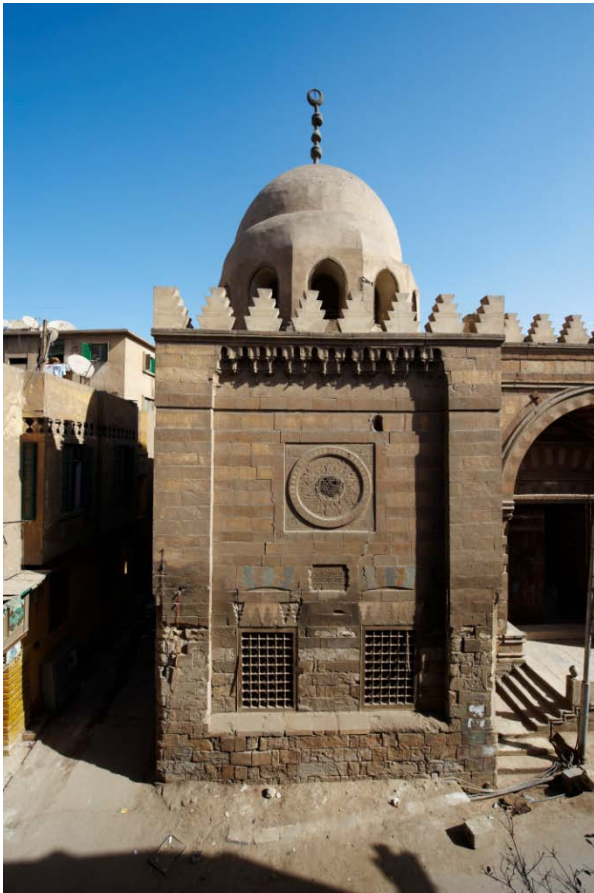
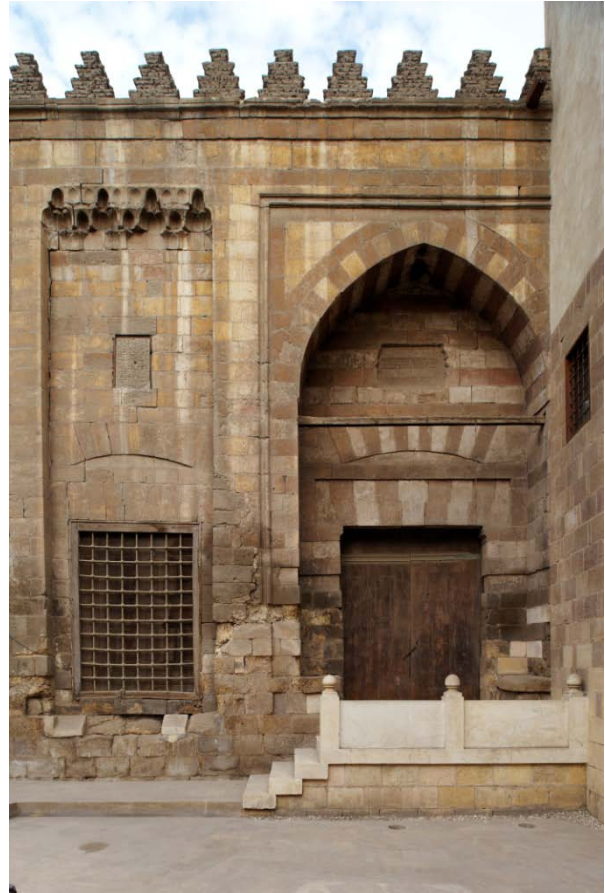
(Top Right) The Elevation of the Kujuk mausoleum, (Top left) The entrance to the Mosque from the South
Both facades are affected by similar moisture damage dislocating the lower part of the stone masonry up to 3m of height
(Bottom) Detail of the North elevation. Capillary action causes dislocation of stones in the area between 1.5m and 2.5m of height from ground. Pointing mortar loses its consistency in the same zone causing risk of structural collapse.

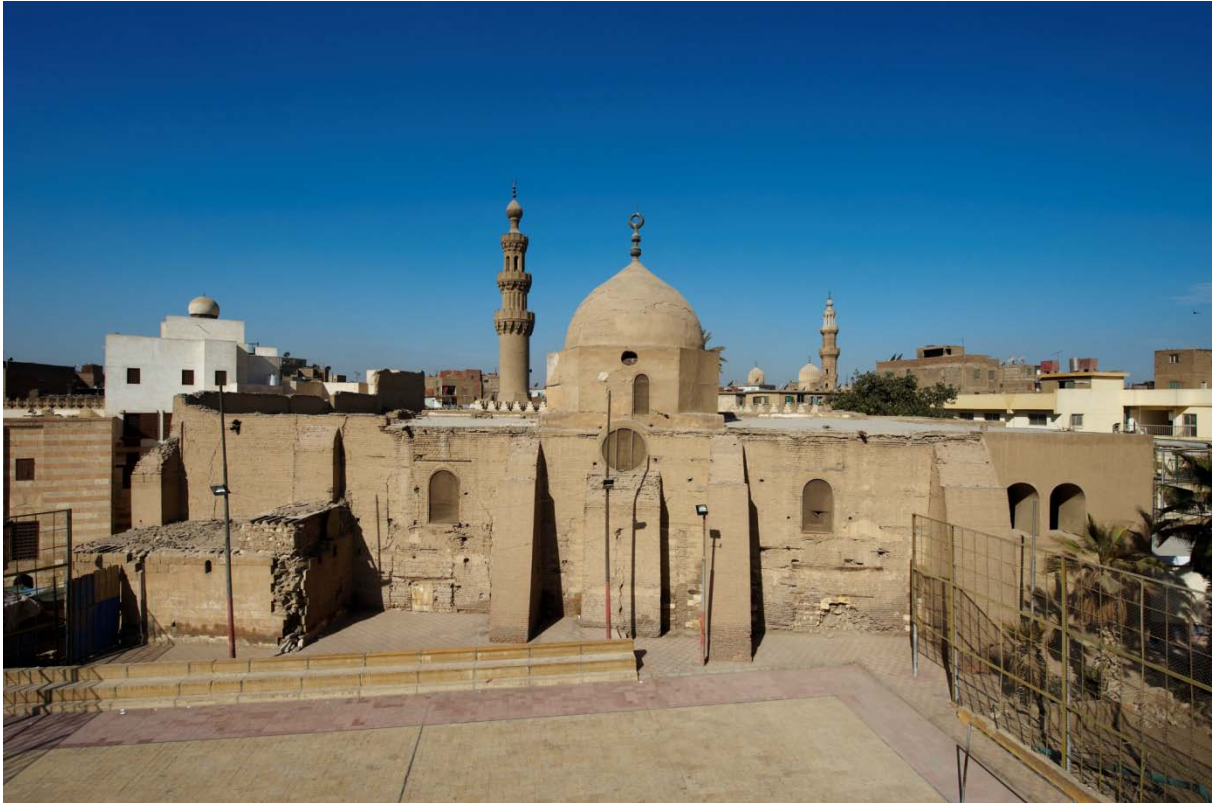
(Top) The Elevation of the Mosque from the East
(Bottom) Detail of the East elevation

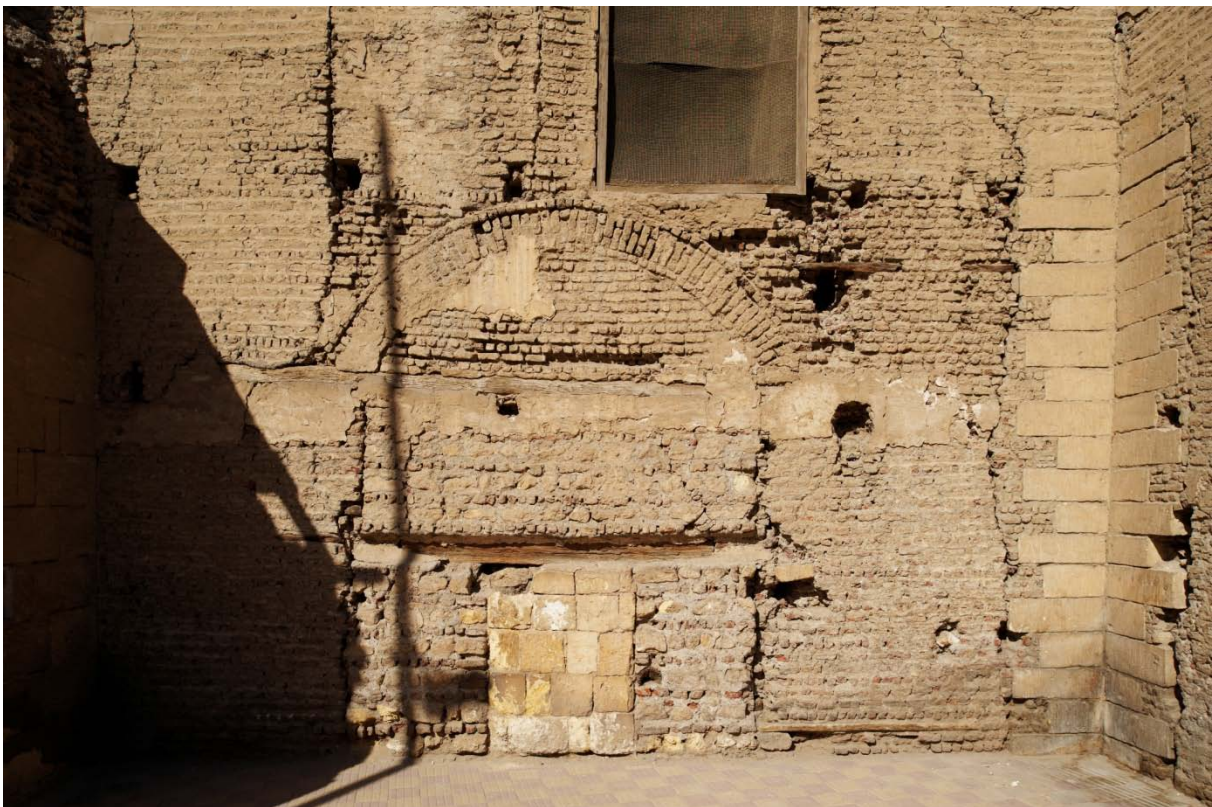
This rear elevation, made almost exclusively in brick masonry, was not expected to be visible. It still bears the marks of encased beams, entrance doors, evidences that the prayer space was connected in the past to small buildings, shrines, which used to be abutted and were later demolished. Robust buttresses were constructed to support the qibla wall. Connection of the façade with the current sport ground tiling causes risks of water ingress into the stone masonry.

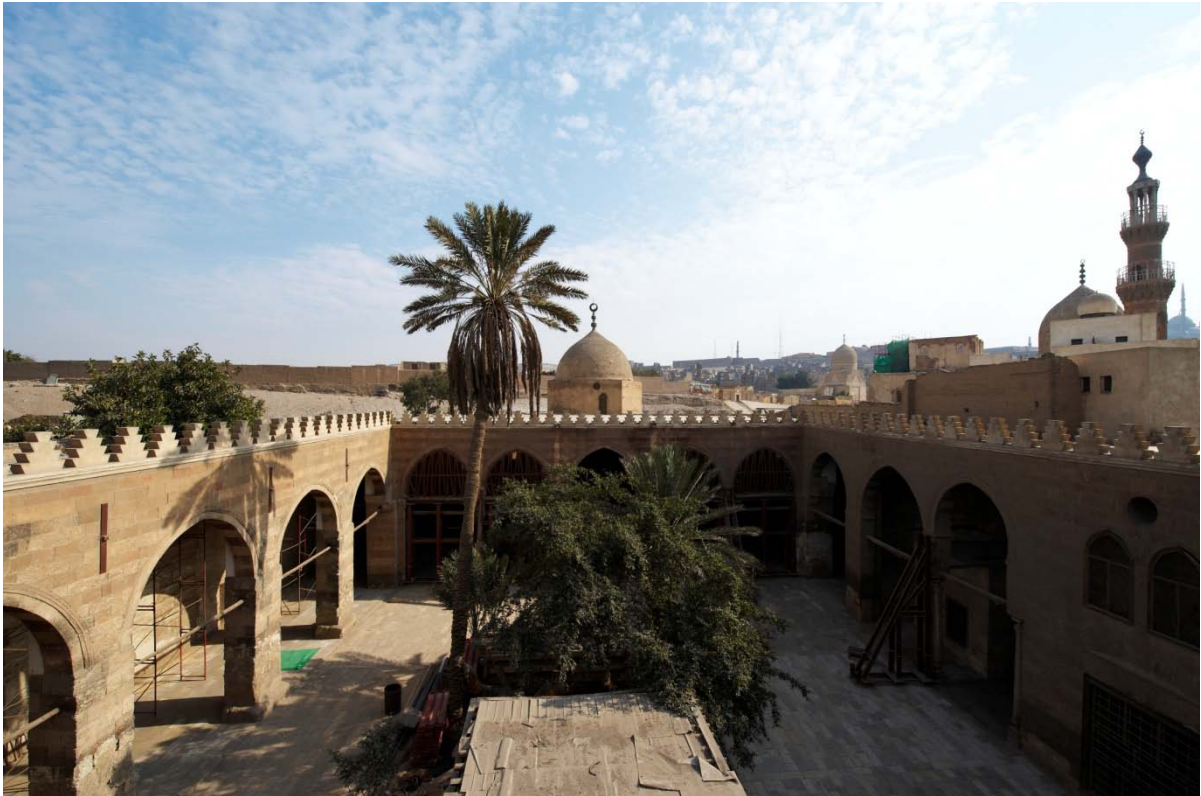
(Top) General view of the courtyard from the West

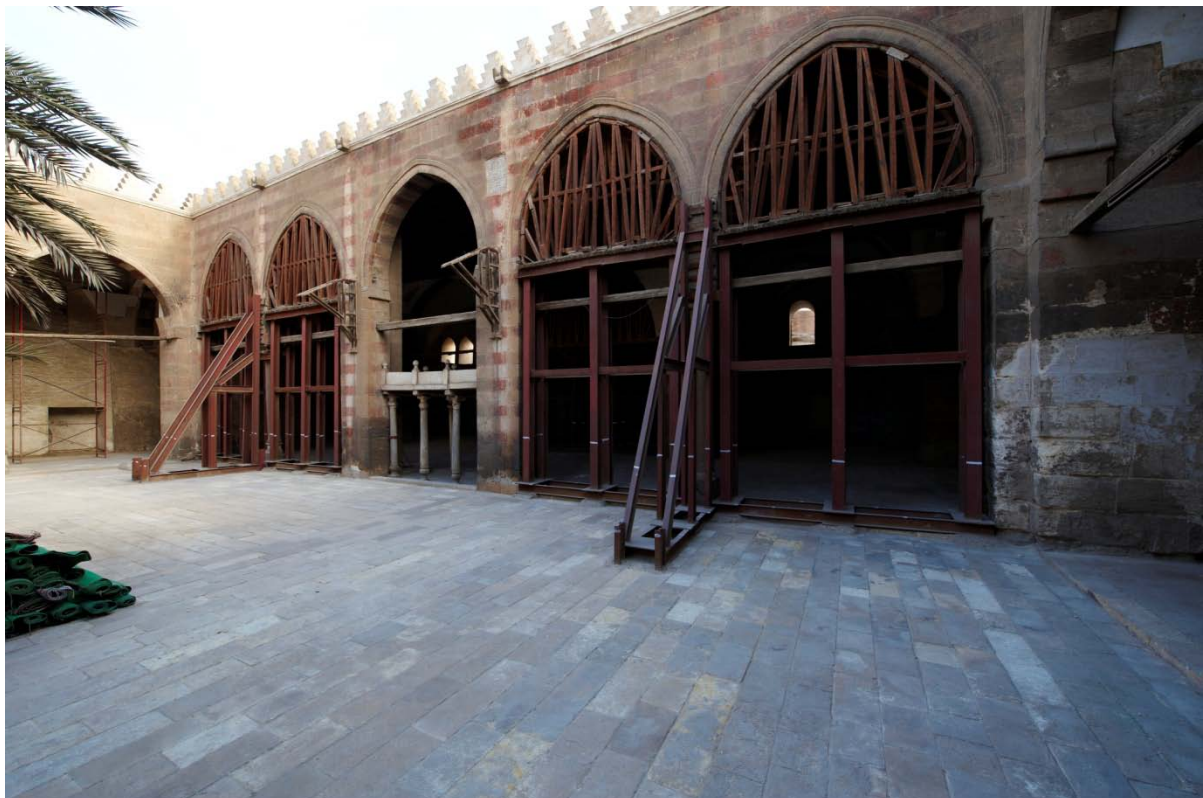
Note the good condition of the stone masonry and facing stone in the elevation. The natural color of the stone bands (orange and white) is accentuated by white and red lime wash.

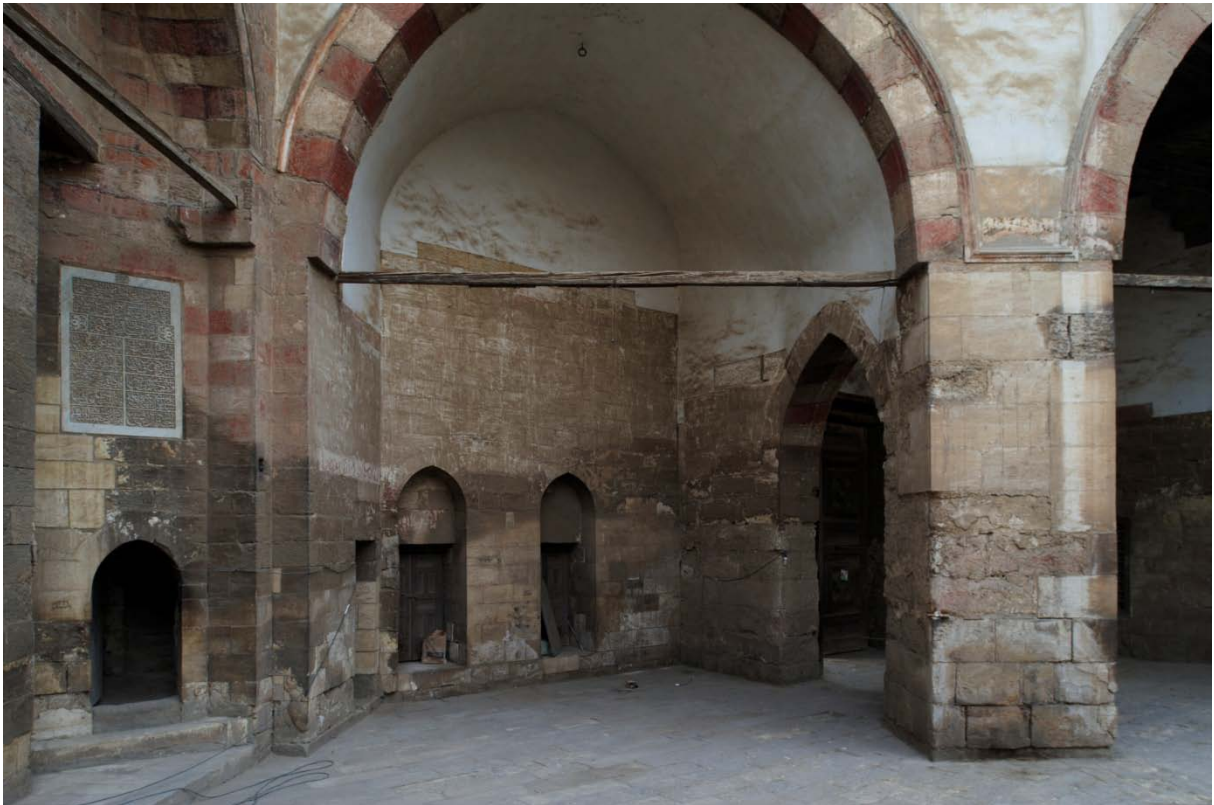
(Top) The geometrical connection between the façade walls aligned on the street and the courtyard pillar marked by an orientation to the qibla. Despite significant stone repairs by the Comité, stone masonry is not in good condition, in particular in the areas concerned with salt efflorescence.
(Bottom) Detail on typical stone masonry of the Kujuk mausoleum walls. The area is subject to a strong erosion of stones due to salt migration and efflorescence associated with general neglect

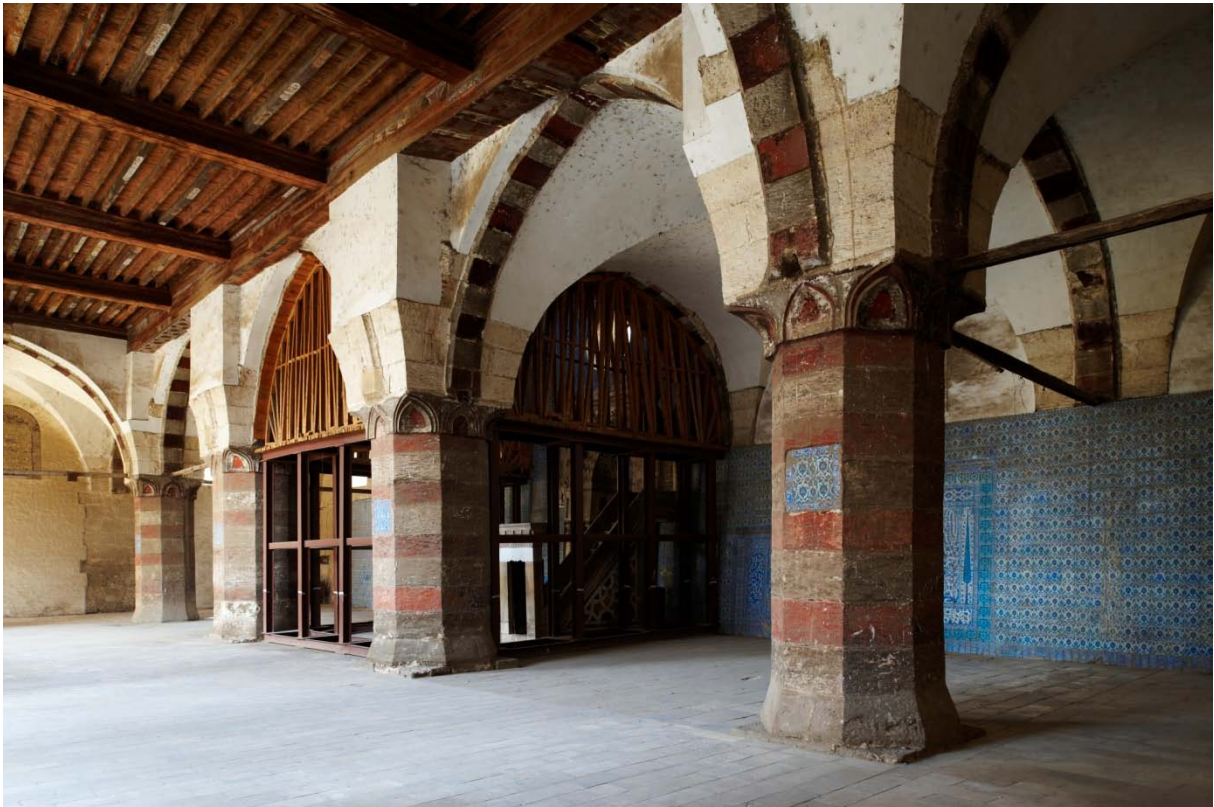
(Top) The covered prayer hall supported by octagonal pillars

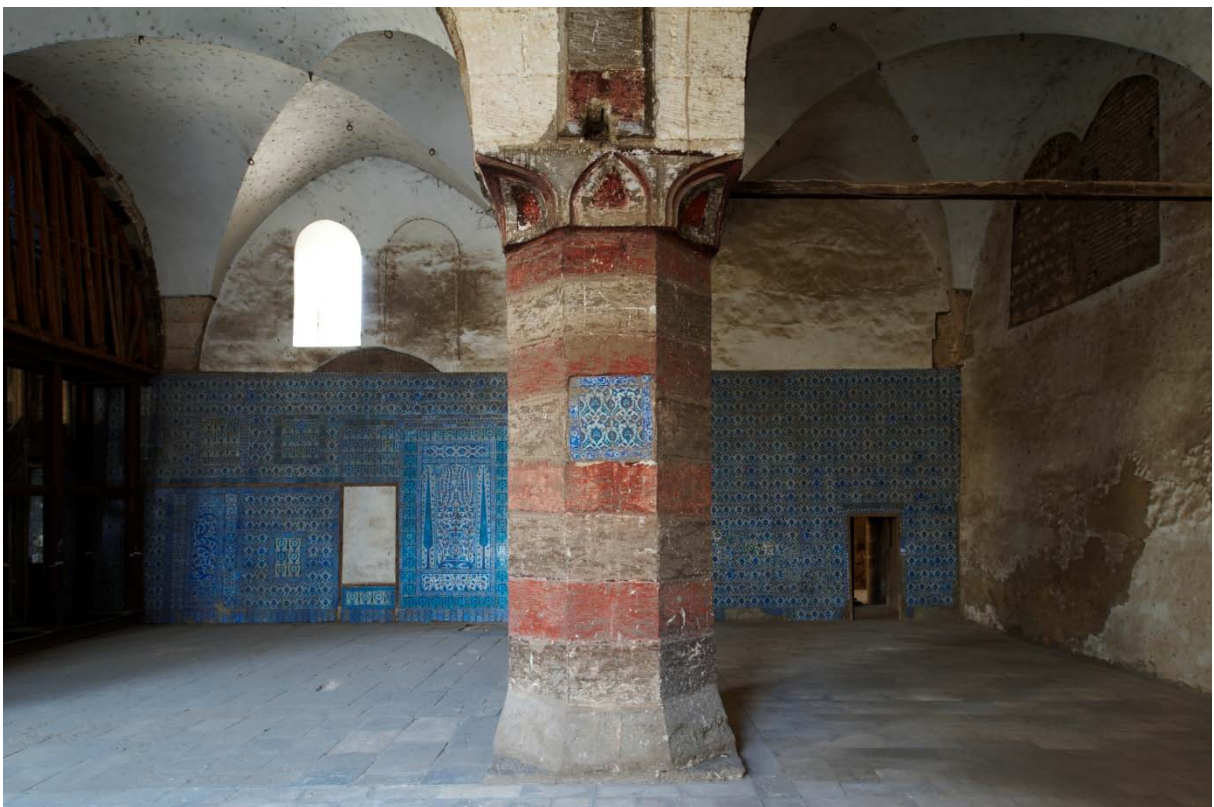
The interior prayer area is marked by two different roofing systems: stone masonry cross vault and timber flat roof related to two construction phases. Insertion of Iznik tiles on the pillars and al along the qibla wall are the most visible dimensions of the refurbishment by Ibrahim Agha in the 17th century. Apart dirt and neglect, the area is in a relatively acceptable condition.

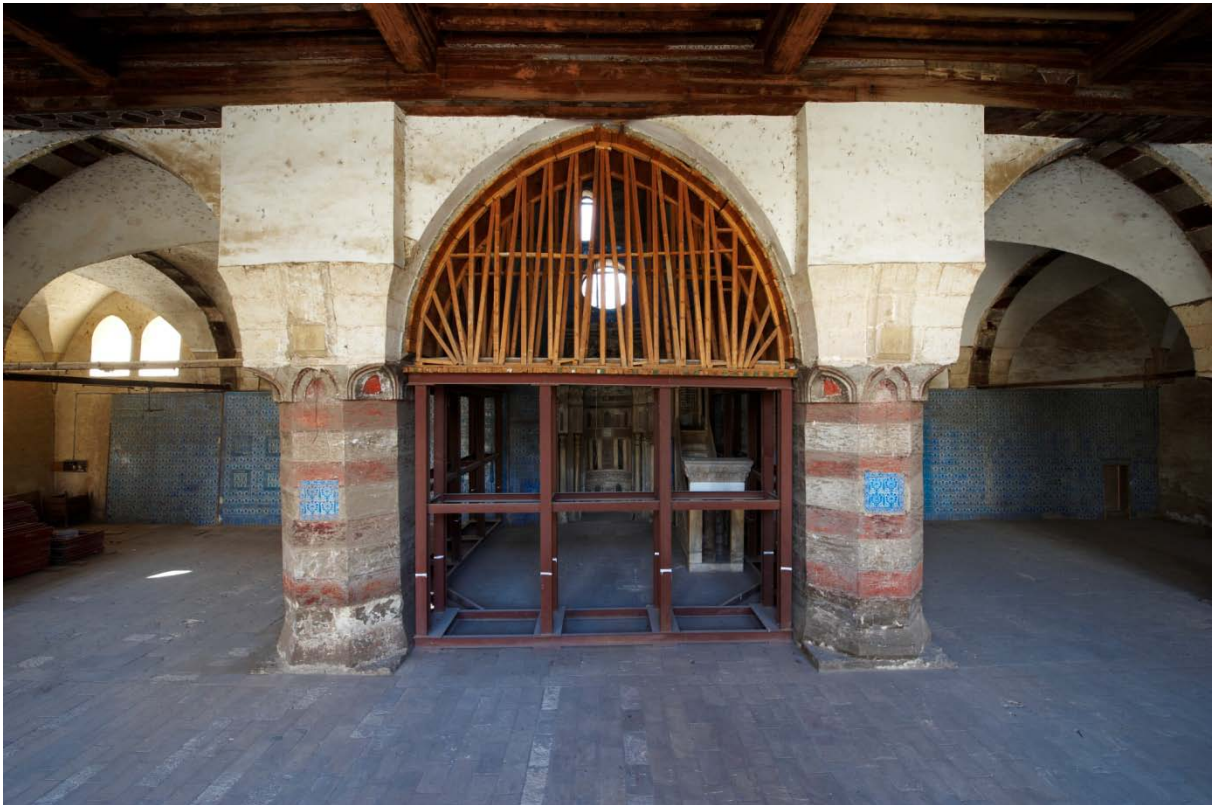
(Top) The central part of the covered prayer hall supported by octagonal pillars, with temporary shoring of the arches carrying the dome
(Bottom) the central dome with spines over the prayer area.
Cracking of the dome was found critical after the 1992 earthquake to be the reason for the construction of temporary support on its bearing arches.

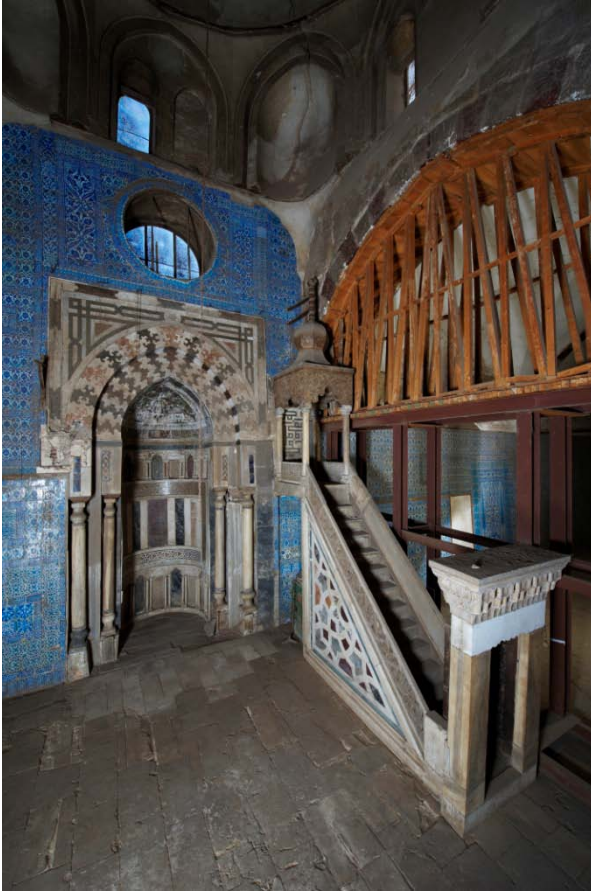
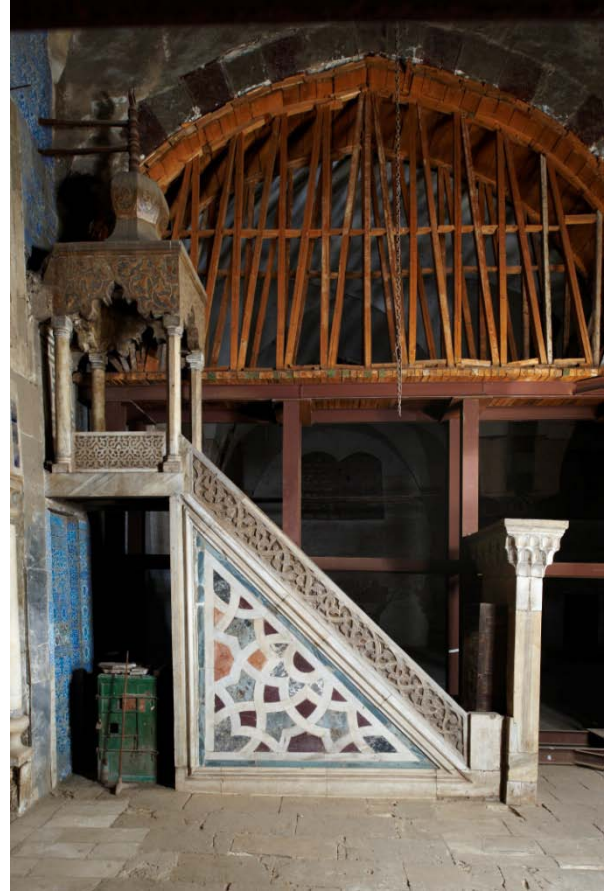
(Top left) The mihrab and minbar (Top right) the minbar, made of polychrome marble, porphyry, painted and gilded marble.
(Bottom left) the mihrab, pre existing the Iznik tiling refurbishment. Marble paneling is much deteriorated particularly in the lower zones, where gypsum base is subject to powdering and expansion due to salts migration. (Bottom right) the upper octagonal bulb, adorned with painting and gilding on marble panels

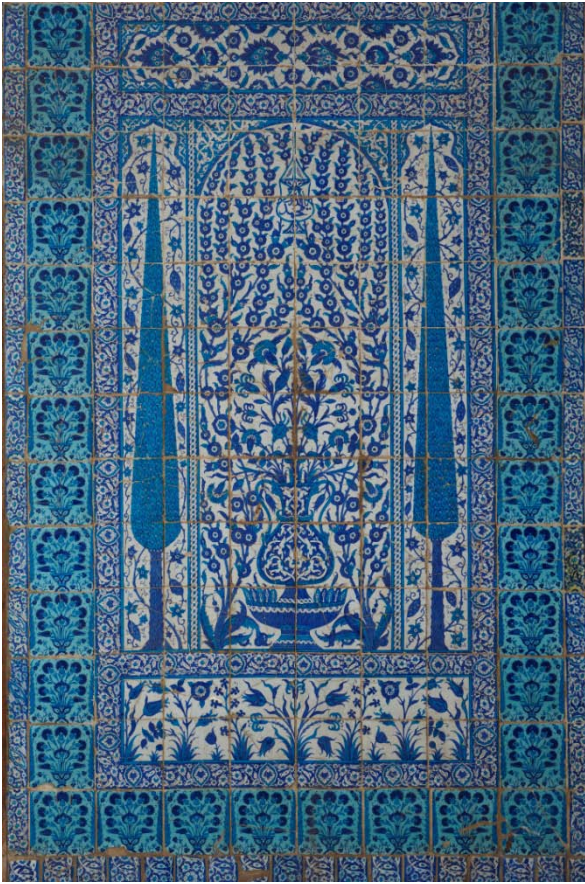
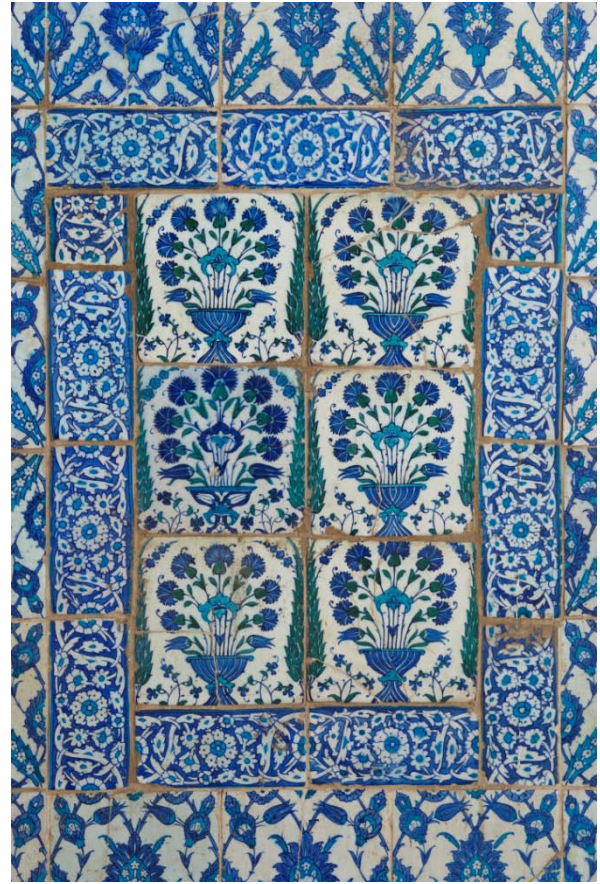
Various motives of Iznik tiling of the qibla wall: Iznik tiles were in relatively good condition. A large number of them were cracked but stable; some had disappeared due to theft. Neglect and absence of up keeping had caused tiles to be covered by dust and dirt.

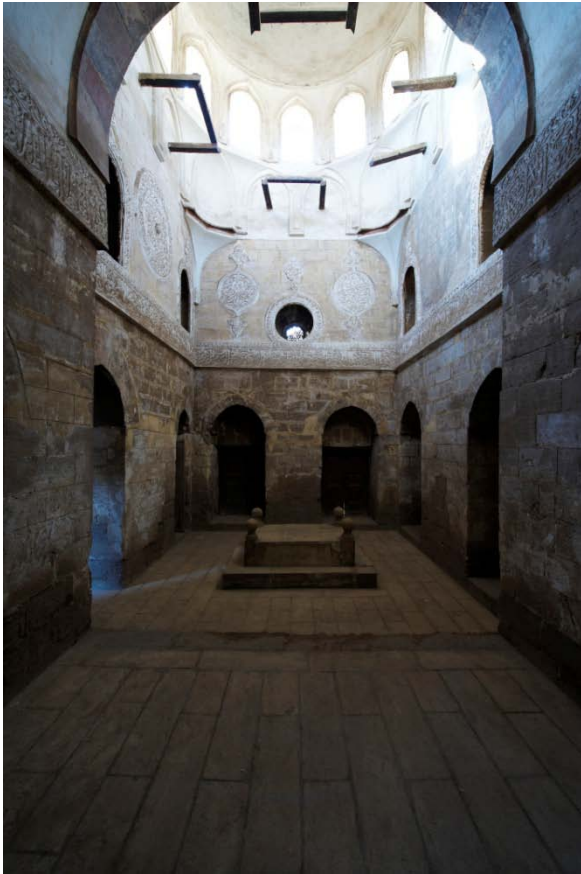
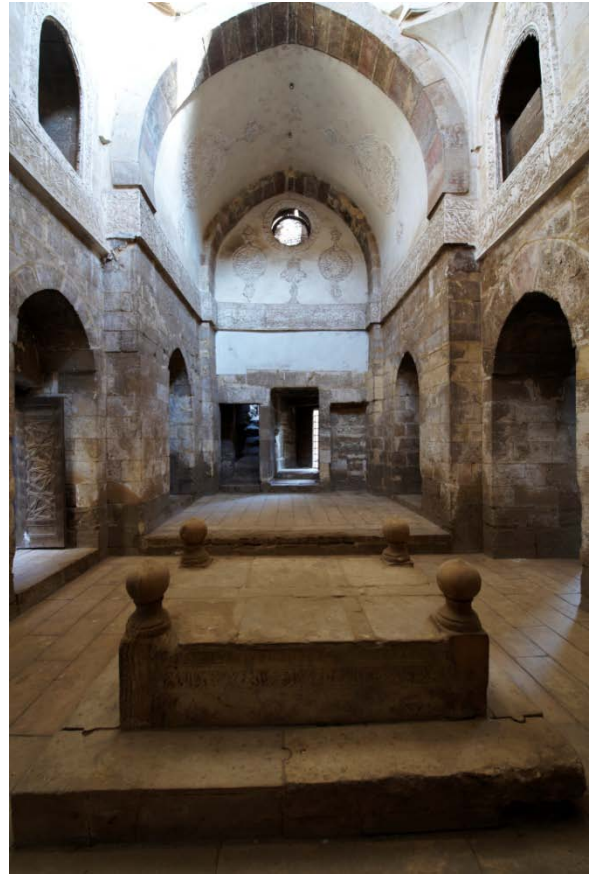
The mausoleum of Kujuk

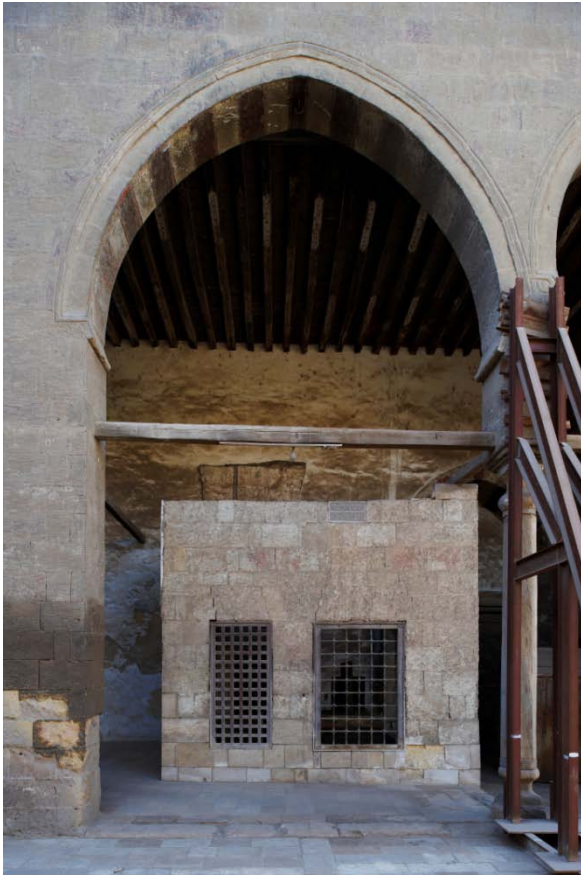
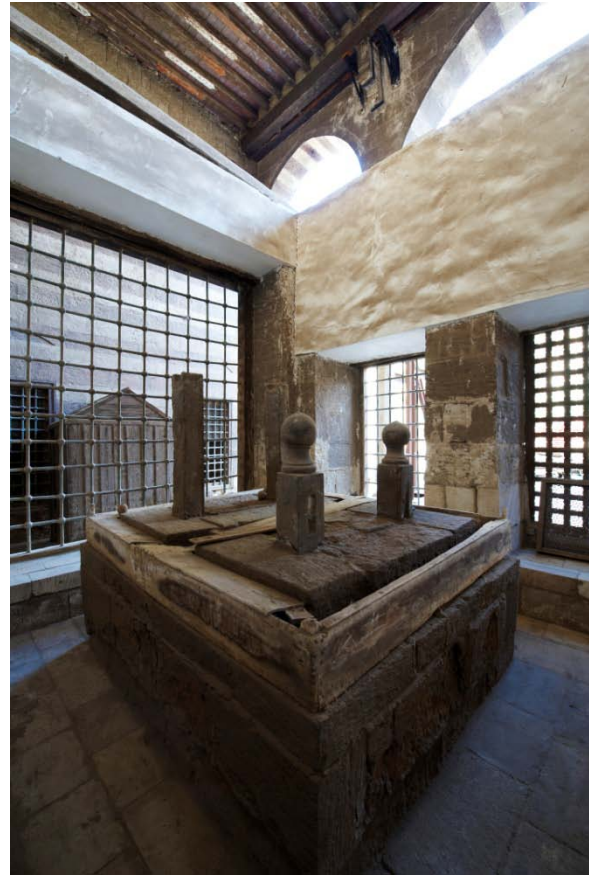
Amir Aqsunqur Mausoleum

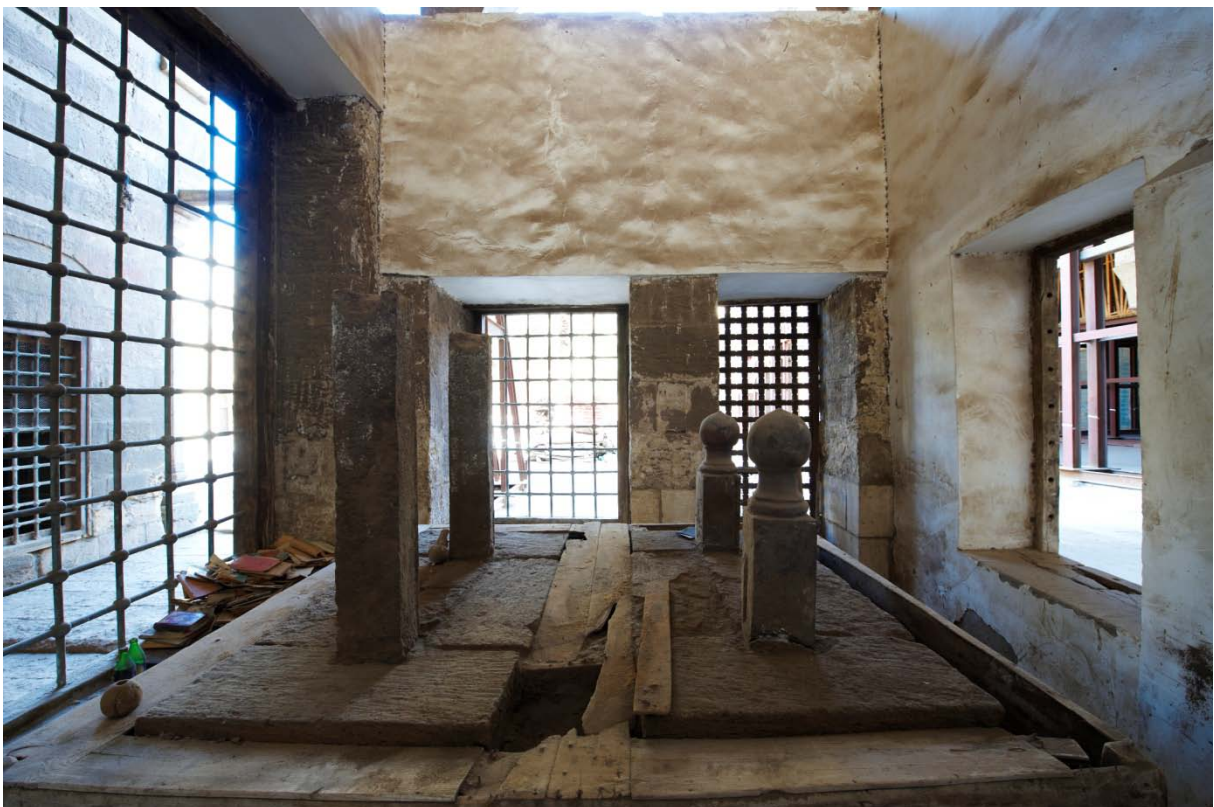
(Top left) The small edifice accommodating the tomb of Amir Aqsunqur is located on the South portico of the courtyard. (Top right) the cenotaph appears to be constructed during the ottoman period to refer to the Tomb of the Mosque's founder
(Bottom) Despite its modest size and unsophisticated finish, this mausoleum is in derelict condition.

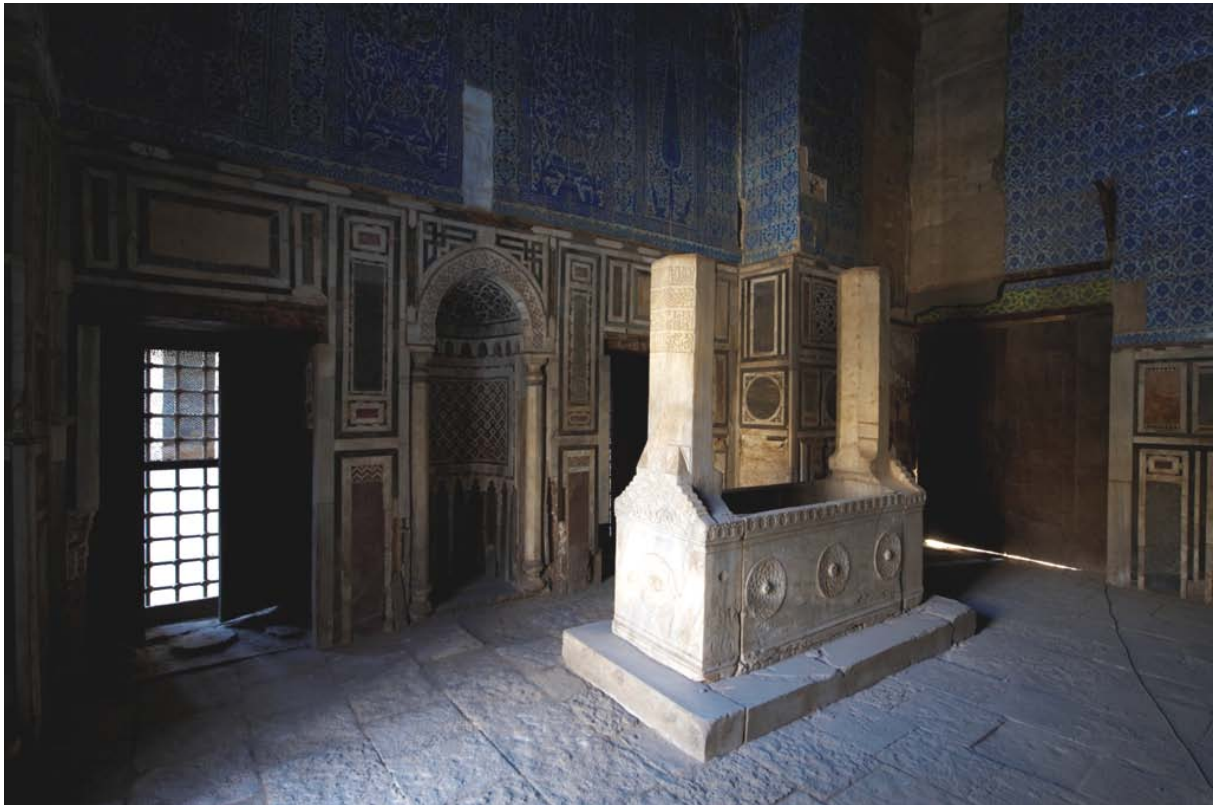
The mausoleum of Ibrahim Agha Mustafazan
