AGA KHAN TRUST FOR CULTURE

Historic Cities Programme

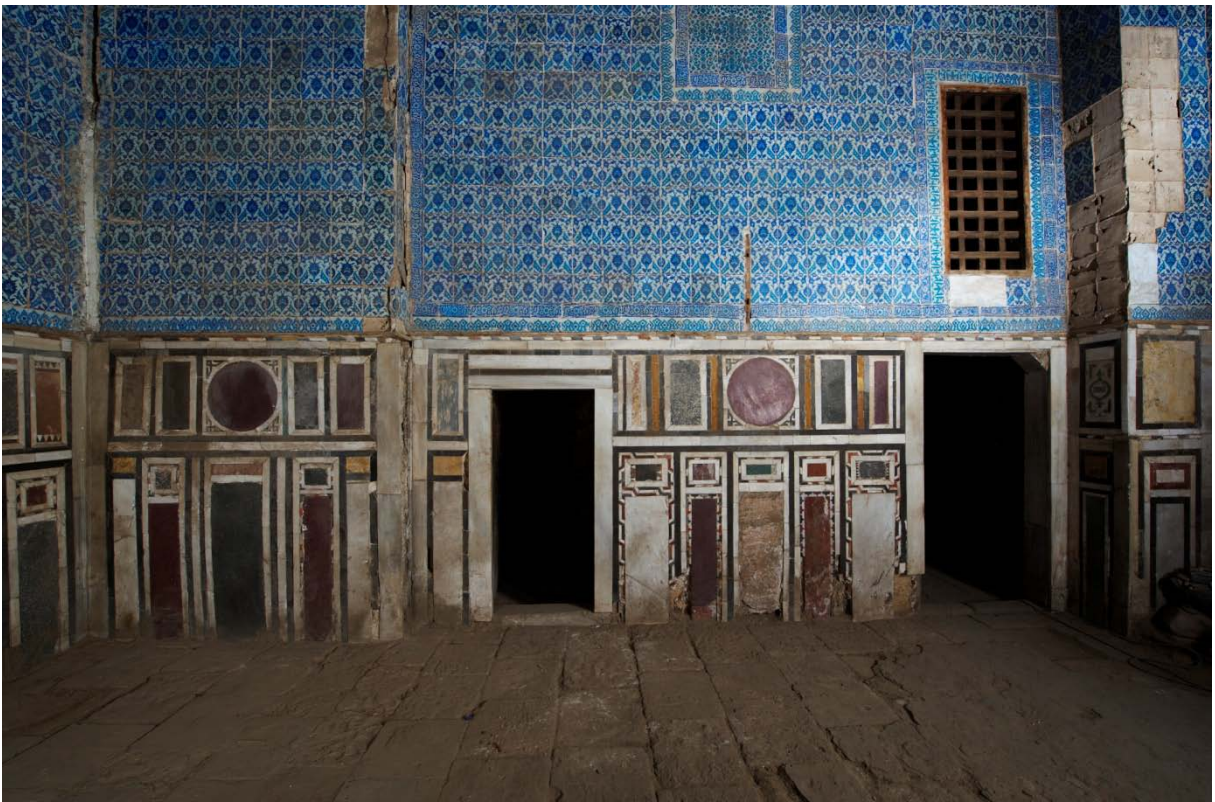
4. PROJECT ACHIEVEMENTS

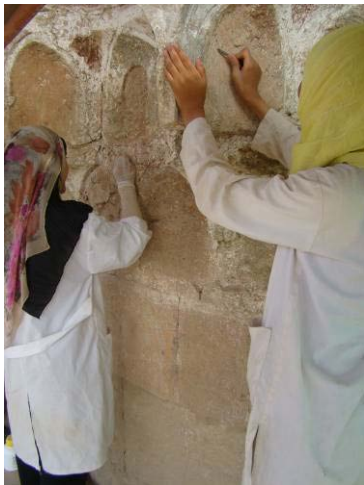
Mechanical cleaning of the lower balcony stalactites

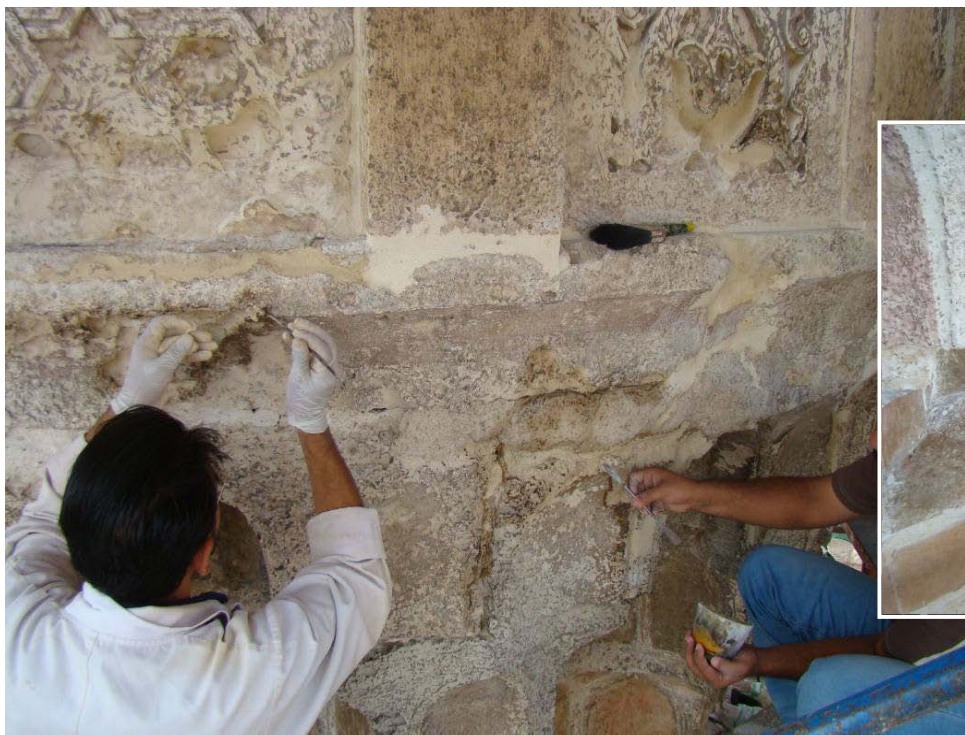
Re-pointing of joints and mortar completion of cracked and eroded stone parts

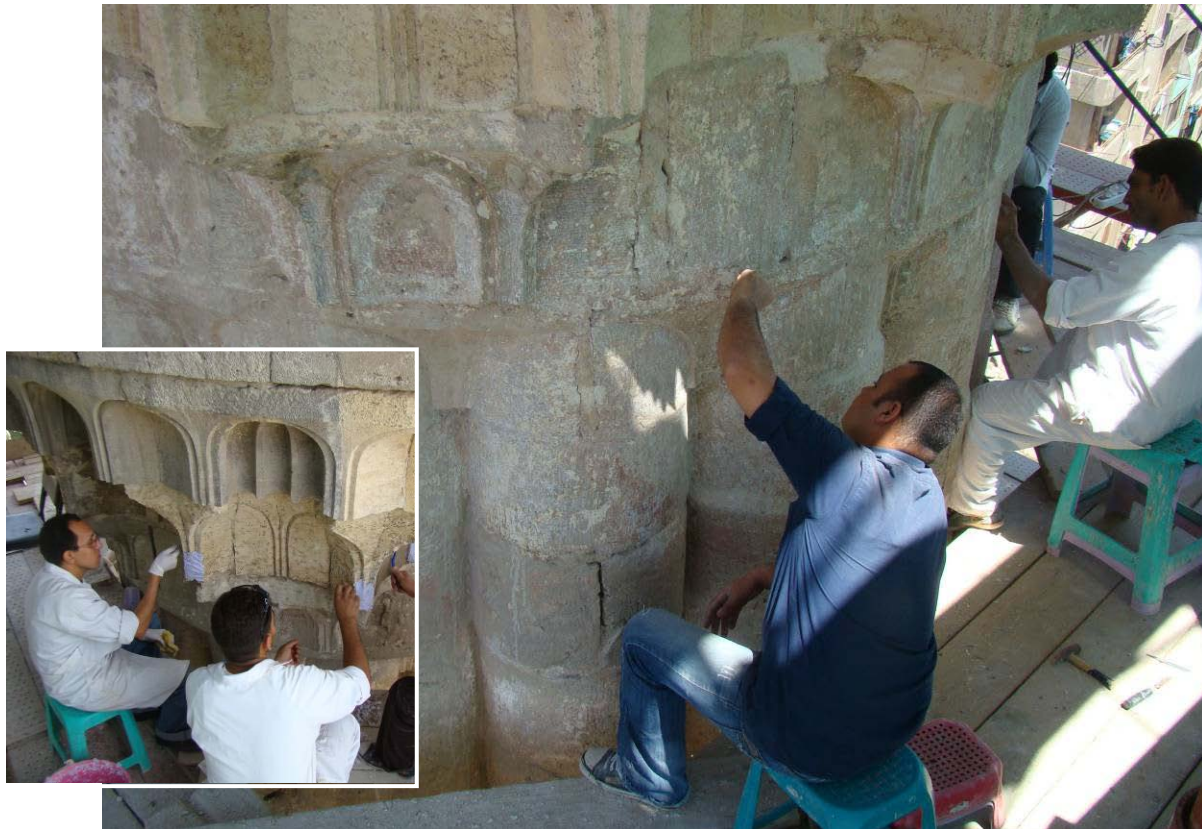
View of the work progress and the remains of colors on the first row of stone stalactites in the second balcony

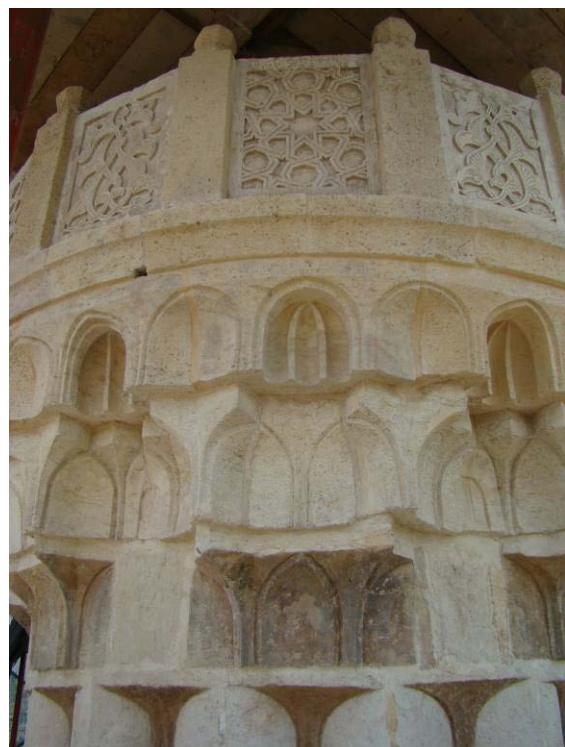
View of the damaged stone tiles after cleaning

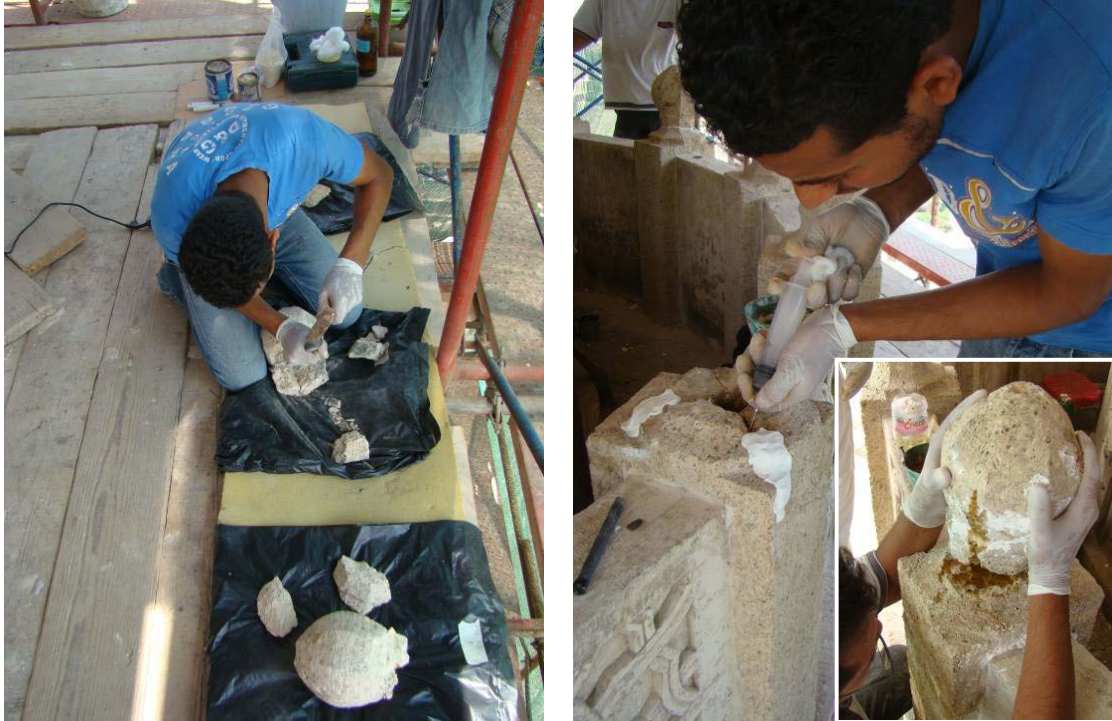
Fixing and Assembling process of the stone column top

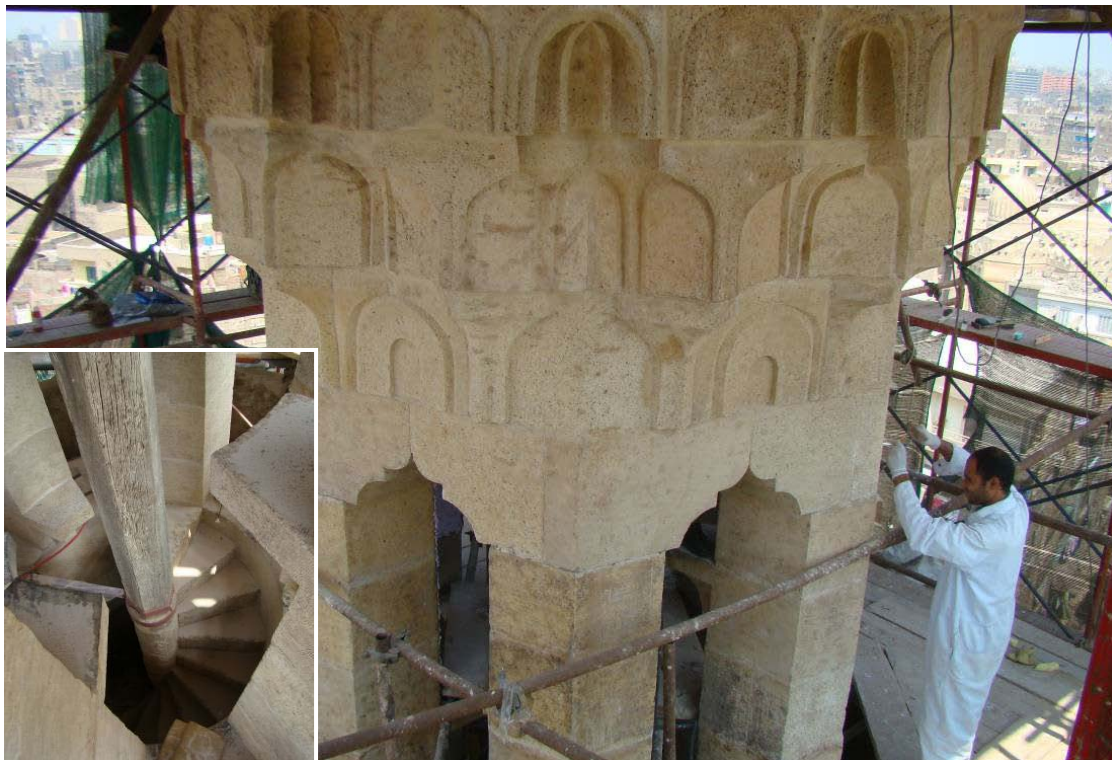
Conservation activities of the upper stalactites and stone columns

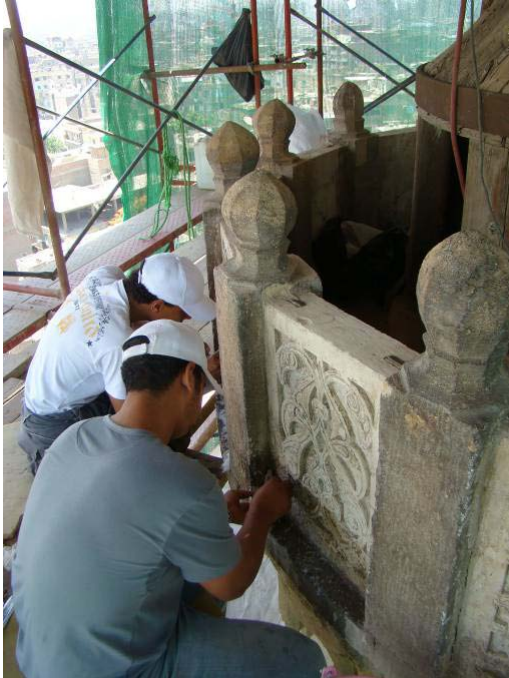
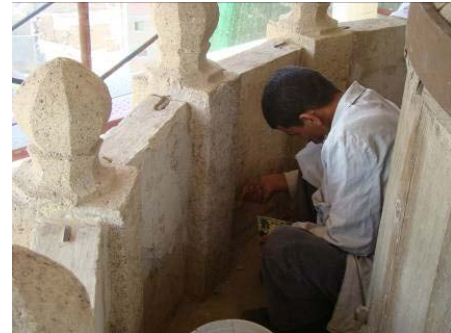
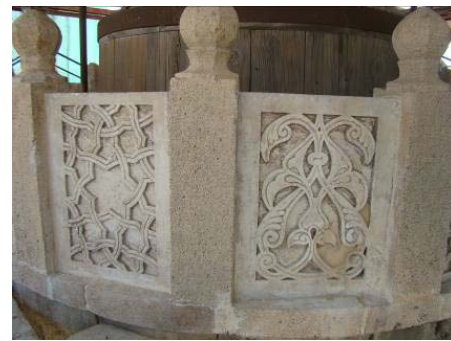
The upper balcony during the cleaning and the consolidation activities

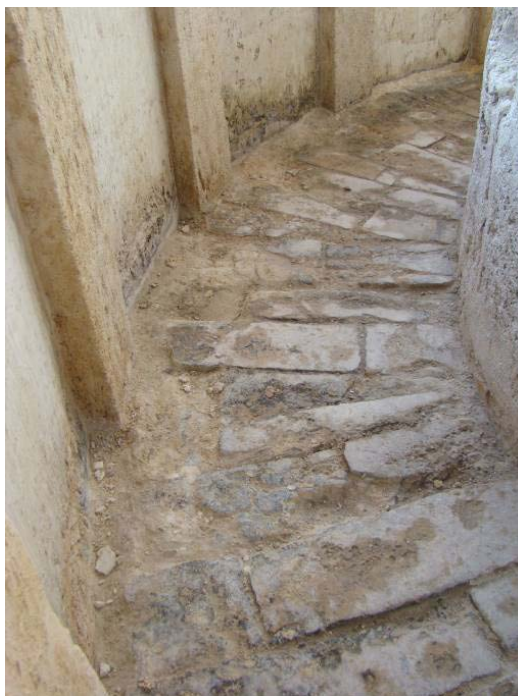
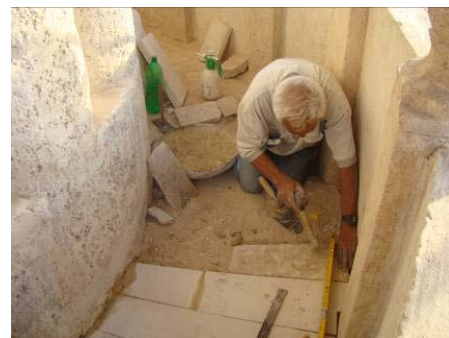
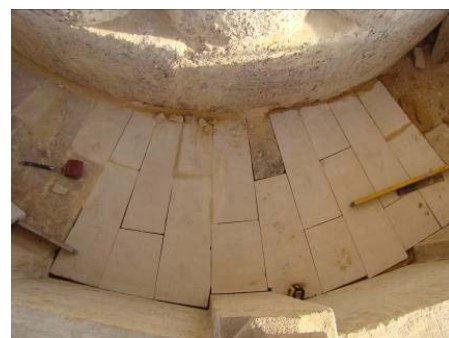
View of the damaged stone tiles before and during replacement activity of the completely damaged or lost ones

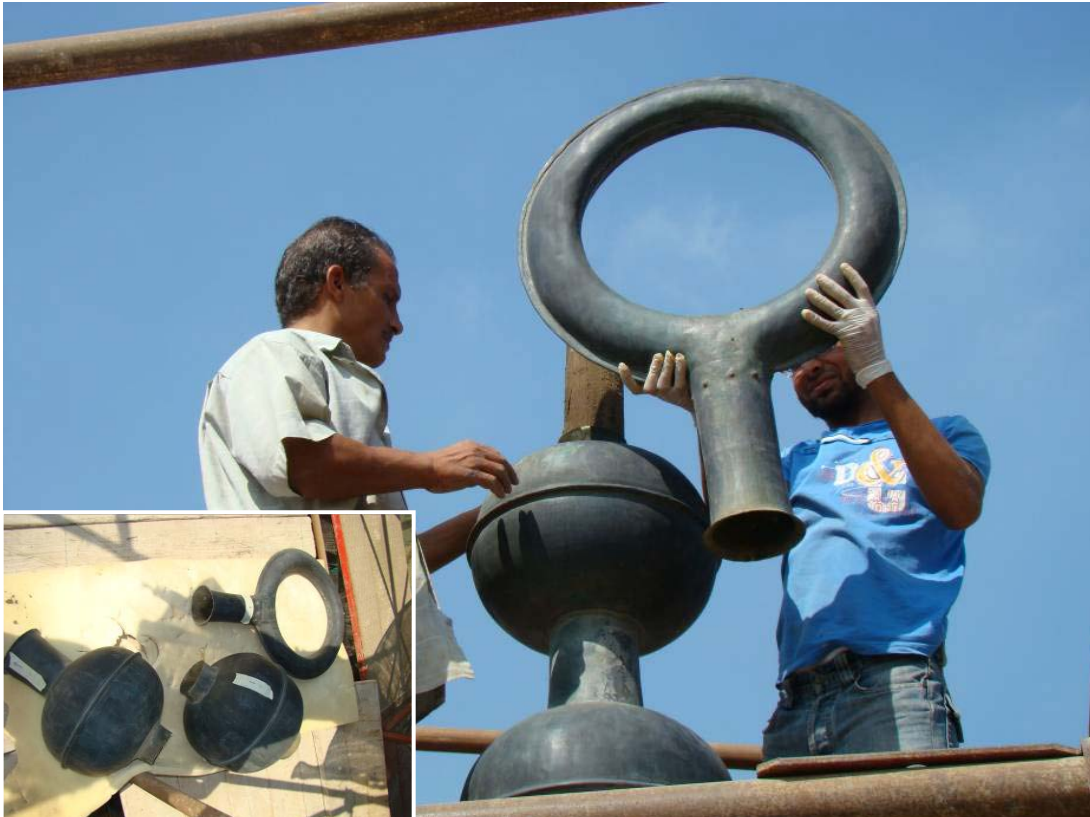
Dismantling and numbering of the brass crescent to enable the replacement of the led sheets

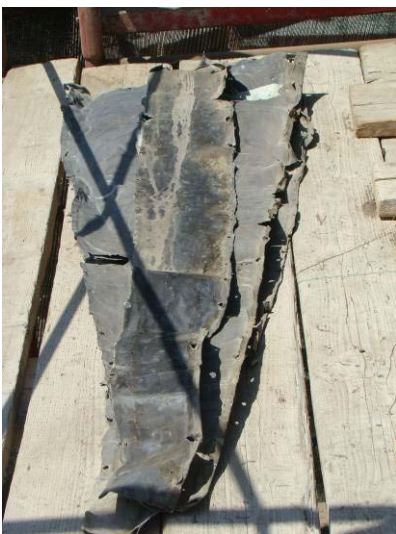
View of the old led sheets

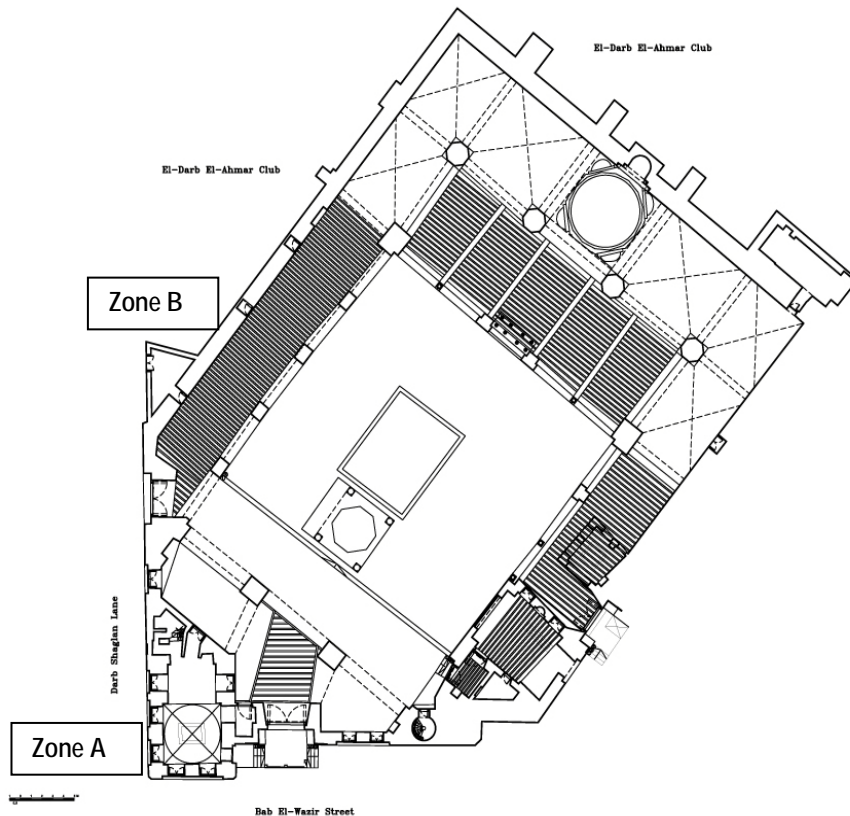
Ground floor Plan showing the variety of roofing systems

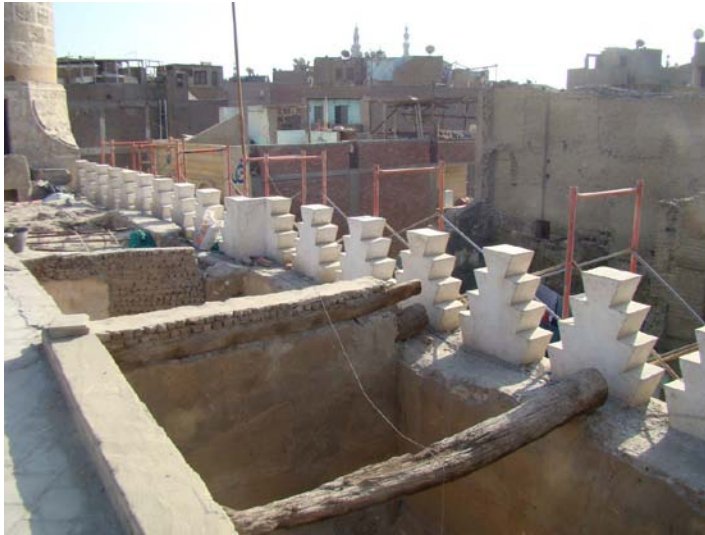
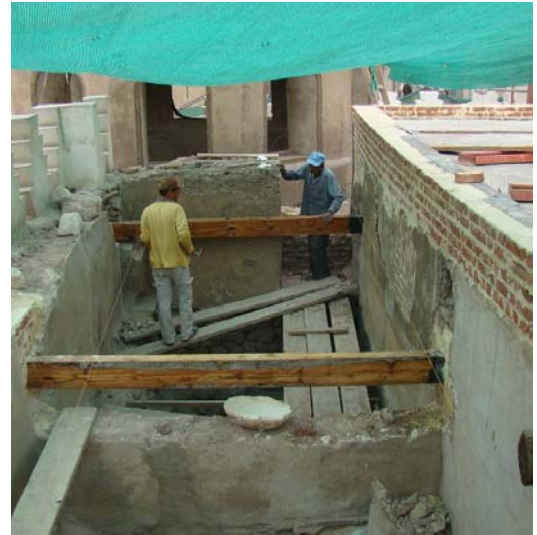
View of the space above the main entrance showing the existing condition

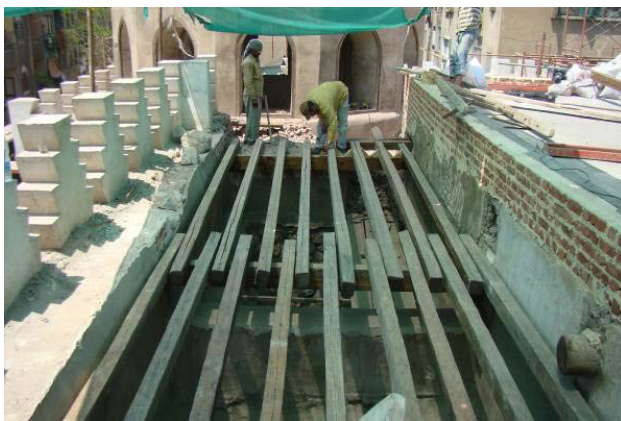
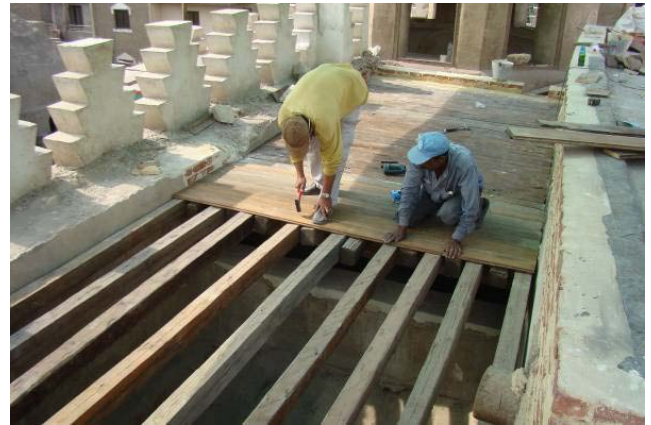
View of the space during carpentry work

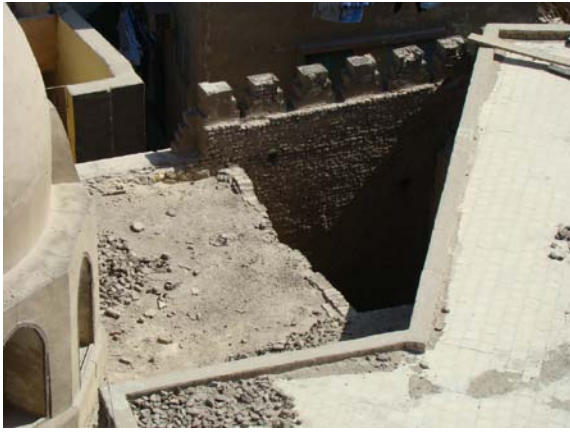
General view showing the existing condition

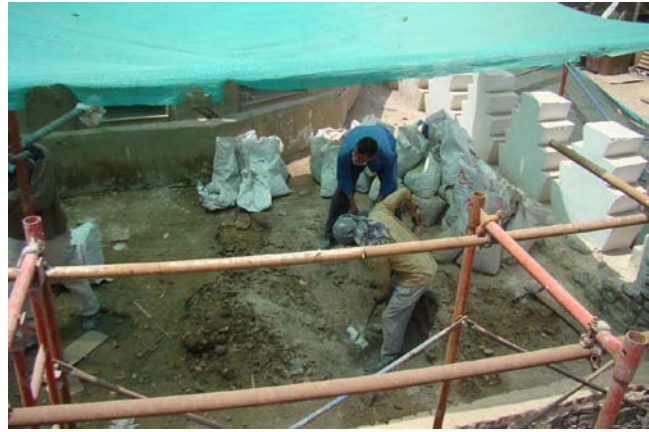
Removing the rubble layer

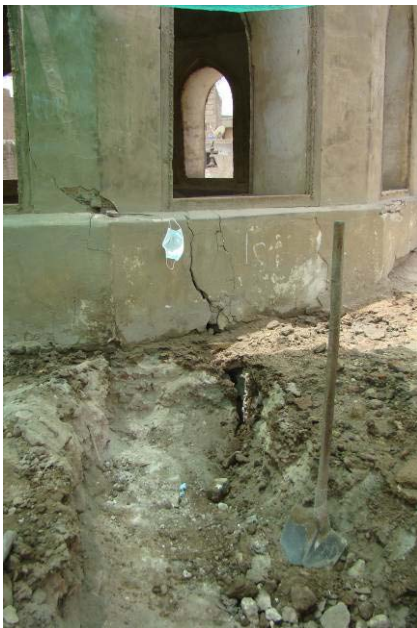
Crack repair in the drum of the dome

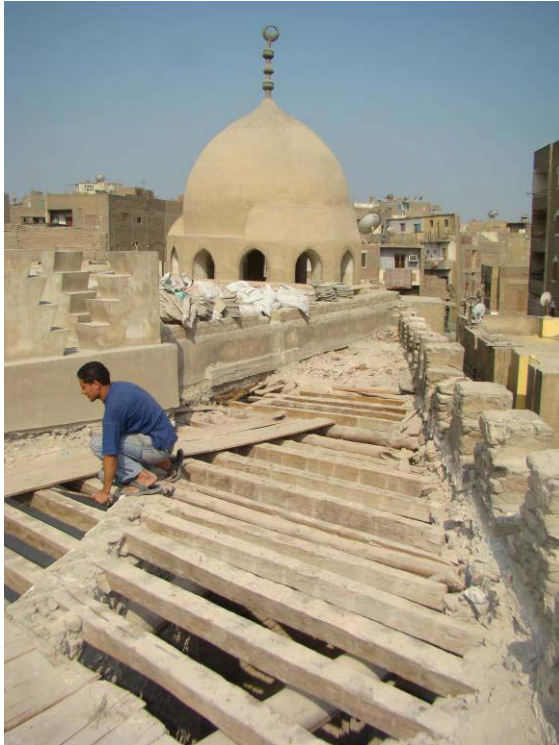
North Eastern Roof during removal of shingles

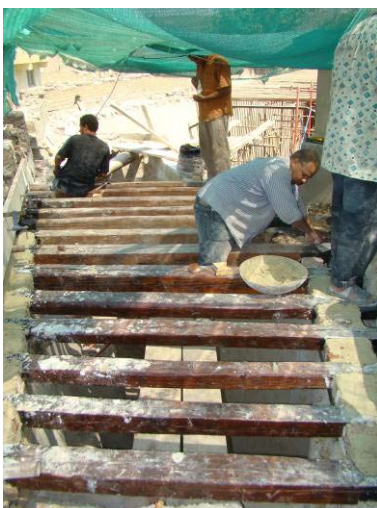
Brick repair activities and replacement of wooden beams and shingle proceeding in parallel

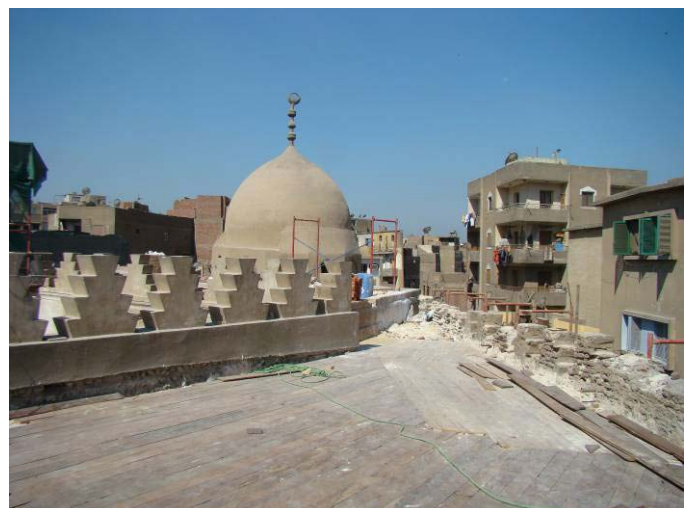
SOUTH EASTERN ROOFS (THE BAYS PARALLEL TO THE QIBLA);

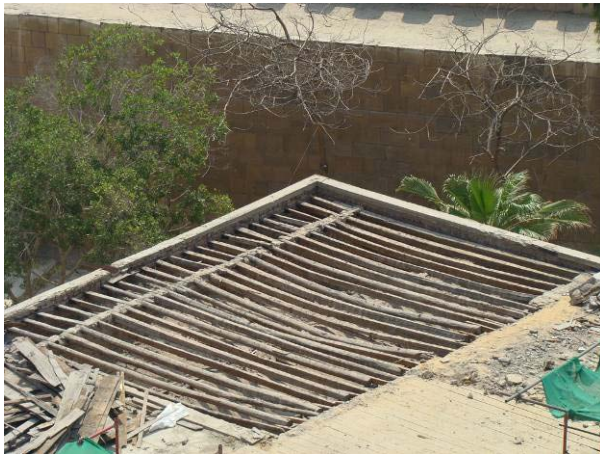
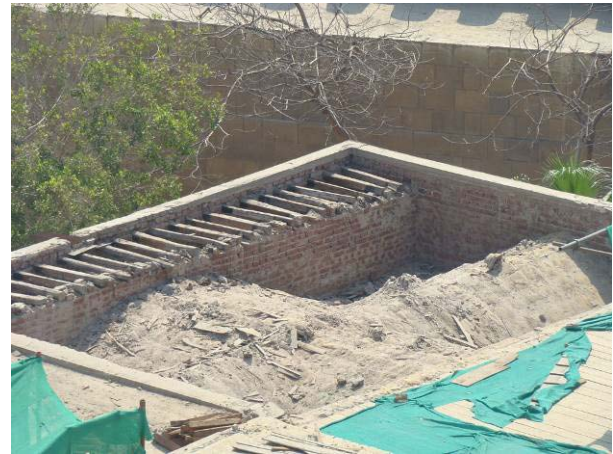
View of the roof removal of shingles and wooden beams

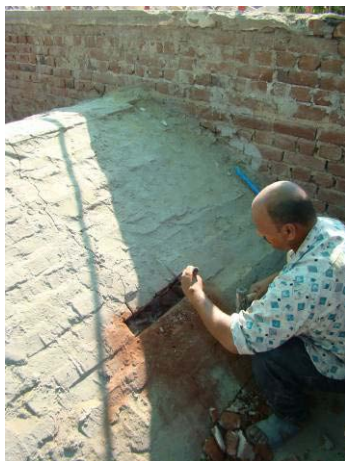
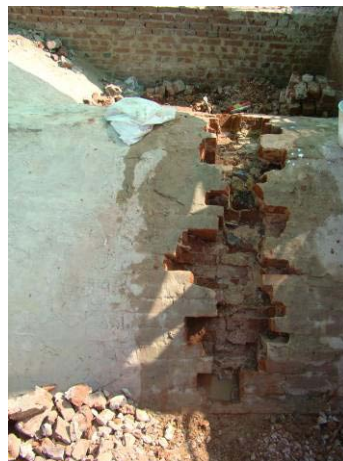
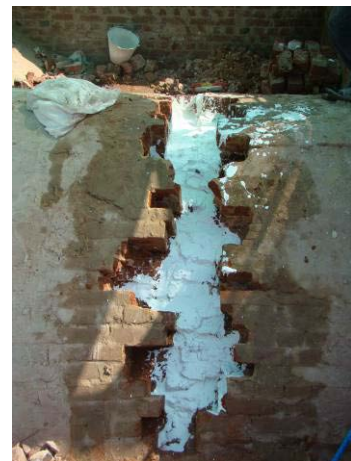
Brick repair activities

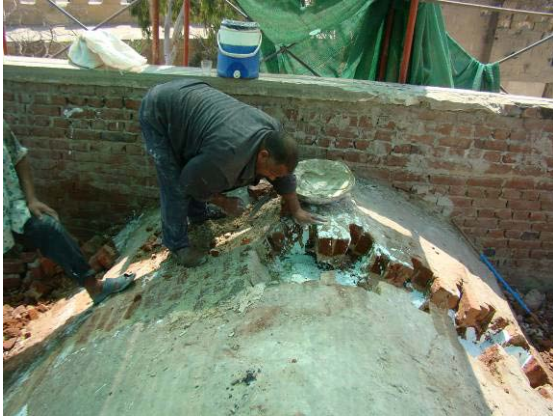
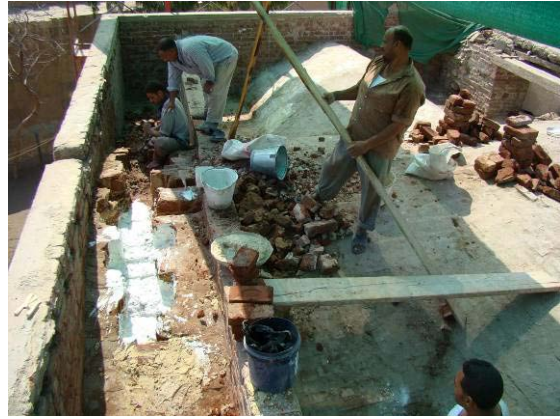
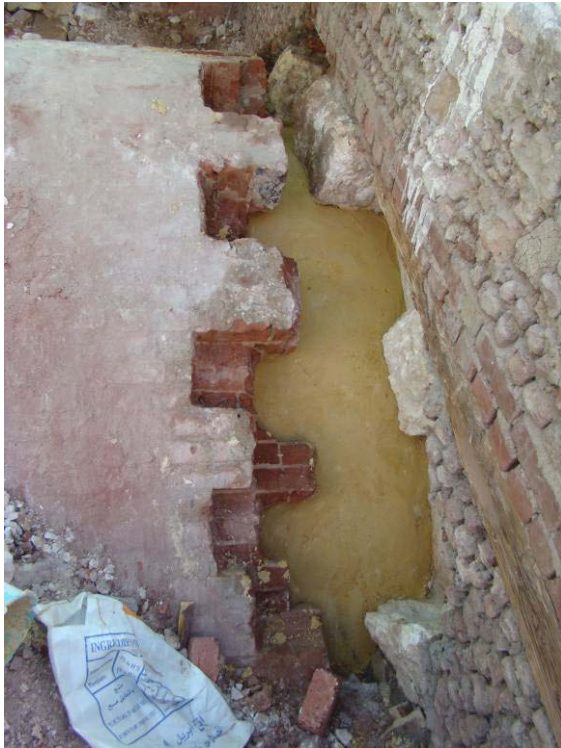
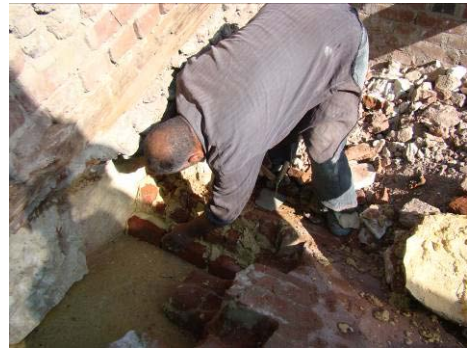
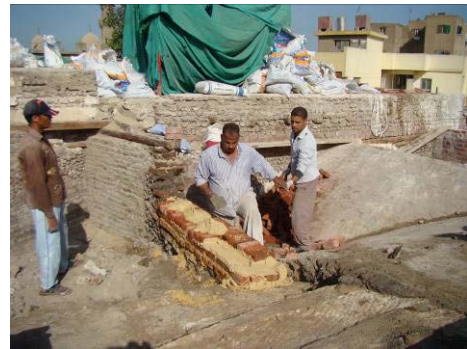
Brick repair activities

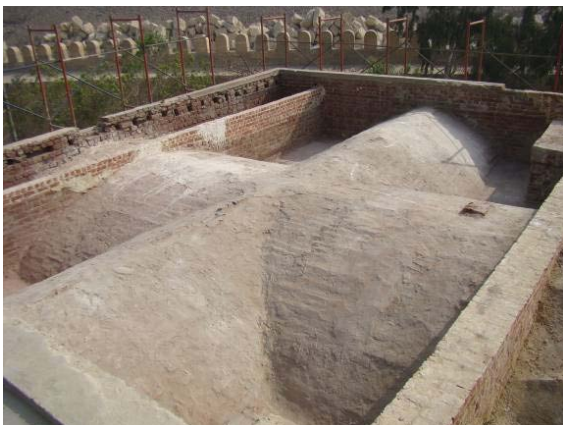
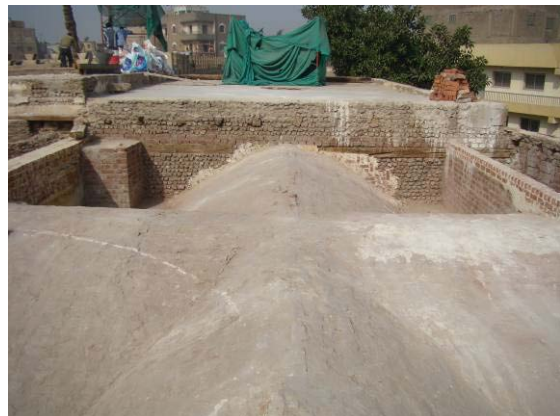
View of Section after brick repairs

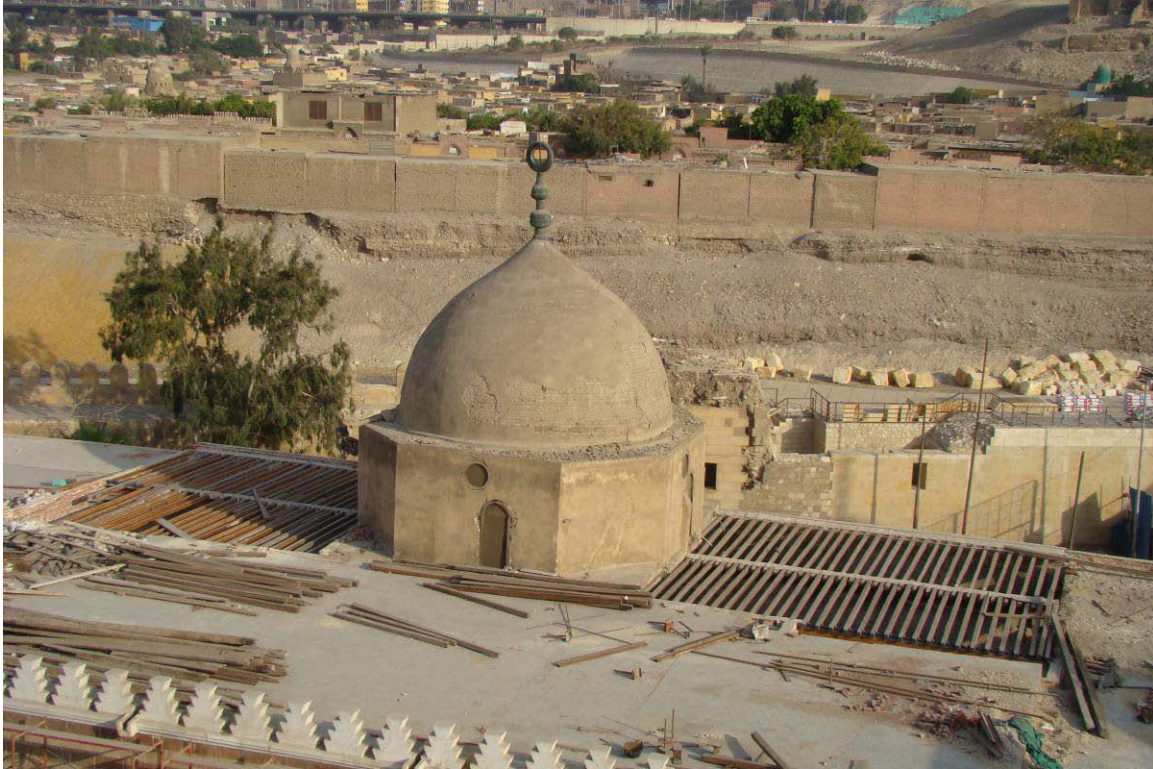
General view of SE roof after placing the steel I-beam and completing the carpentry activity

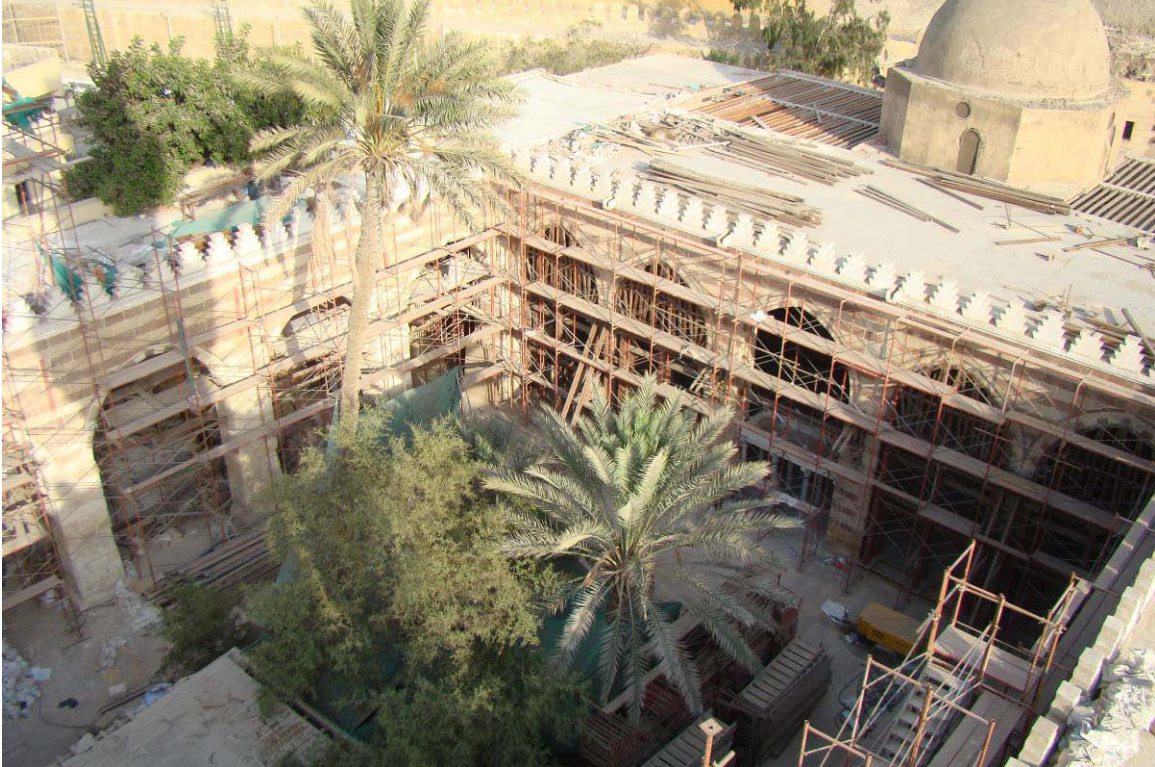
View of the courtyard facades with site installations and scaffolding

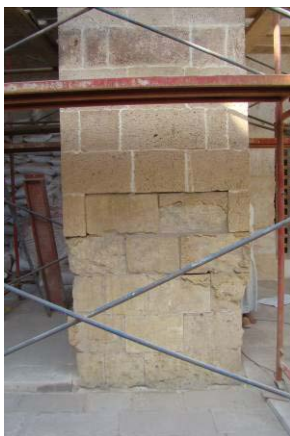
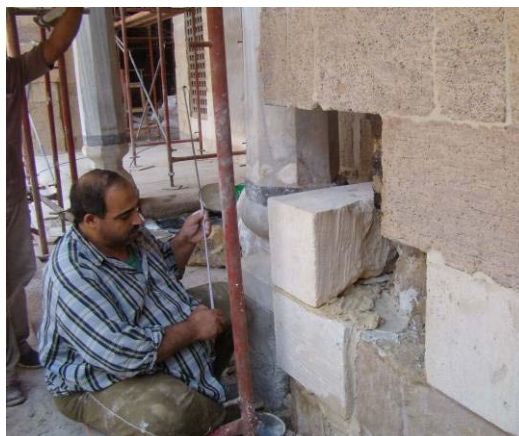
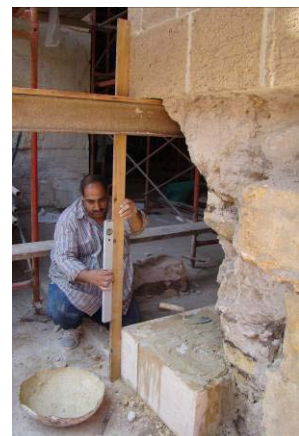
Stone replacement activities in the South Western Facade

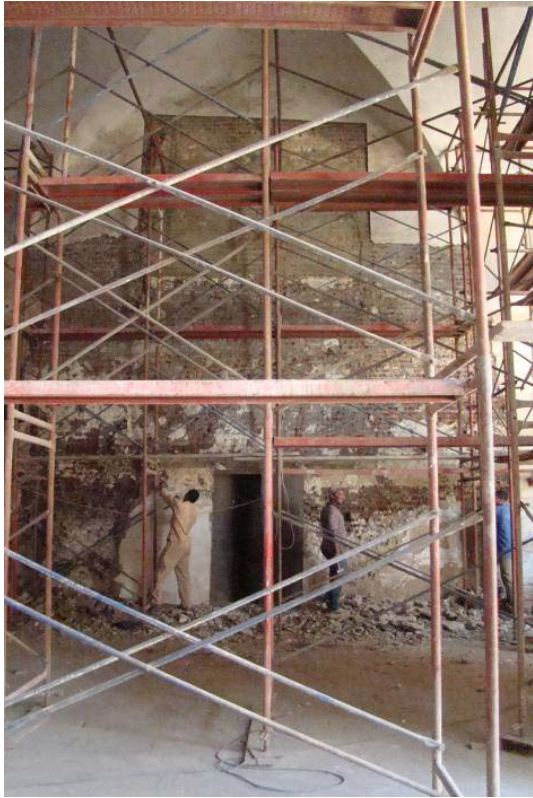
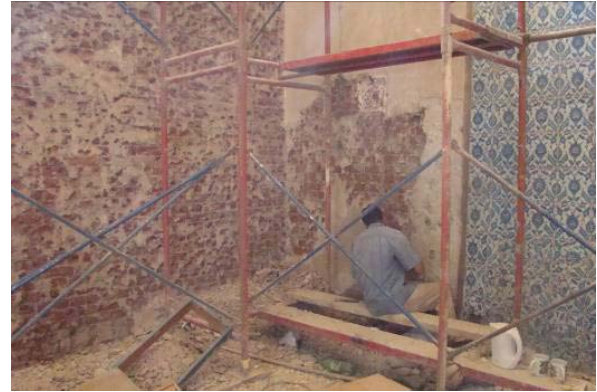
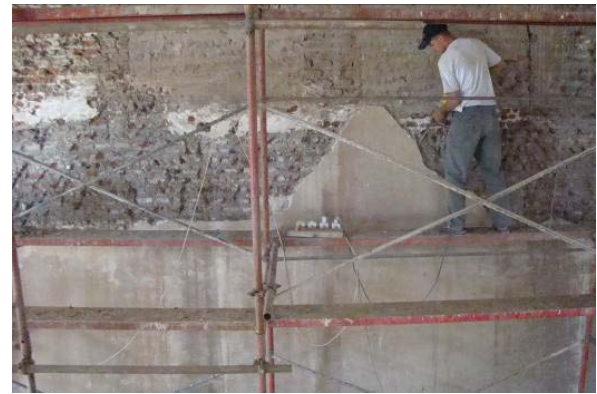
Brick repairs activity

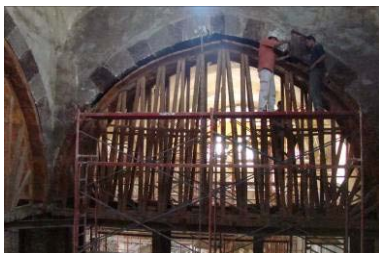
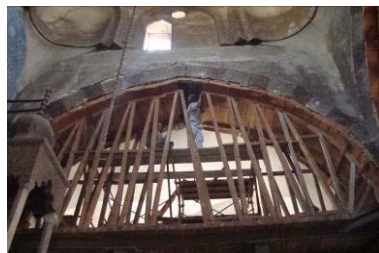
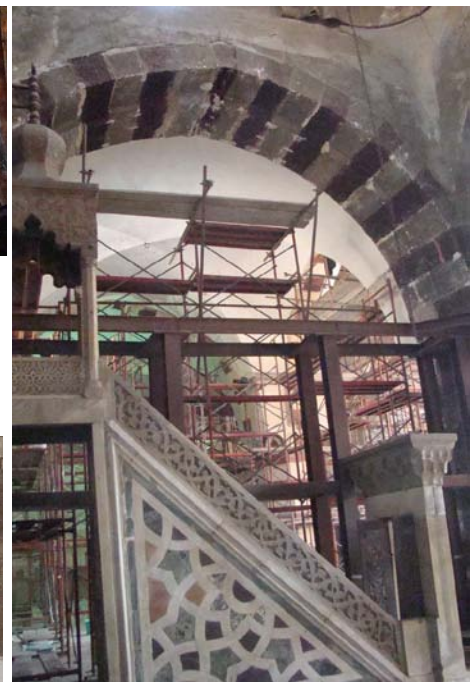
Shoring dismantling phases (from top left to bottom right). To be noted was the absence of contact between the timber poles and planks with the stone arches, due to timber shrinkage. The shoring in place was not playing any structural support function

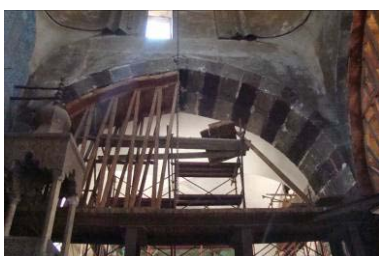
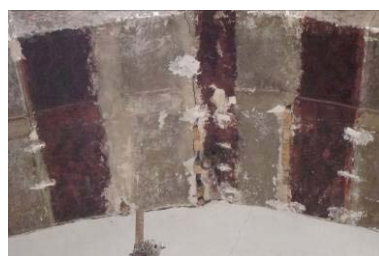
STRUCTURAL STRENGTHENING OF THE *QIBLA* DOME:

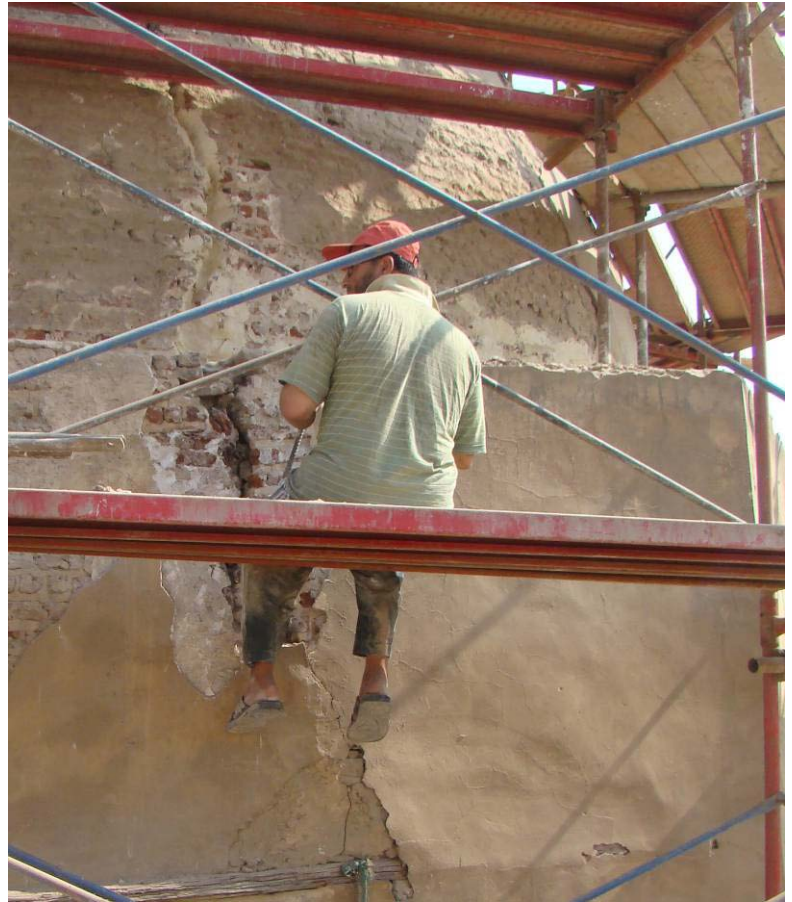
Opening the vertical cracks

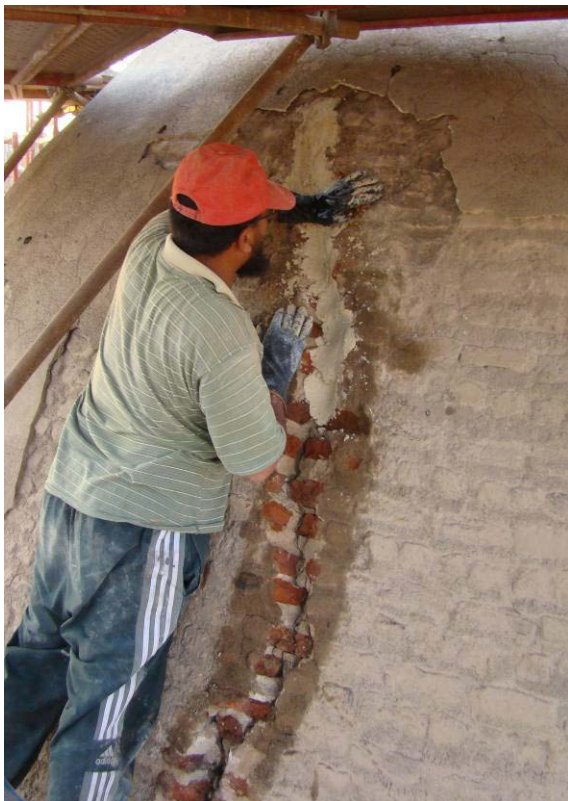
Filling the vertical cracks

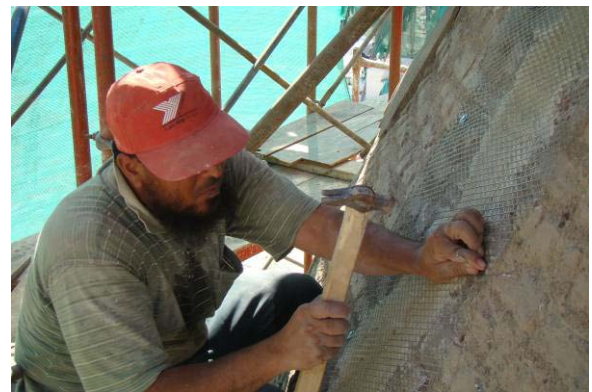
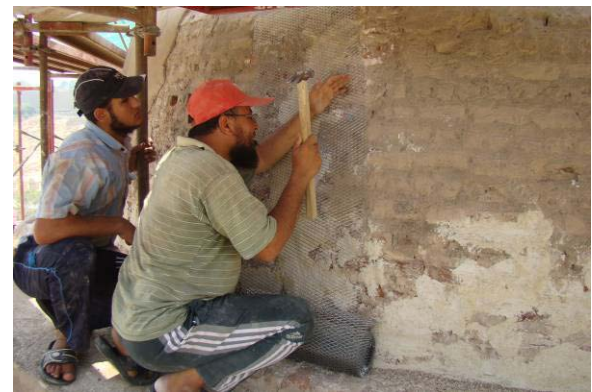
Installing the galvanized steel mesh

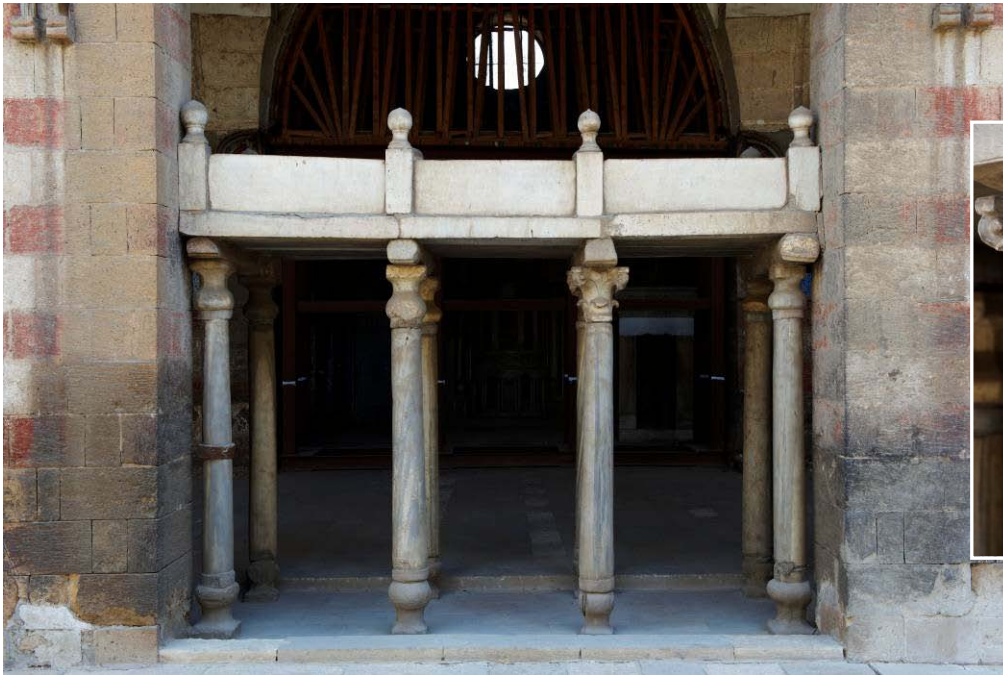
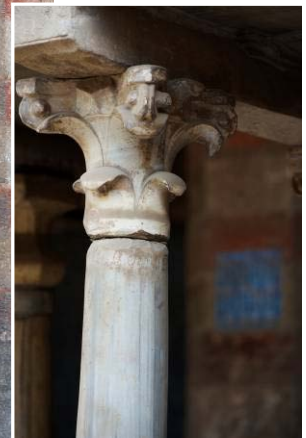
Detail on marble column

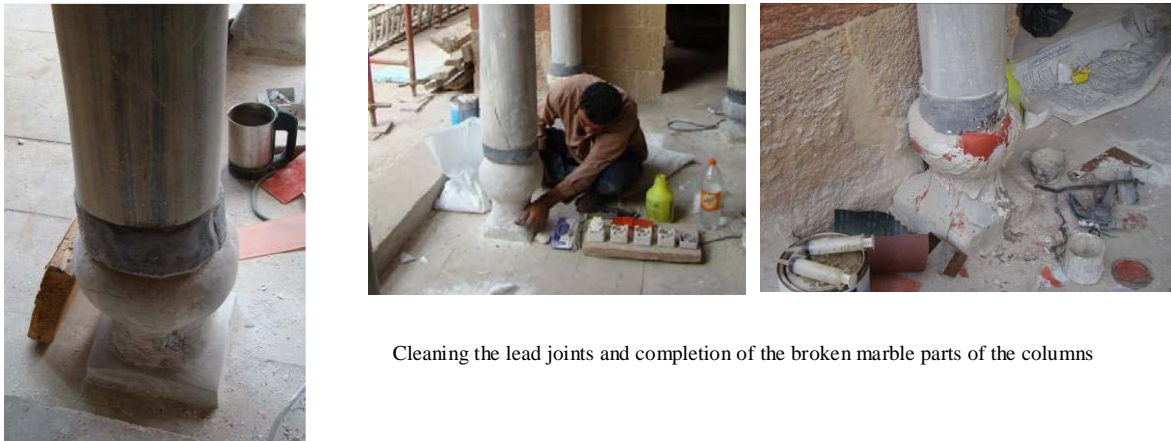
Cleaning the lead joints and completion of the broken marble parts of the columns

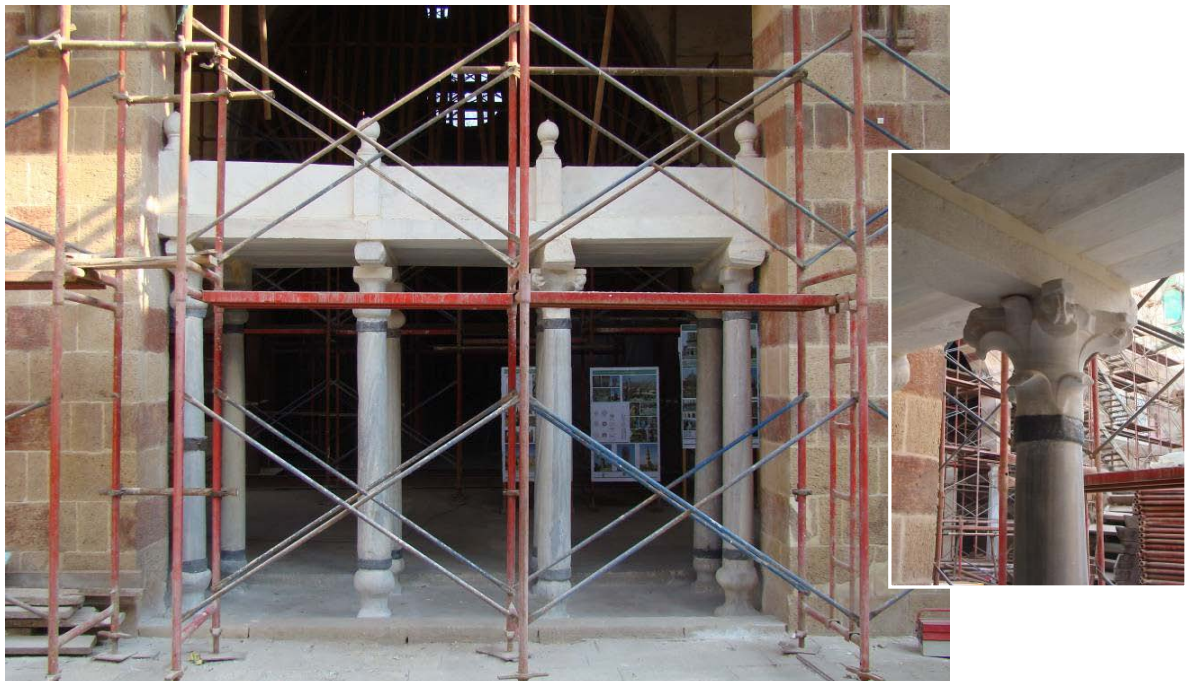
View of *dikkat al-mobaligh* after conservation

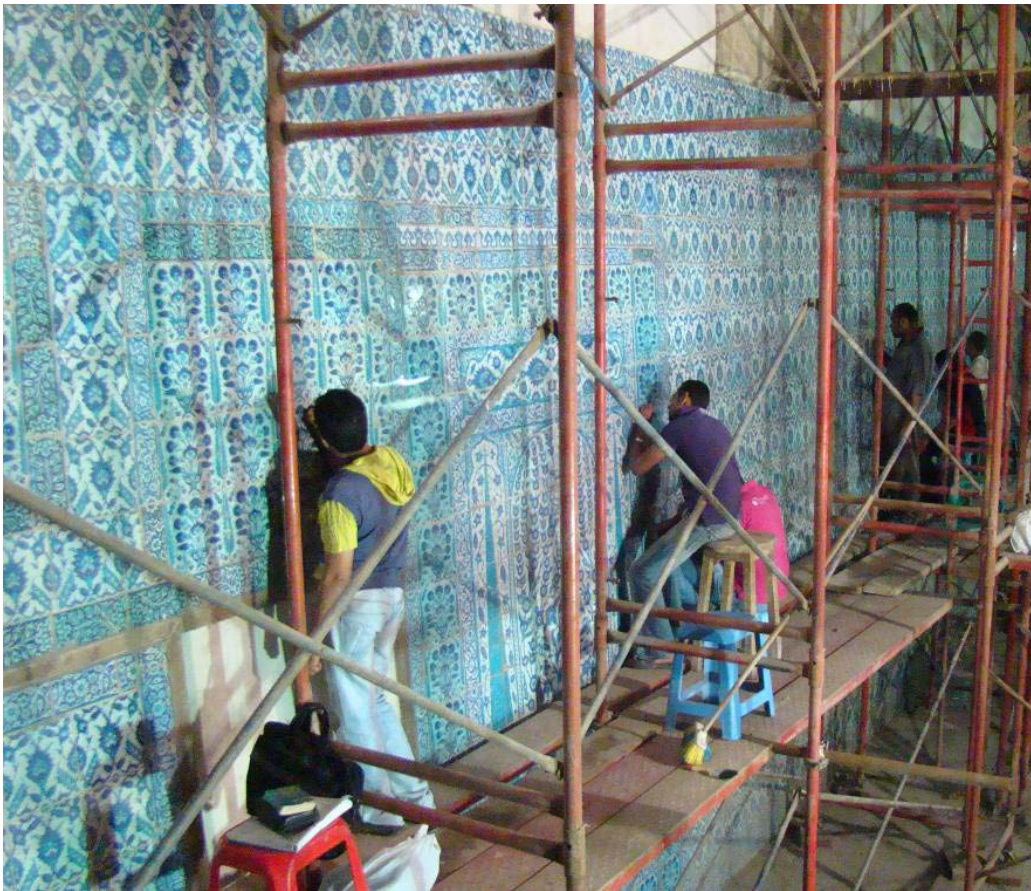
Iznik tiling cleaning and retouches: water based manual cleaning was performed, local repointing and retouches to integrate damaged areas.
