AGA KHAN TRUST FOR CULTURE

Historic Cities Programme

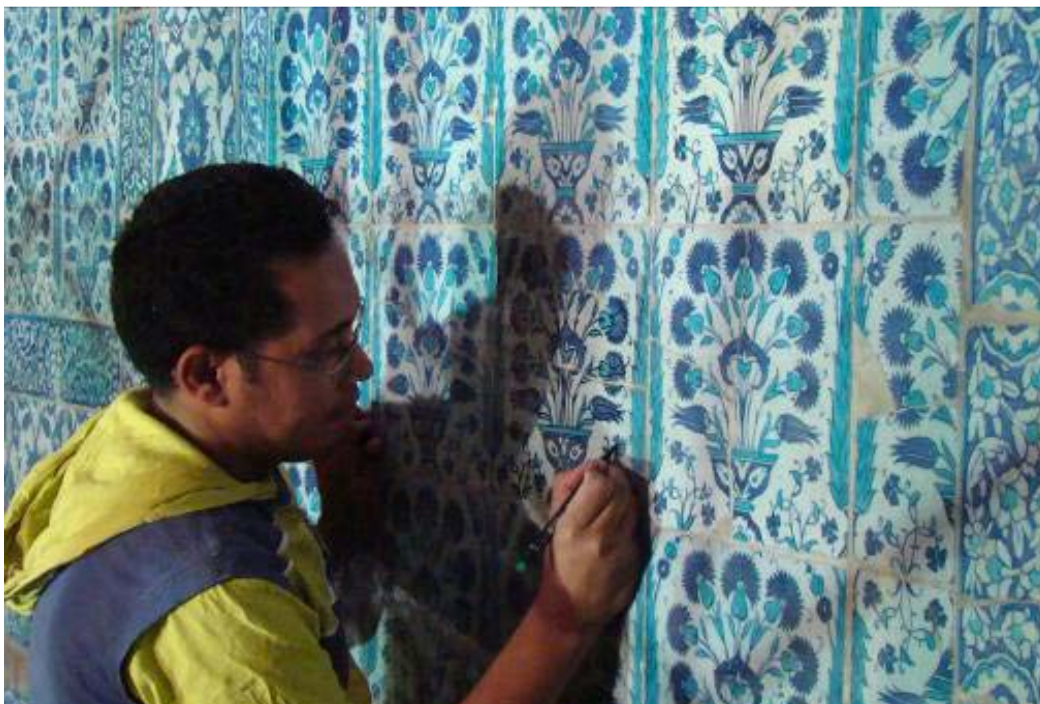
IZNIK TILING AND MARBLE PANELS CLEANING AND CONSERVATION: THE IBRAHIM AGHA MAUSOLEUM

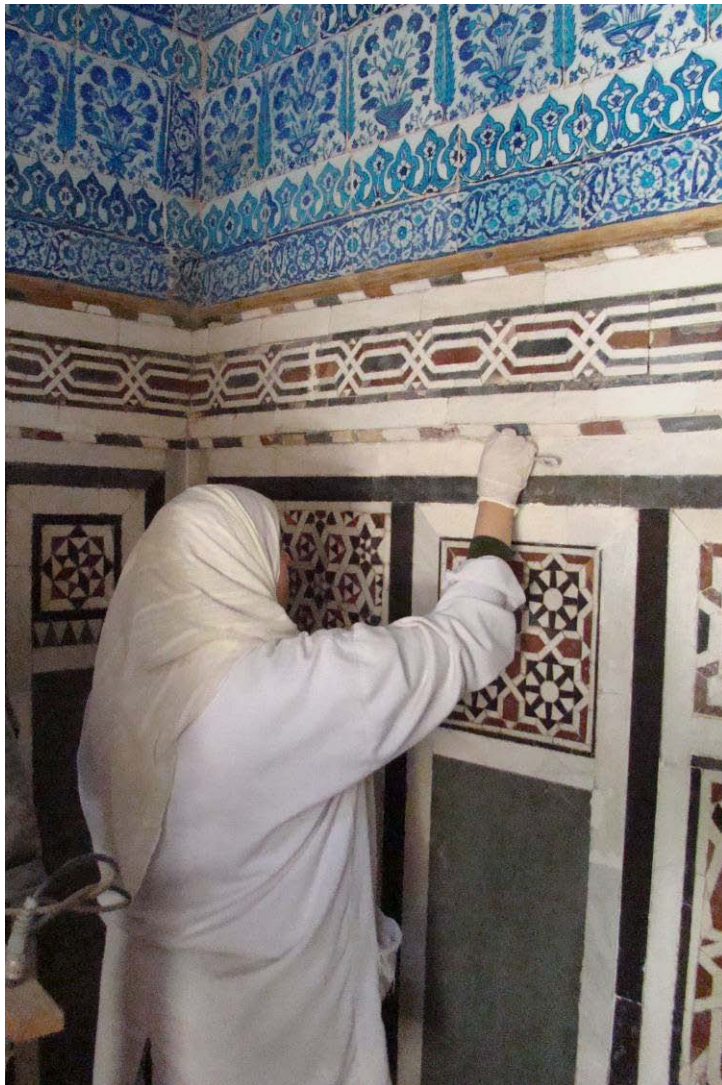
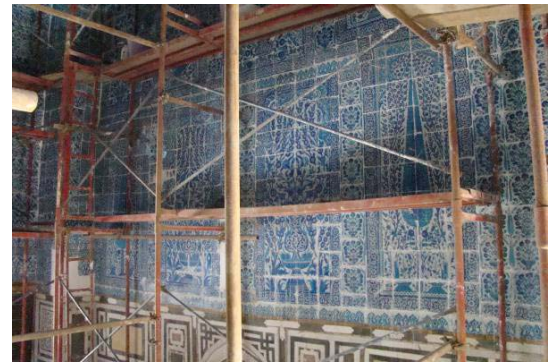
Cleaning and re-pointing activities of the blue tiles

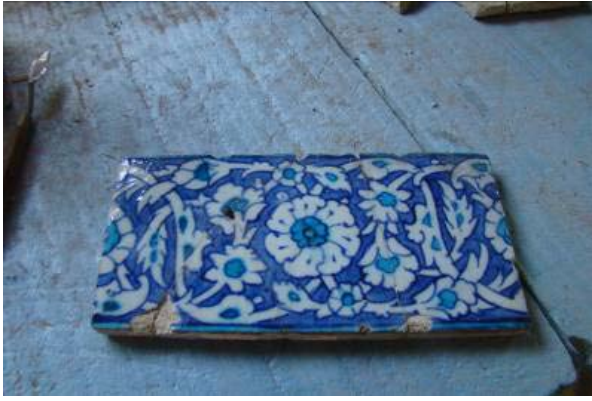
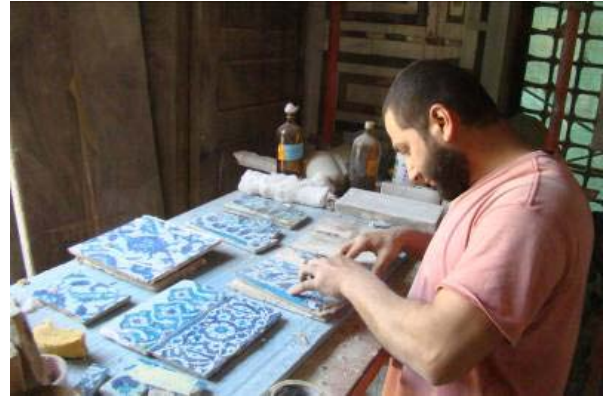
Reassembling of broken elements

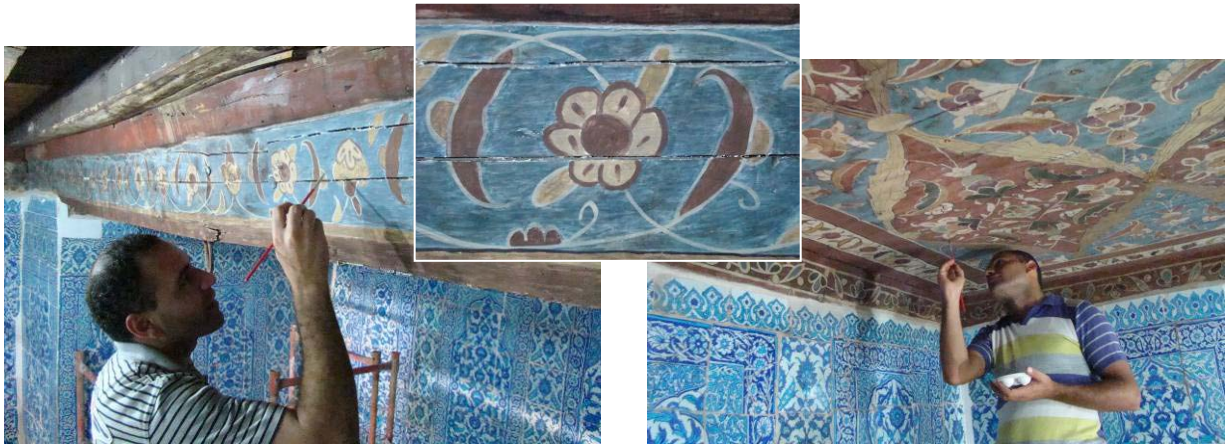
Painted ceiling conservation and retouches

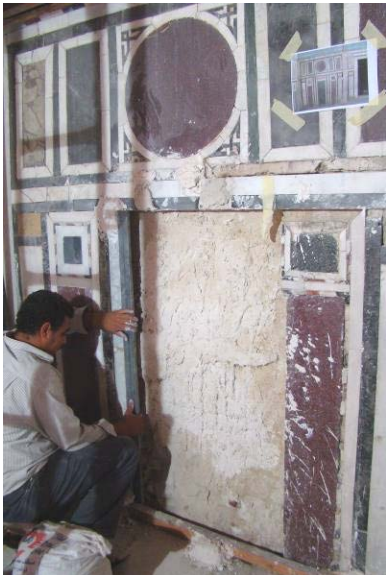
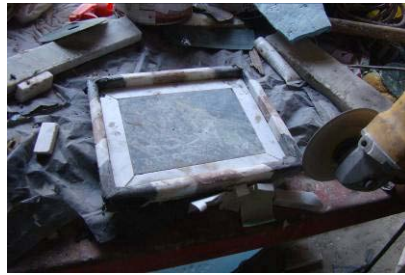
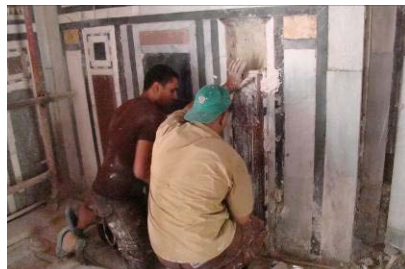
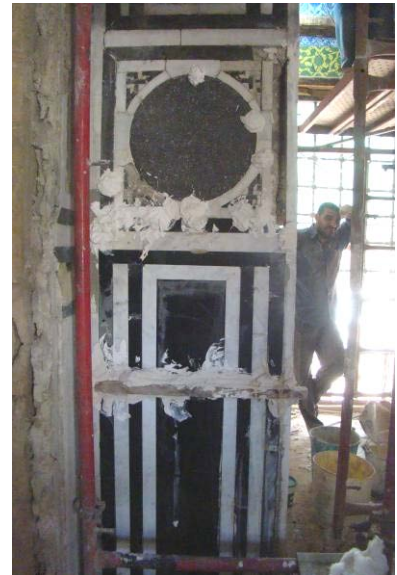
The marble replacement activity of the lower part

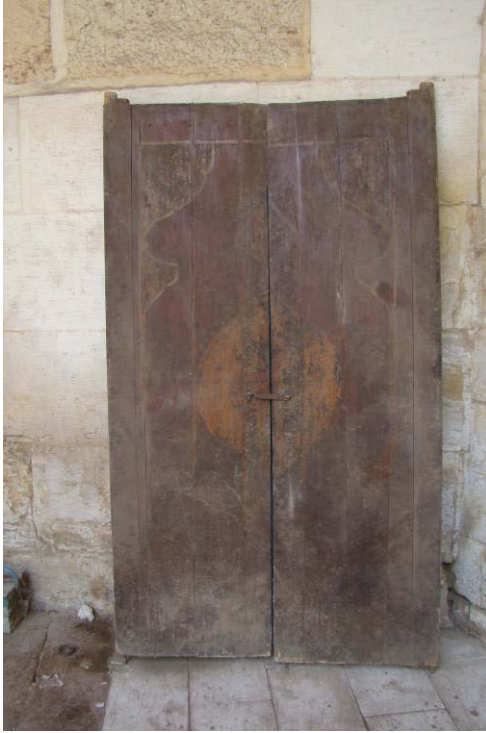
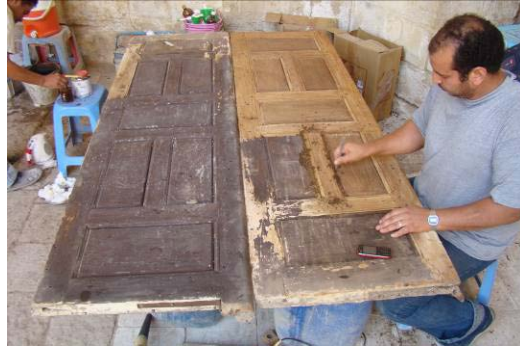
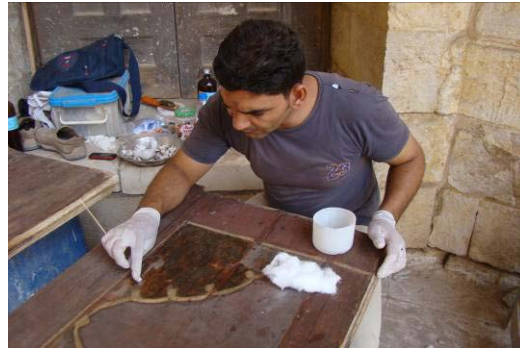
Cleaning the wooden shutters of the mausoleum and removal of the modern paint on the back

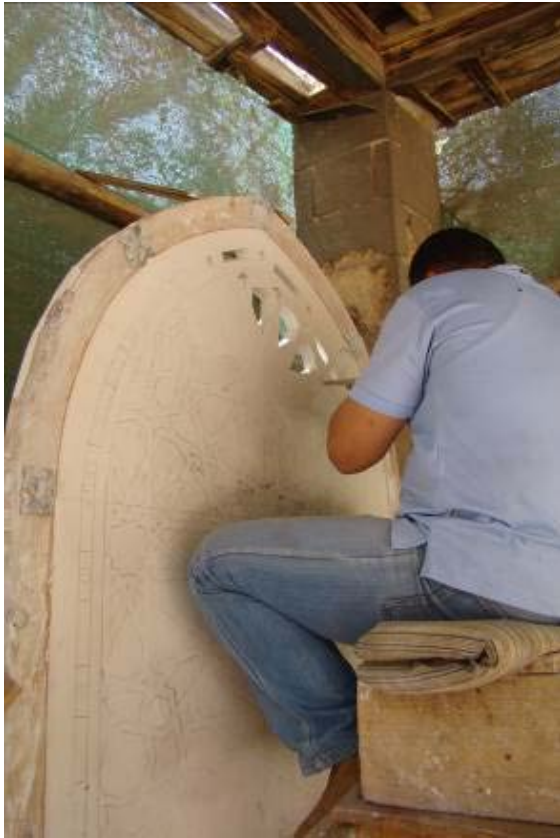
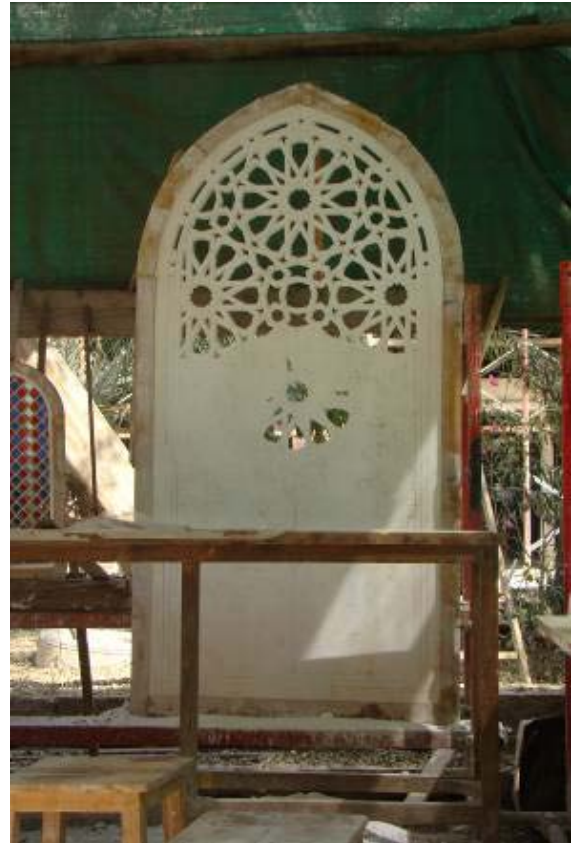
Producing and erecting the gypsum grills: gypsum is being cast inside a timber frame. Once solid enough, but still humid, the carver replicates the design by facsimile onto the gypsum and starts to carve the voids. After carving is complete, the panel is left to dry, before being erected in the opening.

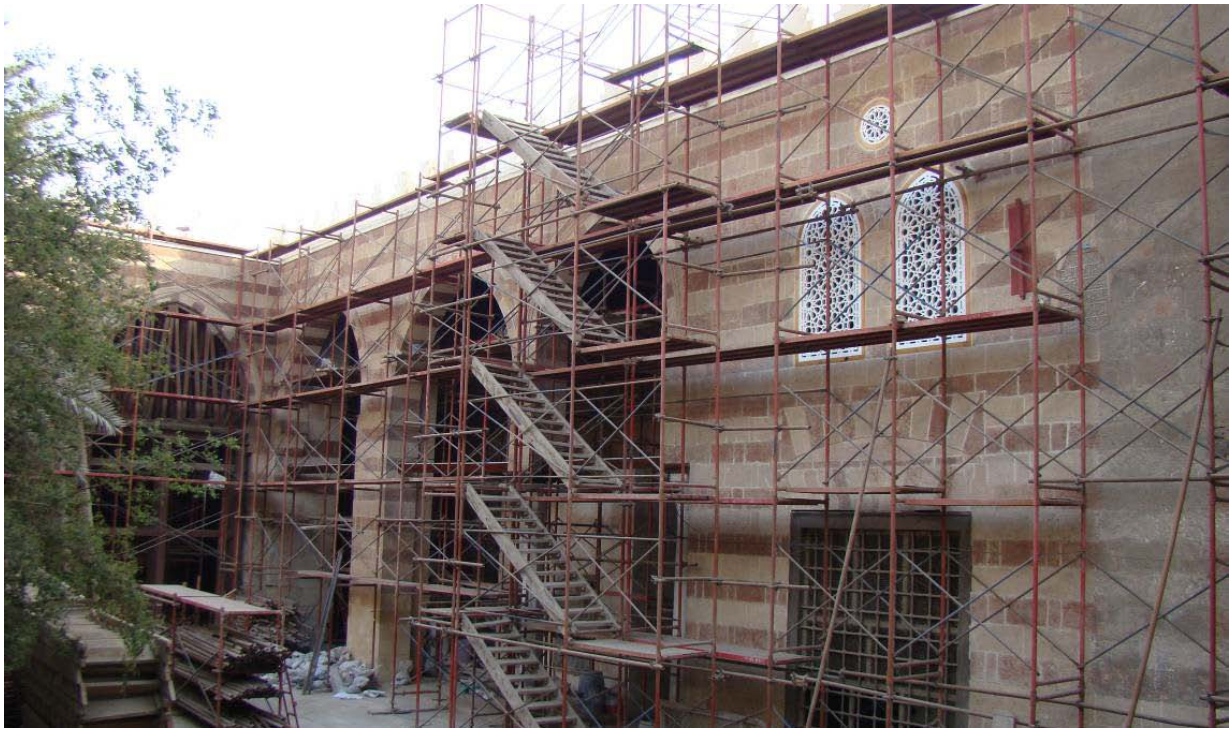
(Above) General view of the façade after conservation and installation of the gypsum windows. (Below) phases of work and installation of gypsum windows on Kujuk mausoleum

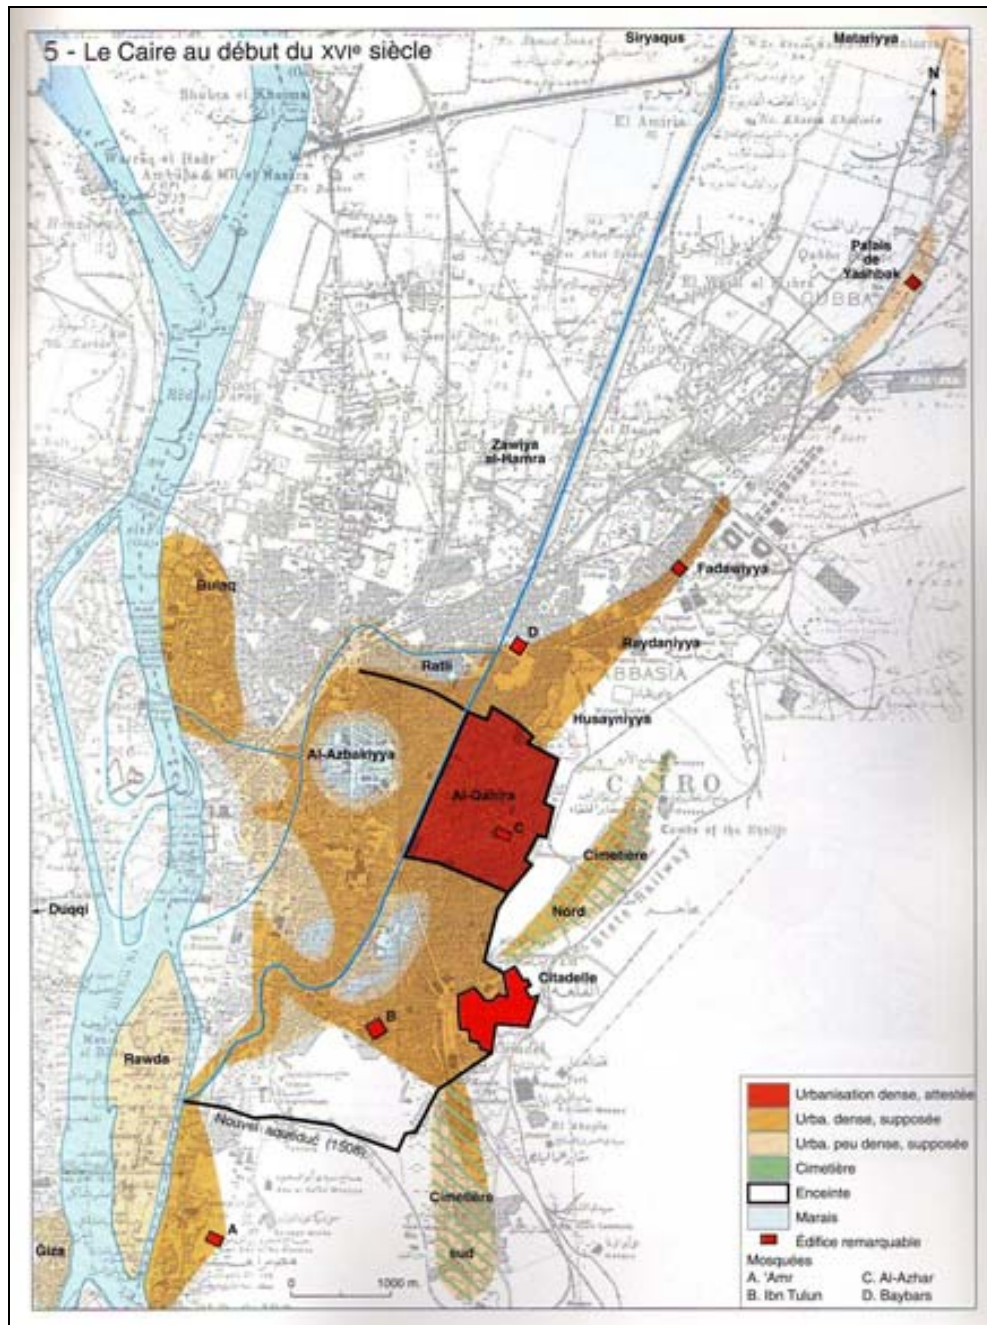
doc. 1 : map of 16th century Cairo (J.-C. Garcin, 2004).

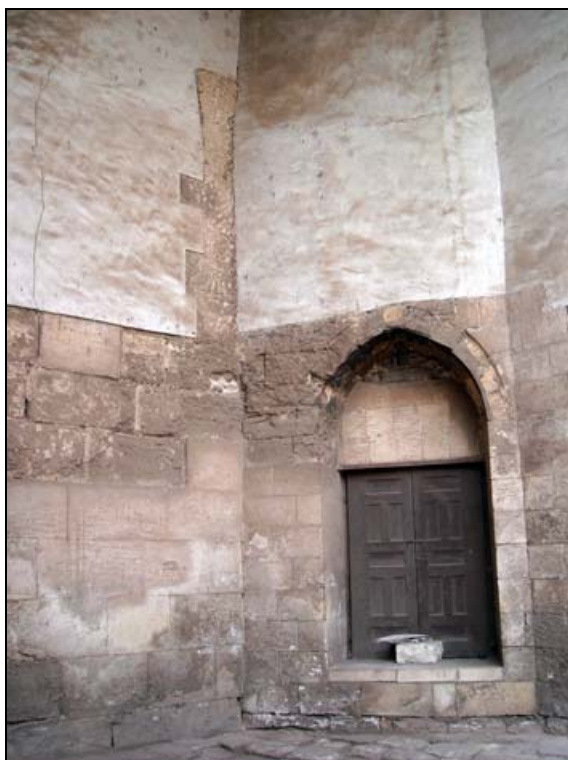
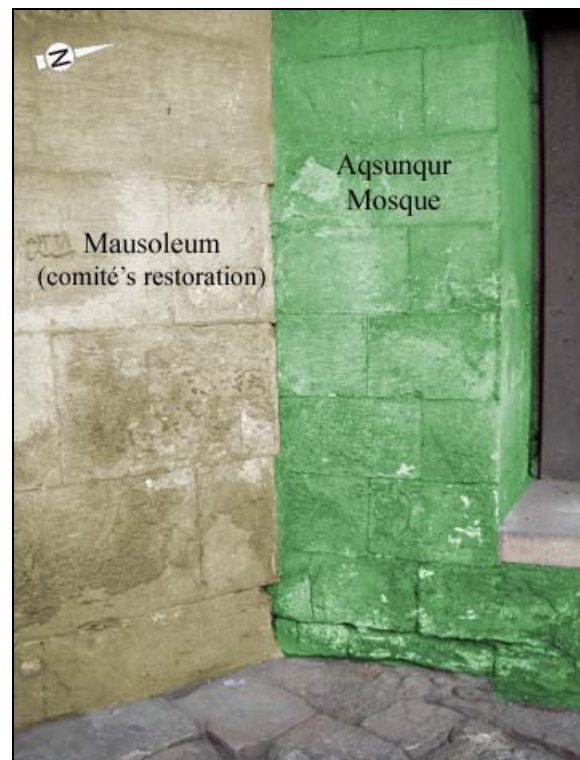
doc. 10a : General view of the junction between the Mausoleum and the Mosque / 10b : closer view.

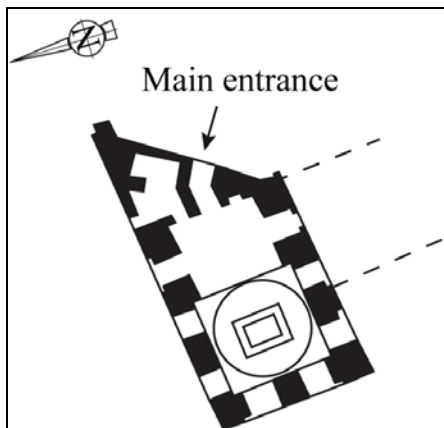
doc. 13 : First phase of the Mausoleum - 1341

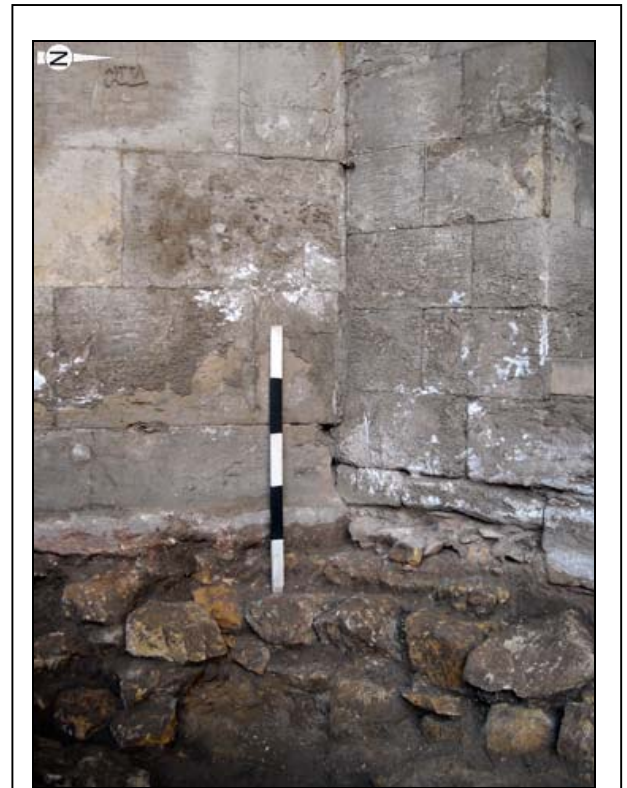
doc. 11 : TP2 - Foundations of the Mausoleum and of the Mosque.

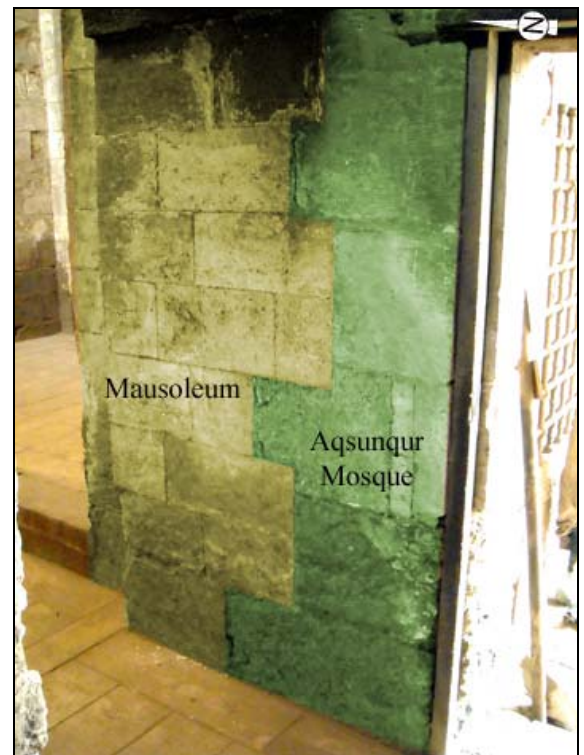
doc. 12 : Adjustment of the Mausoleum SE window into a door

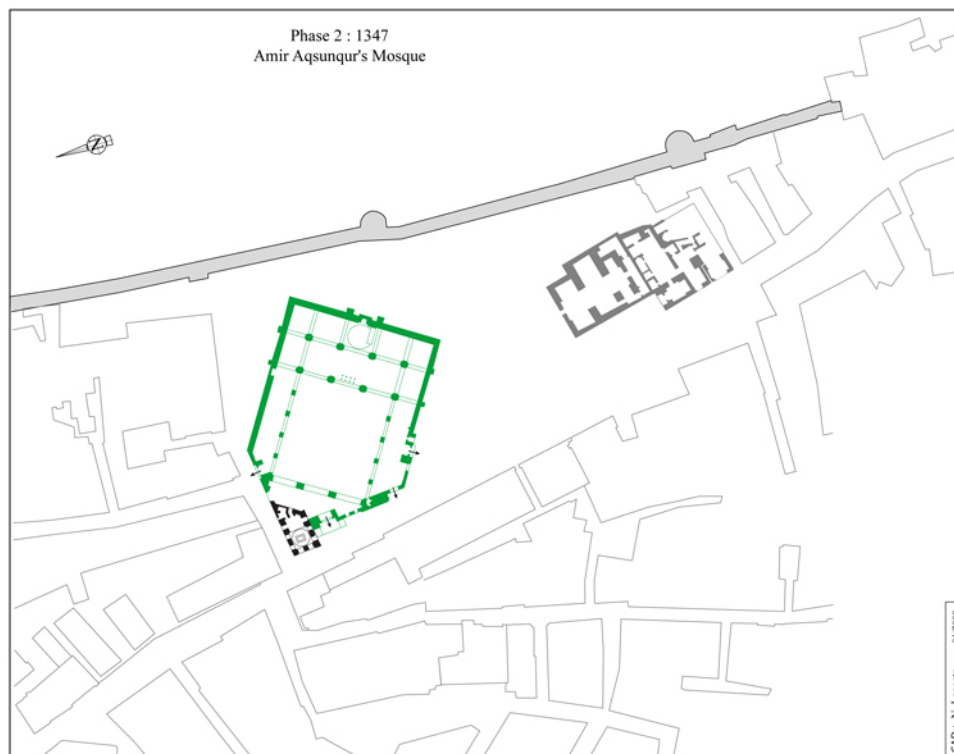
It's now well known that Blue Mosque has been done by the same architect that did **Mosque Amir Altinbugha al-Maridani**⁷. The Emir Aqsunqur (or Ak-Sounkour el-Naseeri) was really found of architecture and, as we said in the historical context, is supposed to have supervised himself the construction. The Mosque's construction started on 16 Ramadan 747 (**31st December 1346**), and worship was first celebrated there on Friday 3 Rabi I 748 (**13th June 1347**)⁸. Since the beginning, Aqsunqur had decided that himself and his wife were to be buried there.

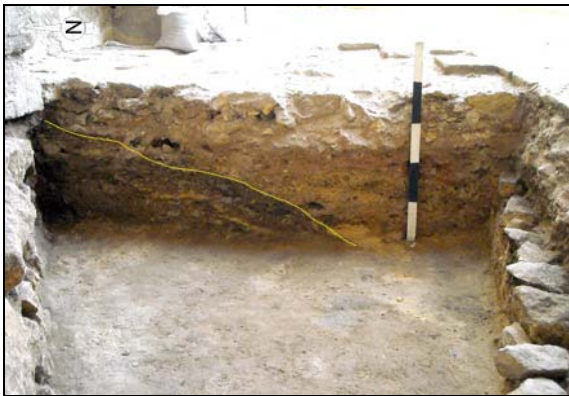
doc. 17 : TP2 : Eastern stratigraphical section

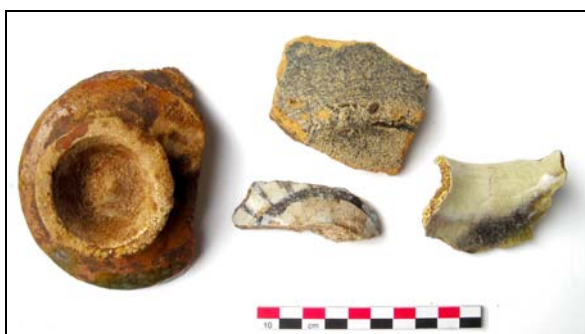
doc. 18 : Blue Mosque - TP2 : ceramic found in Layer TP2.6

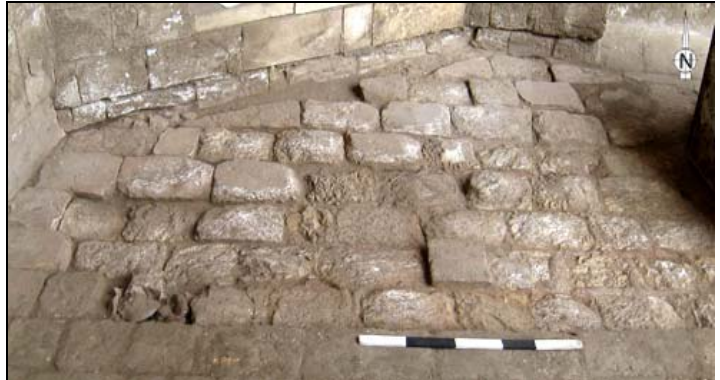
doc. 14 : TP2 : Pavement after its cleaning

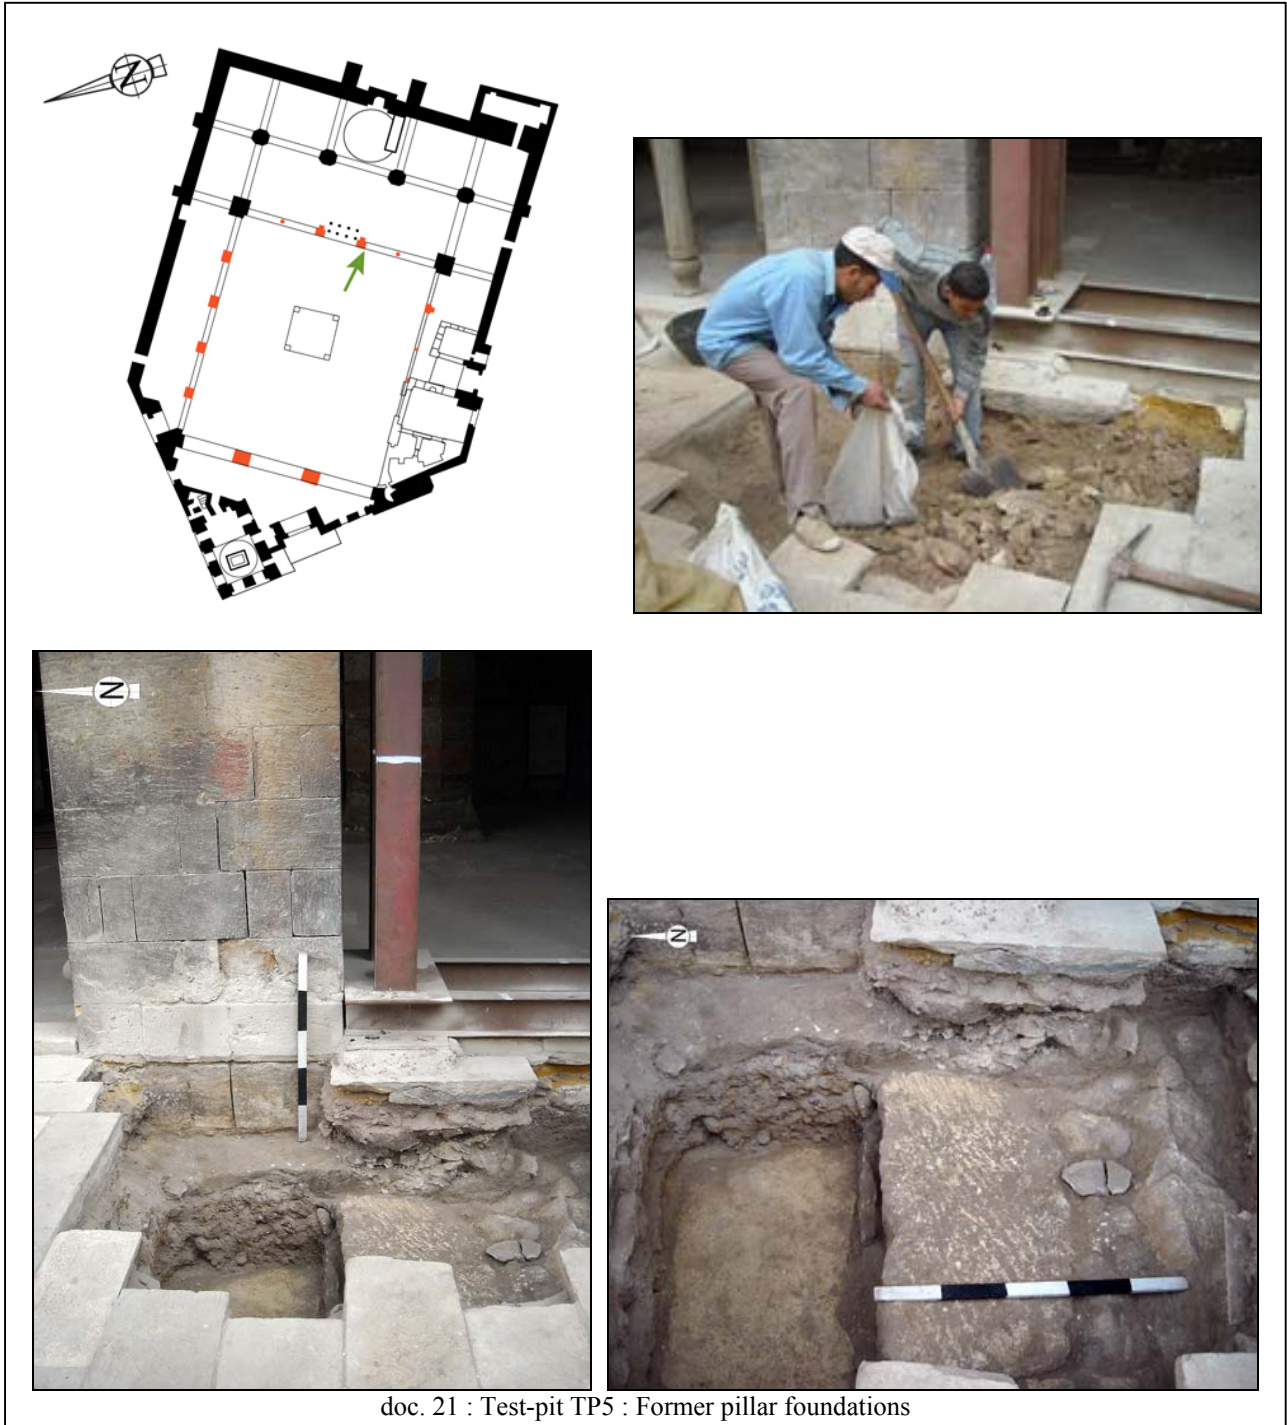
Considering the size of the foundations on **doc 21** and **42**, we can tell that the pillar there were much bigger than the actual ones. They were also slightly to the south, aligned with the qibla ones. The ceramic found in **TP5** is clearly Ottoman, which corresponds with the general understanding we had of the place. To summarize, this particular test-pit shows that the pillars were bigger and aligned both with the corner and with the mirhab ones. Probably not shaped like a palm-tree but squared, decorated in *ablak* and massive.

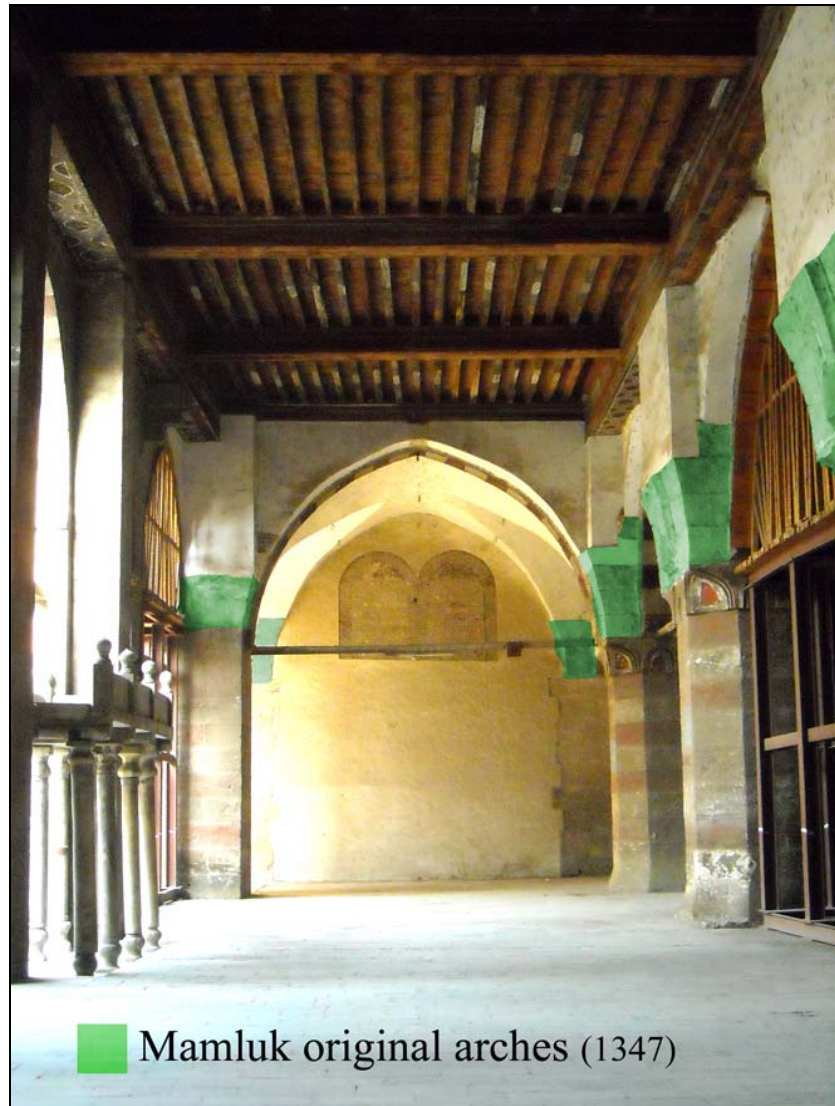
doc. 23 : Traces of the original mamluk arches

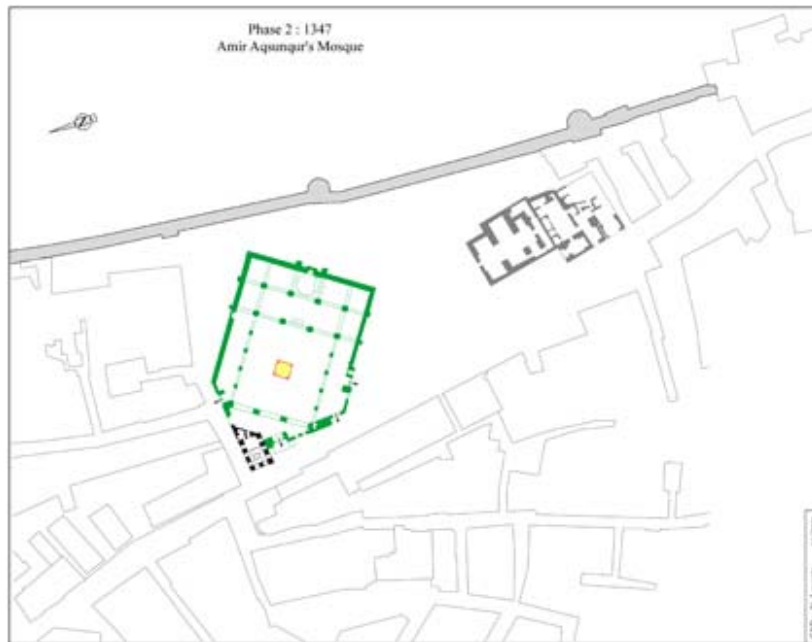
In 1412, the **Emir Tughan ad-Dawadar** started the construction of a fountain in the centre of the mosque. It was surrounded by marble columns supporting a small roof. The columns are supposed to come from **El-Khandak Mosque**, so did the water¹⁰. Test-pit **TP4** was performed to check this integration and also to verify if any trace of the former mamluk pavement could be found.

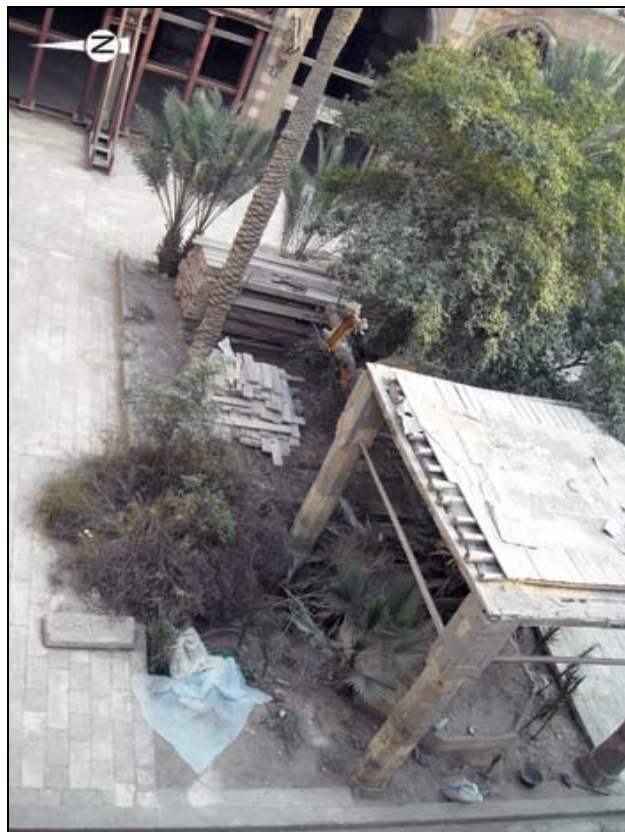
doc. 24 : View of the actual courtyard

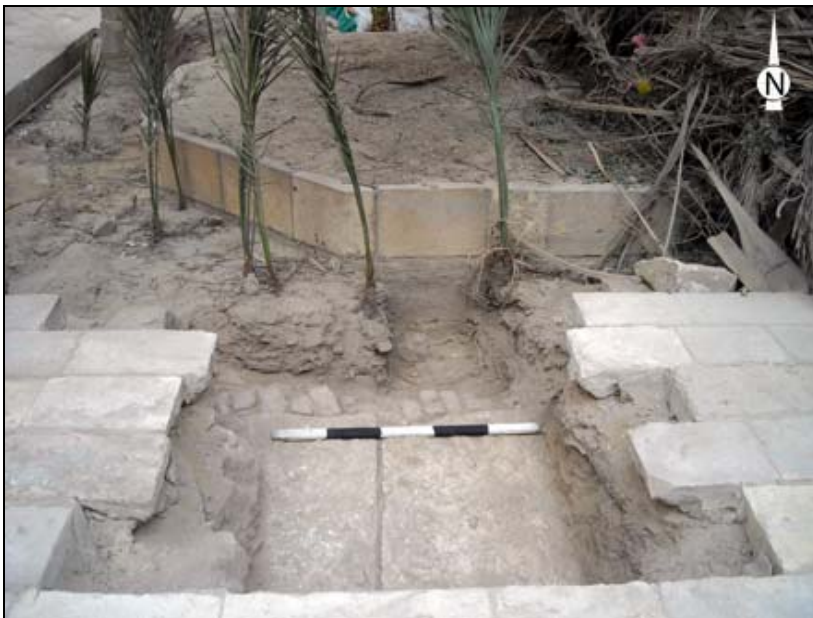
doc. 25 : Test-pit TP3, 1992 & Comité's pavement

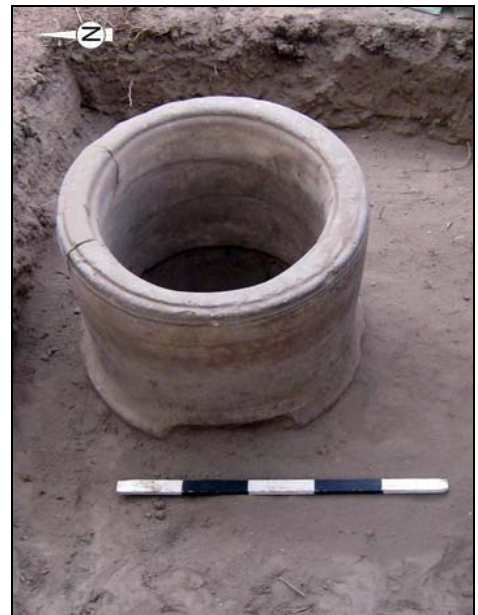
doc. 26 : Test-pit TP4, marble basin

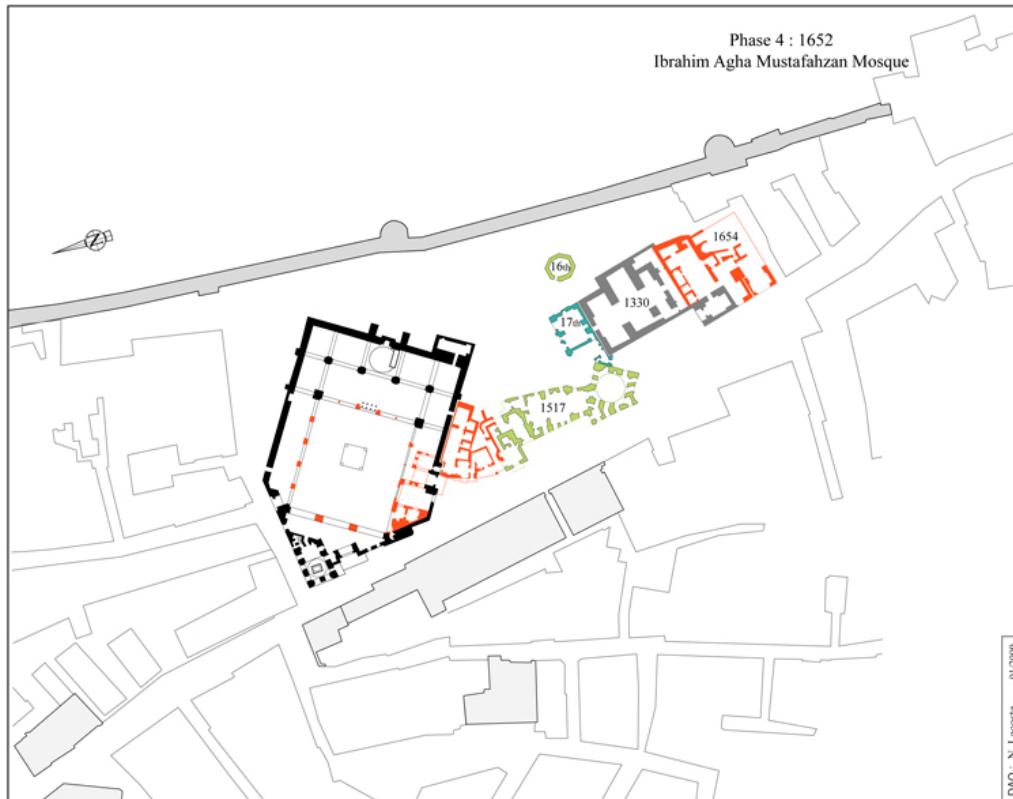
As we said earlier, the Emir Ibrahim Agha was a really rich and important actor of the urbanisation of this neighbourhood (on the previous phase plan you can see in red the major constructions made in the area). In a strange way, Ibrahim Agha had deeply restored this mosque but with a lot of respect for the pre-existing pattern and style. At the Ottoman period many sponsors of religious foundations restored old mosques that had fallen into decay or built upon their foundations and walls, rather than building new ones. Such mosques then acquired the name of the restorer, and this mosque, after restoration, was sometimes called the mosque of Ibrahim Agha. He already had built a place for its mausoleum, in front of **Umm al Sultan Sha'ban Mosque**.

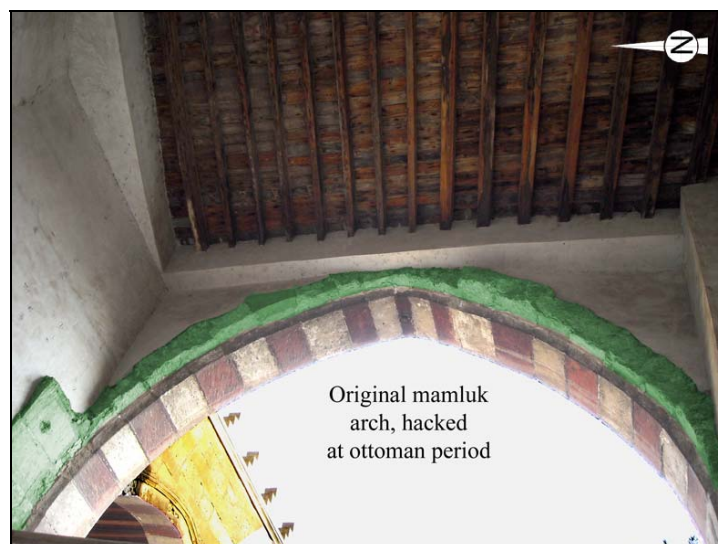
doc. 27 : Hacked mamluk stone arch and Ottoman wooden roof

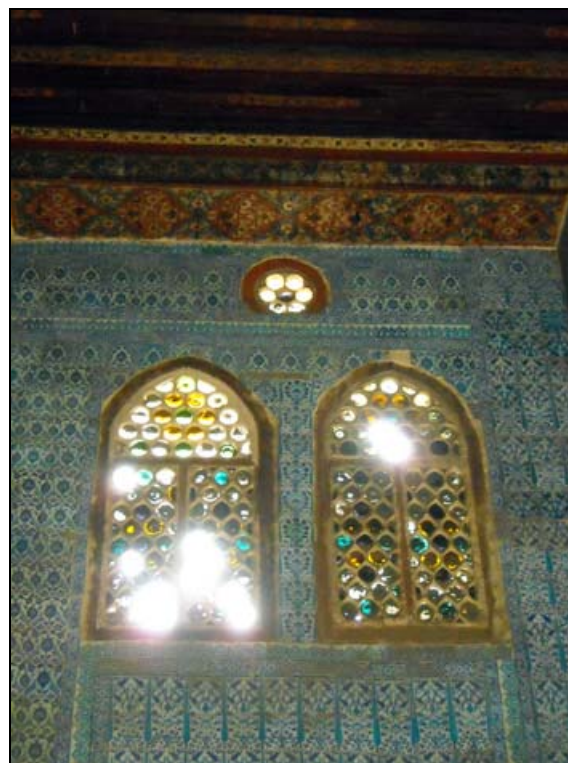
doc. 31 : Ibrahim Agha's mausoleum, blue tiles and decorated roof

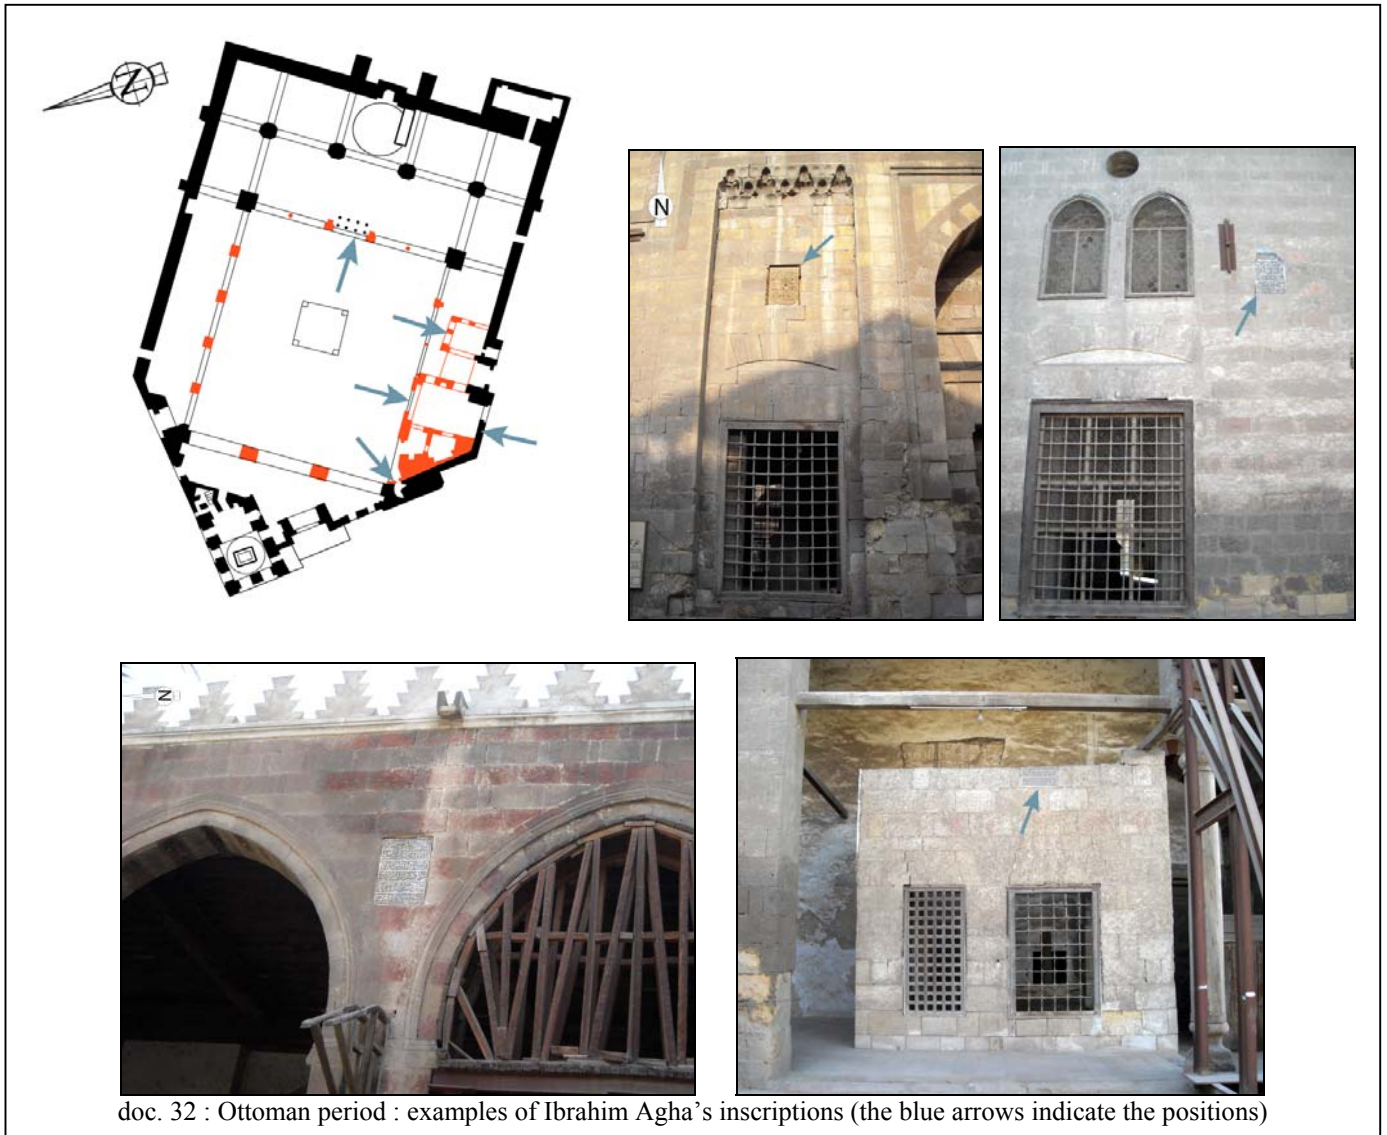
5- Comité's restoration - 1888/1924

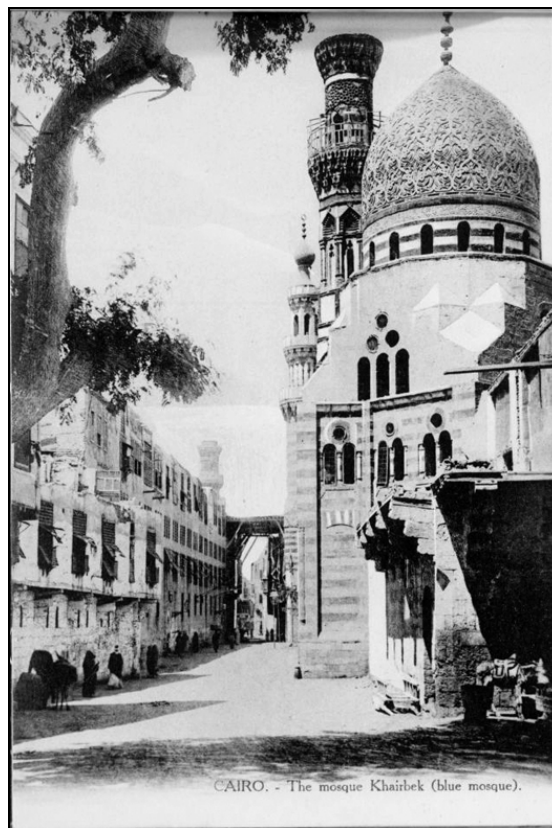
doc. 33 : 19th century picture of Sharia Darb el-Ahmar, wooden roof in front of the Blue Mosque

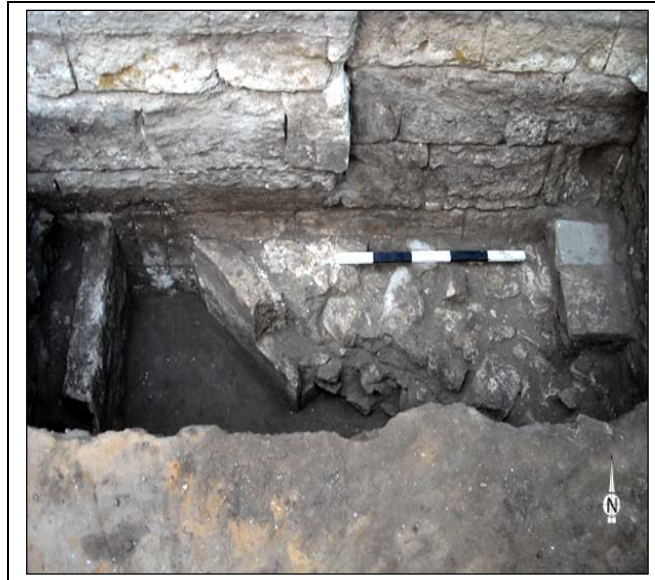
doc. 38: Alin Aq' courtyard - Test-pit TP6 against the Blue Mosque.

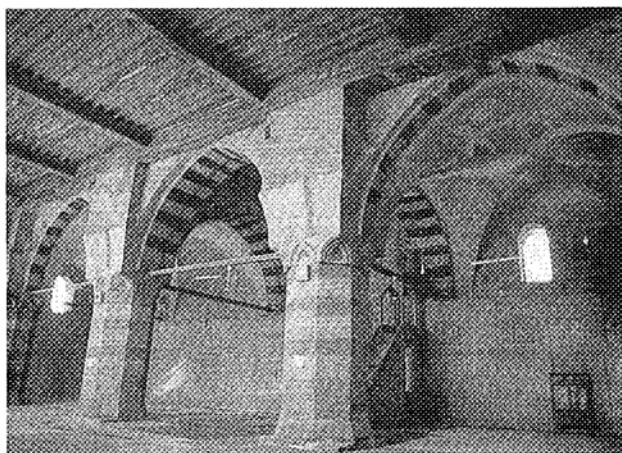
Pl. 82 The sanctuary of the mosque of Amir Aqsunqur.

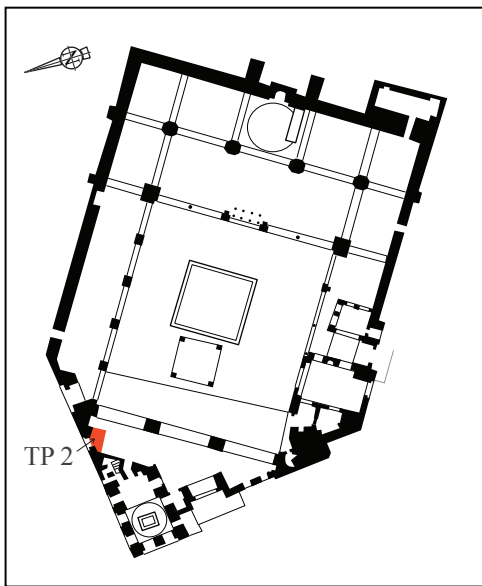
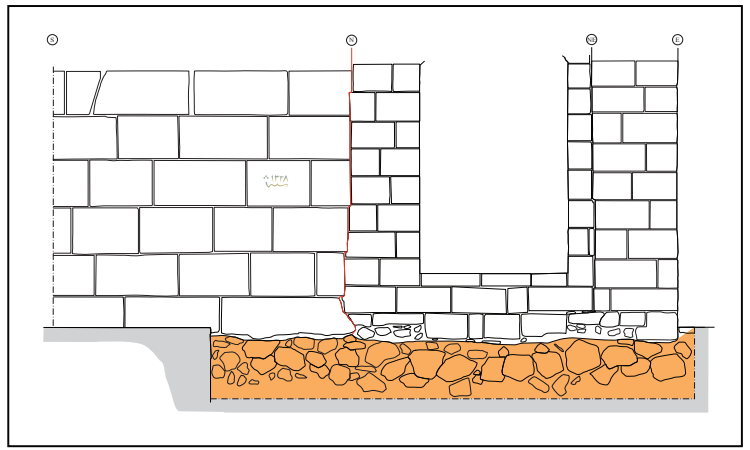
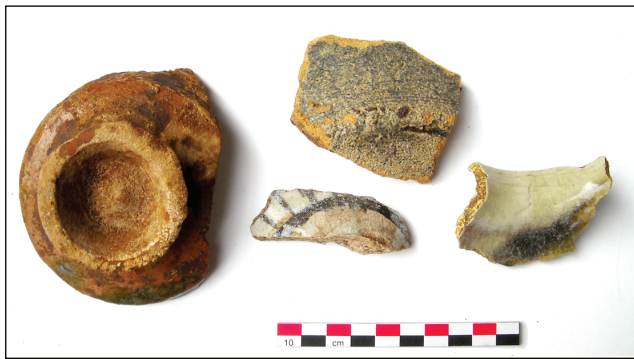
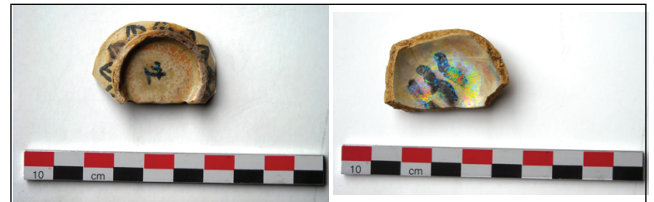
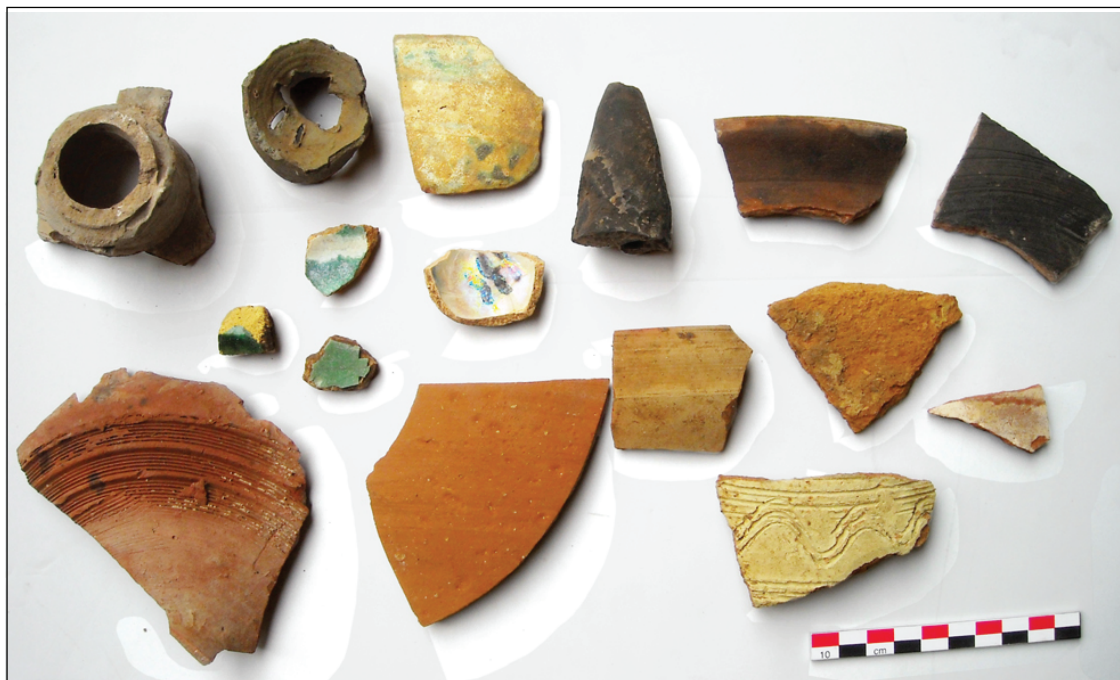
doc. 43 : Blue Mosque - Test Pit TP 2 : Ceramic collected in the layer L TP2-6.

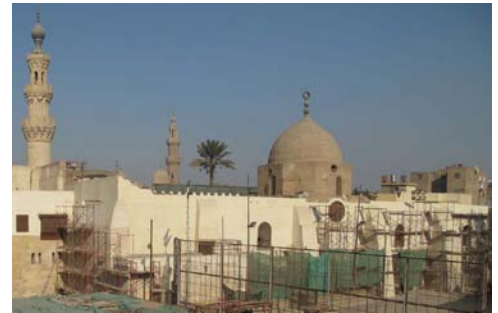
**Structural Engineering
Report on
The Blue Mosque, Cairo**
