AGA KHAN TRUST FOR CULTURE

Historic Cities Programme

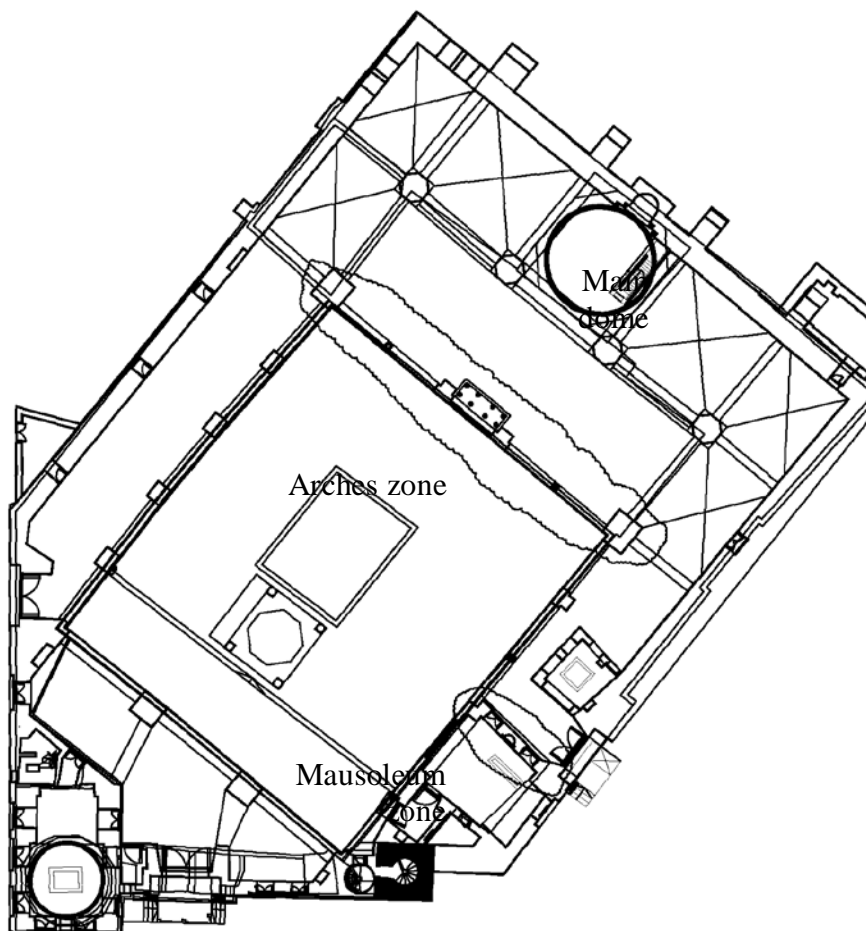
Fig 2. Location of various zones considered in modelling.

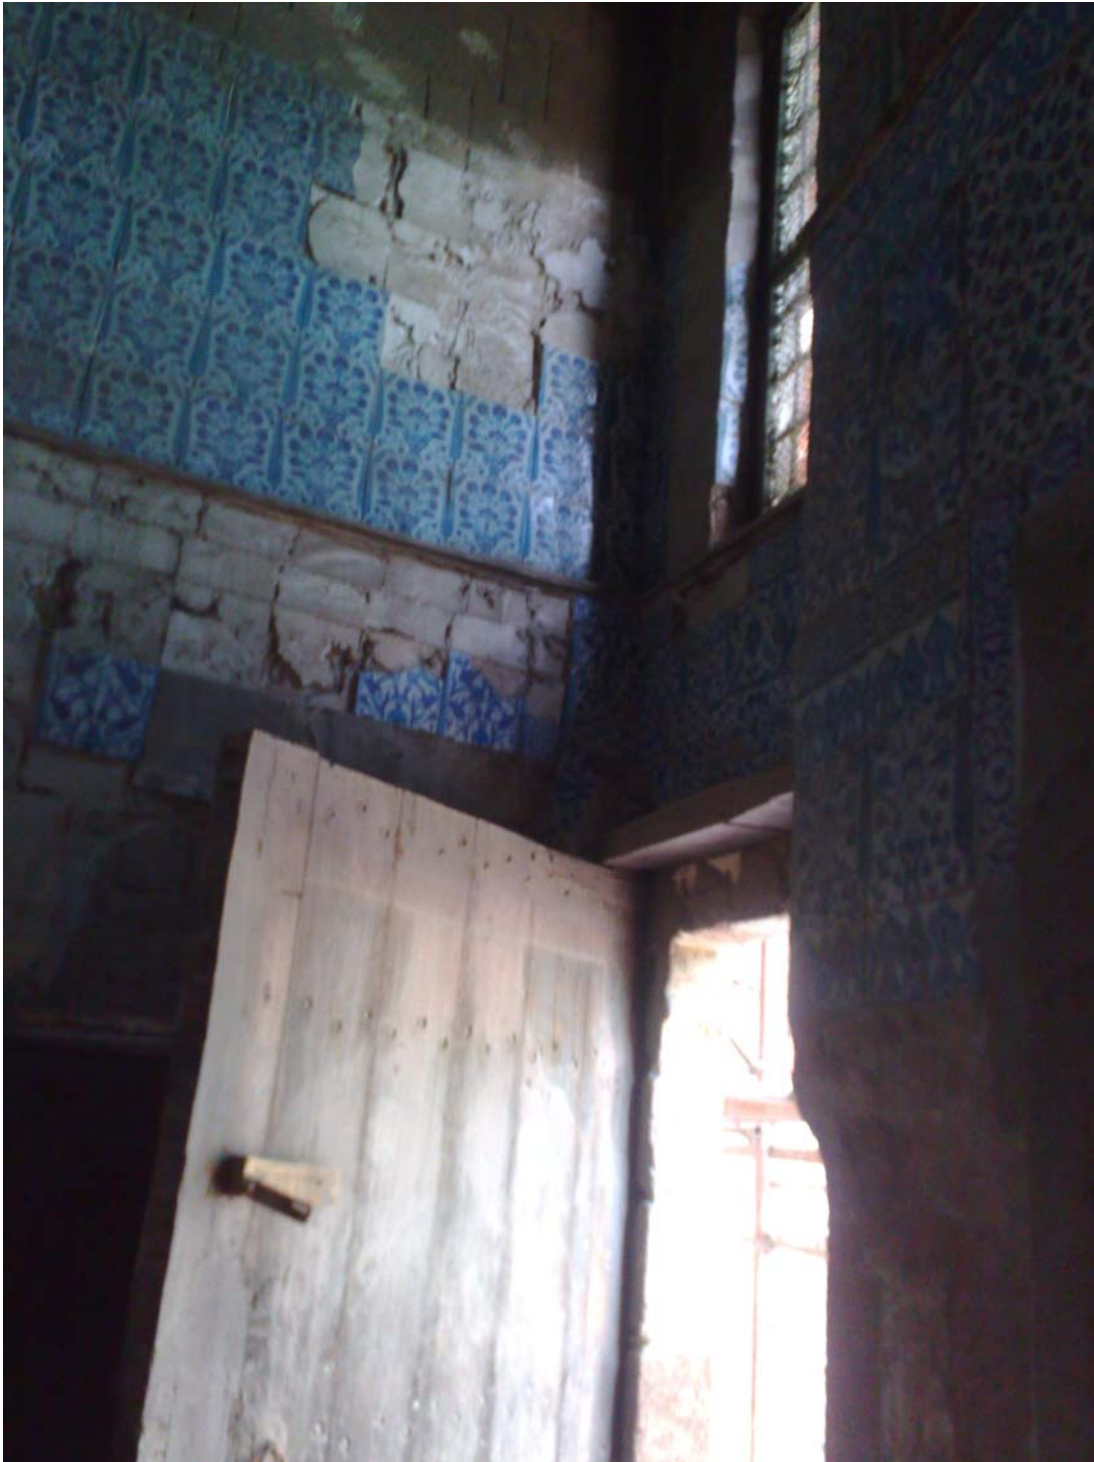
Picture A4: Bulging Mausoleum walls and cracked and fallen ceramic tiles.

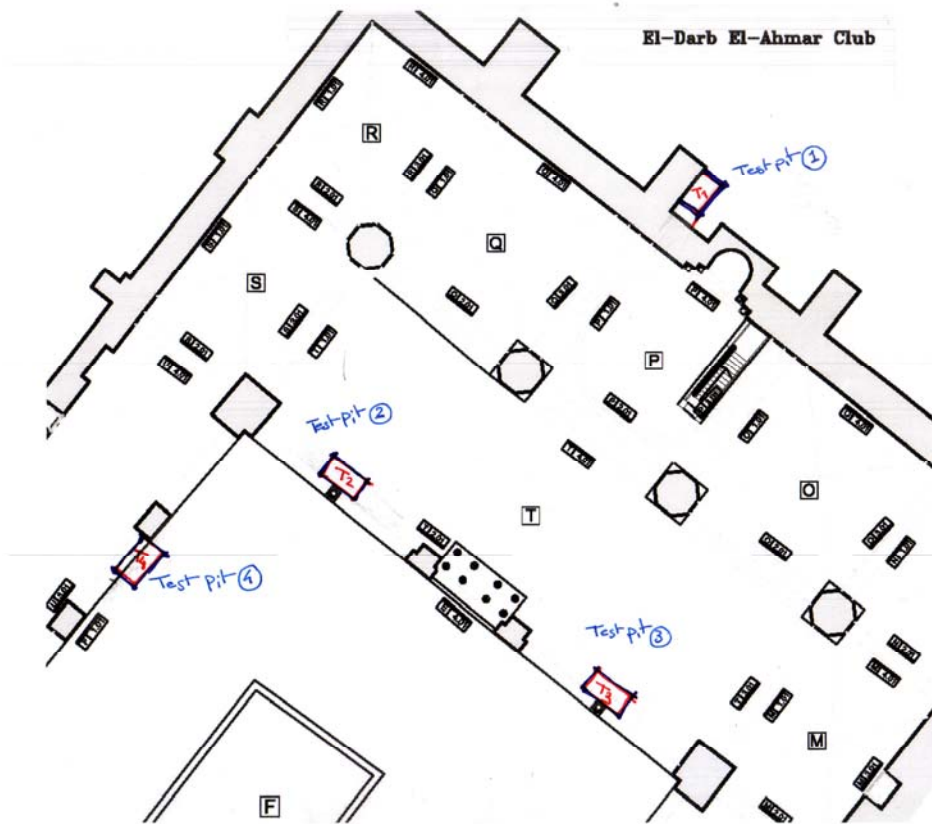
Fig. D1: Location of four open pits to examine the foundations.

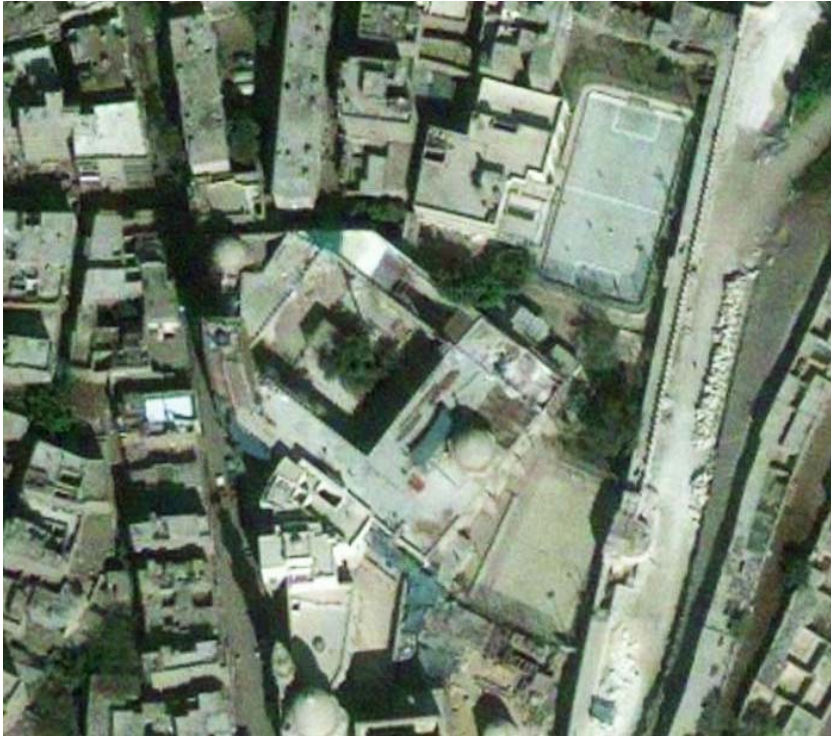
Image (2): Satellite image depicts AQSUNQUR MOSQUE
(The Blue Mosque)
