**1995 Technical Review
Summary**
by Selma Al-Radi

Restoration Of Eski Cami and Hadem Ali Bedestan

Yambol, Bulgaria
1751-2.BUL

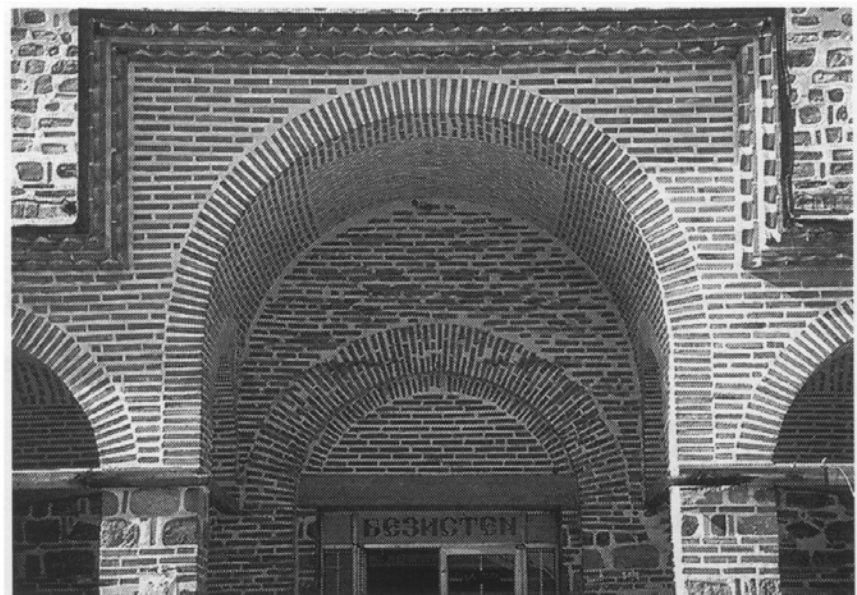
Principal iwan, detail of stone and brick re-pointing

High-fired bricks and cut river stones were the basic materials used in the restoration process in both projects. The mortar was the traditional khurasan lime mortar with additional white cement to give it extra strength. Iron and concrete were new additions. Lead roof and domes were restored using largely traditional methods. Window frames, originally of brick, were restored, using limestone from Musel or from Aitas stone which is easily cut.
