INVESTIGATION OF PERIODIC ARCHITECTURAL CHANGES IN MARDIN ULU MOSQUE

Conference Paper · July 2022

Sema Kızılelma

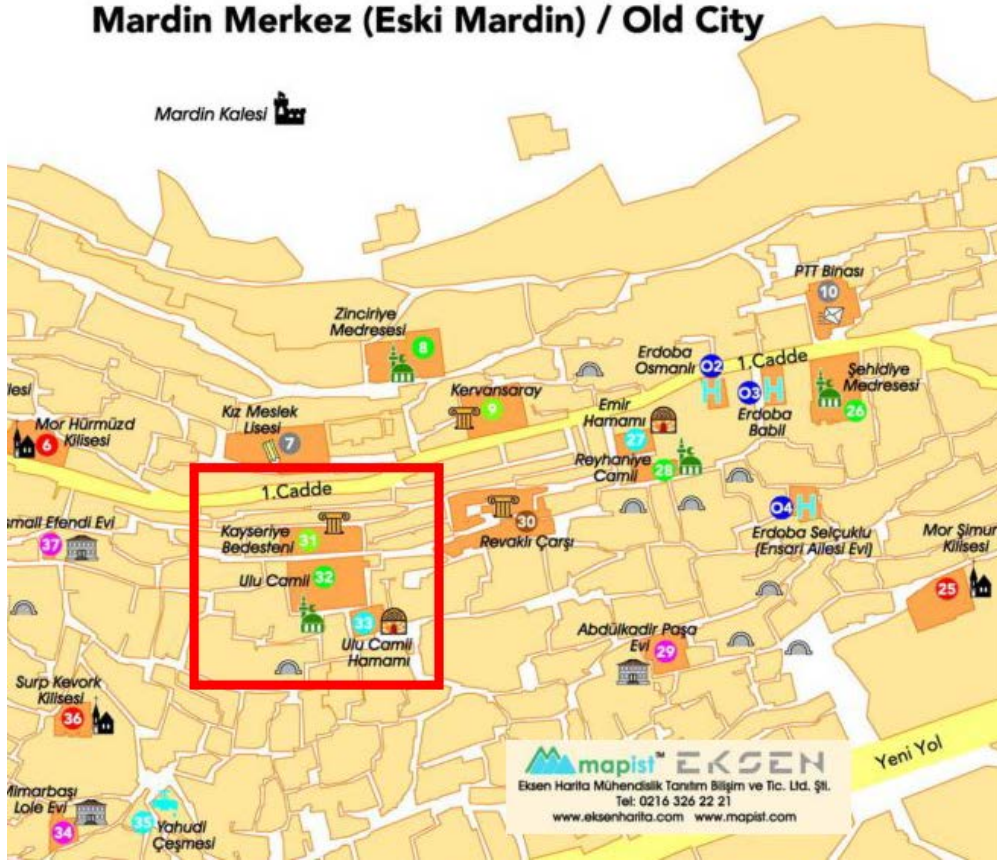
Figure 4. Kayseriye Bedesten, which Abdulgani Efendi thought belonged to the mosque foundation (URL 2)

However, in the Archives of the General Directorate of Foundations, Department of Culture and Registration, there is the foundation charter of Kudbeddin bin Necmeddin al-Artuki, the founder of the Great Mosque, which is stated to be written on the 50th and 70th pages of the logbook numbered 605 (Çağlayan, 2018). Sadi Bayram (2007), who is considered to be one of the first people to examine the related foundation, states that the builder had the building built with double minarets, and that in addition to the mosque, he had a fountain, imam's room, madrasah and a toilet built. Abdülğani Bulduk (1999, 2004) states that the shafilier mosque, the madrasa, the fountain (with lower-upper layout) and the imam's room in the north of the courtyard were built by Kudbeddin Ilgazi in 572 (1176-77). In addition, İbrahim Artuk (1944) states that the madrasa and outbuildings were built during K. İlgazi's enthronement. The madrasa, which is claimed to be in the north of the courtyard, is located in the west according to the charter (VGMA, notebook no 605, pages 50-52, row no: 70) (**Figure 3**). According to what is stated in the charter, the madrasa, located to the west of the western minaret of the mosque, is bordered by roads from the south and west, while it is held by the minaret of the mosque from the east. There is also a barn belonging to the madrasah, to the south of the mosque and opposite the madrasah (**Figure 3**). Abdülğani Efendi (1999) thinks that the Kayseriye Bedesteni, located to the north of the mosque, also belongs to the foundation of this building (**Figure 4**).

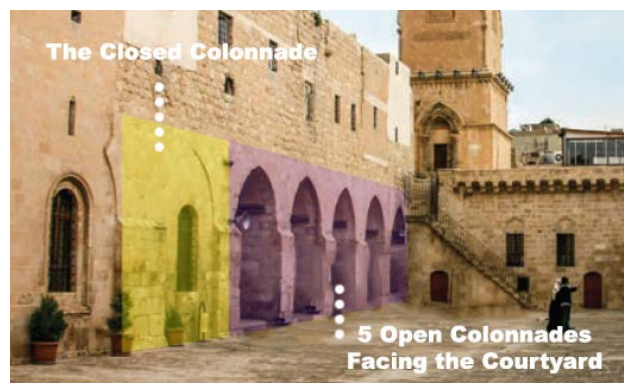
Image 2. Open cloisters and closed cloisters facing the courtyard

Today, five of these porticos from the east are open, the others are knitted and closed.

- During the Artuqid period, the porticoes, which were surrounded on three sides and overlooked the courtyard, were all open, today they are closed and have been converted into rooms. Traces of material in the closed areas are clearly visible.

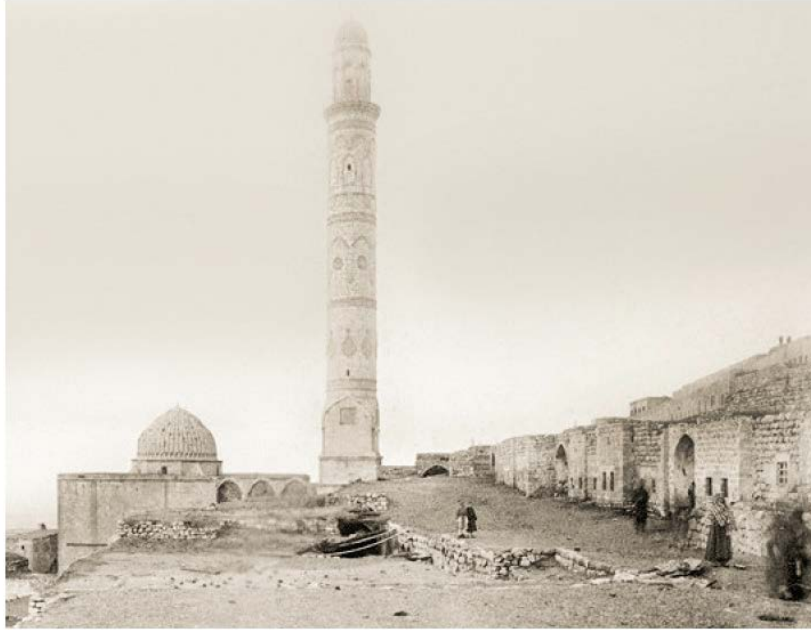
Image 3. Mardin Ulu Mosque in 1889 (Yıldız Saray Photo Archive)

Another restoration of the mosque during the Ottoman period is recorded in the Diyarbakir yearbook dated H. 1318 (1900) (İzğöer, 2012). It is known in the document that a collective repair was made, and the details of the work can not be foreseen. Some of the cloisters in the east-west and northwest of the courtyard were closed and converted into rooms. The iwans in the east and west were left in the form of iwans as entrances, and they were turned into spaces covered with double cross vaults. In the northern part of these, it is shaped as an iwan in the west and a room in the east. The part to the west of the cloisters and the iwan with selsabil, located in the north of the mosque, has been rearranged as the 'Shafiler Masjid' and the south part includes windows, altars; The door to the eastern part was opened. The upper floor porticoes seen in the 1899 photo of the east facade (Yıldız Archive) reveal that the porticoes had two floors during the Ottoman period (**Image 3**).

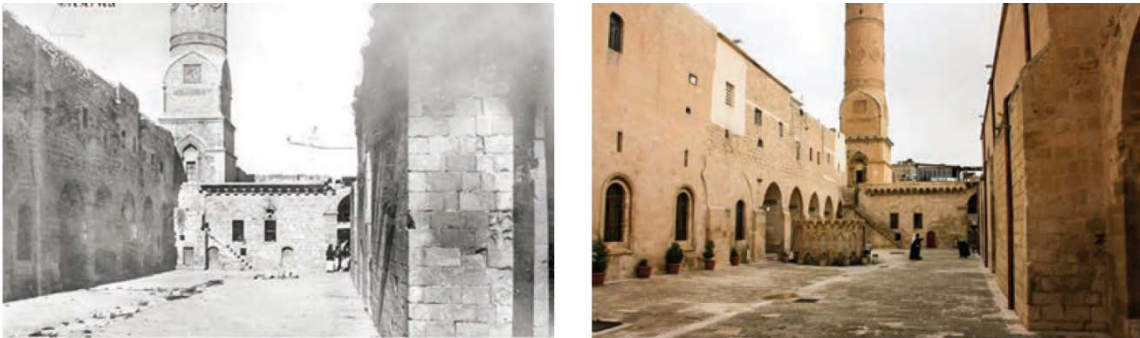
Image 7. A view from the courtyard of the Mardin Ulu Mosque without a fountain at the beginning of the 20th century (Oppenheim, 1930) (left) and the courtyard of the mosque with a fountain today (right)

The Ulu Mosque underwent three major repairs in 1956, 1986 and 2010 by the General Directorate of Foundations and other minor repairs (Archive of the Prime Ministry General Directorate of Foundations, Mardin province, Merkez district, Ulu Mosque folder no. 008). As a result of scaling on the walls of the building during the repair in 1956, all the pencil works were lost. In the repair, refutations were made where necessary, insulation for the roof of the Harim and a fountain were made (**Image 7**). One of the iwans, located to the west of the inner courtyard and opening to the courtyard, was converted into two floors and its front part was closed and used as a space. While this part was used as Mardin Mufti in 1967, it was evacuated in 1968 (Altun, 2006).

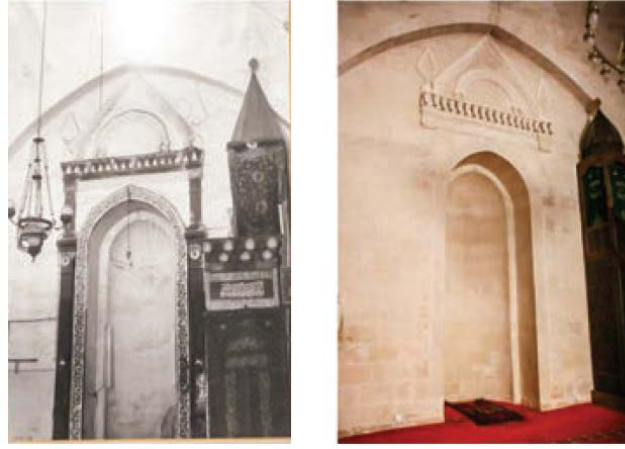
Image 8. The mihrab of Mardin Ulu Mosque in 1967 (Altun, 1971a) (left) and today's mihrab view (right)

In 1986, apart from the repairs, the electrical and lighting project for the building was made and implemented. In 1967, the altar in the form of an oyster shell lost its originality during this period (1986 repairs) and was transformed into a flat semi-dome (**Image 8**).

- The detailed part of the oyster shell in the mihrab was completely flattened and turned into a half dome. This transformation caused the mihrab to move away from its original state.

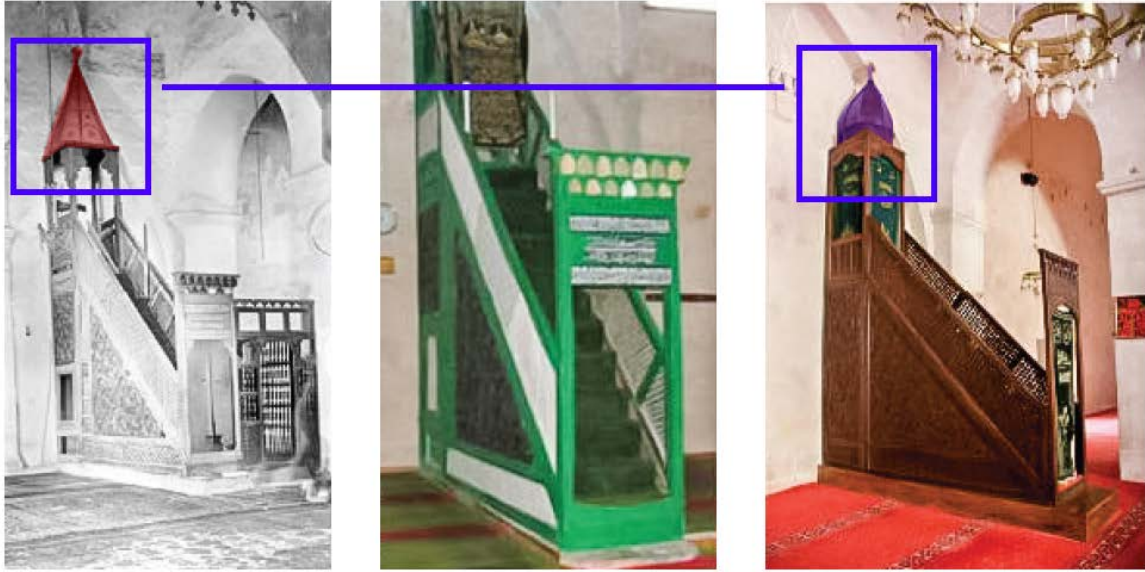
Image 10. Mardin Ulu Mosque minbar (Oppenheim, 1930) in 1899 (left), green painted in 2004 (middle) and today's renovated minbar (right)

The cone of the pulpit did not remain faithful to its original, and its geometry was completely changed (**Image 10**).

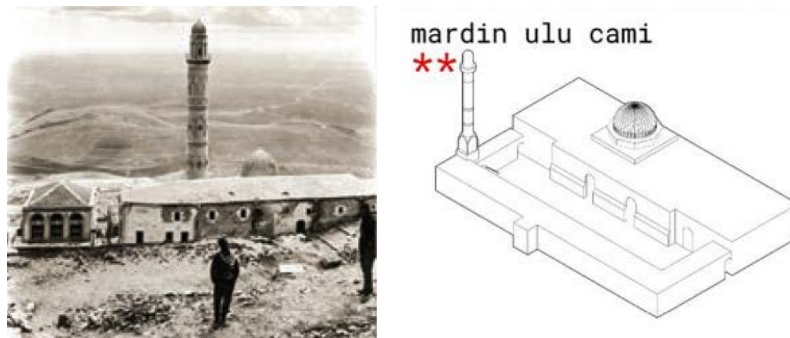
Image 13. The hipped roof of the Mardin Great Mosque in 1911 (Gertrude Bell Archive) (left) **Figure 7.** Today's flat roof (URL 4) (right)

The roof of the mosque was changed when it was a hipped roof and it was transformed into today's flat roof (Işık and Güneş, 2015) (**Image 13 and Figure 7**). In addition, it is stated that the roof material in its original state was a compacted earth roof, it is stated that as a result of the repairs carried out by the foundations between 1950-1980, it was covered with concrete material, and then in the repairs made in the 2000s, concrete screed was poured and it was covered with local limestone belonging to Mardin (Kutlu, 2021).
