A Study on Restoration of Ayaş Şeyh Muhittin Mosque which is an Example of Ankara Traditional Mosque Architecture

In this study, Şeyh Muhittin Mosque in Ayas district of Ankara is examined in terms of traditional architectural features and the restoration carried out by Ankara Regional Directorate of Foundations in 2018-2019 are discussed. The mosque, which is owned by the General Directorate of Foundations and has no construction inscription, dates back to the 16th century. The mosque has no last congregation space and has a transverse rectangular plan. The walls of the mosque are rubble stone up to the basin level and the walls of the body are built with masonry technique with wooden beams and mud-brick. Traditional materials such as rubble, mudbrick and wood are used extensively in the structure. In the interior of the mosque, wood is used in building elements such as wooden posts and beams of women section, minbar, floor and ceiling coverings. The plaster mihrab has the characteristics of 18th century traditional Ankara mosques. Seyh Muhittin Mosque was examined in terms of traditional architecture and art history, and the data obtained during the last restoration and applied

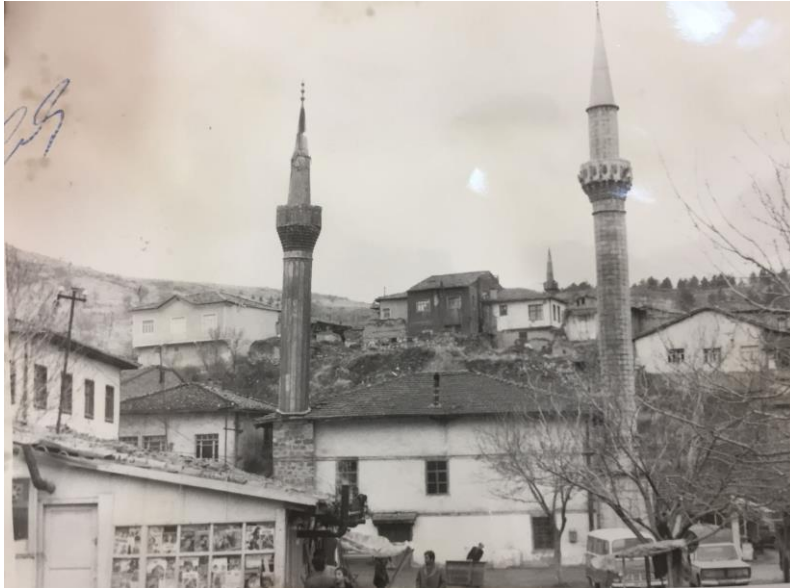
Figure 3. Ayas Seyh Muhittin Mosque wooden and reinforced concrete minaret [9]

The mosque measures approximately 13.20x10x20 m and it has a 2.84 m wide women's section floor and under this floor there is Seyh Muhiddin's sarcophagus. The old minaret in the northeast corner of the mosque has been destroyed and only its base has survived. After the collapse of this minaret, a wooden minaret was built on the stone base. In 1968, a stone imitation reinforced concrete minaret was built on the northwest corner of the mosque. After these two minarets were used together for a while (Figure 3), in accordance with the report prepared by the General Directorate of Foundations, it was decided to demolish the wooden minaret by the decision of the Supreme Council of Immovable Cultural and Natural Assets dated 28.3.1985 and numbered 847 [7]. The original minaret on this stone base is thought to be brick like the other examples in the district (Ulu Mosque and Bünyamin Mosque). Since the information and documents related to this original minaret could not be provided, no changes were made in this direction during the restoration works.

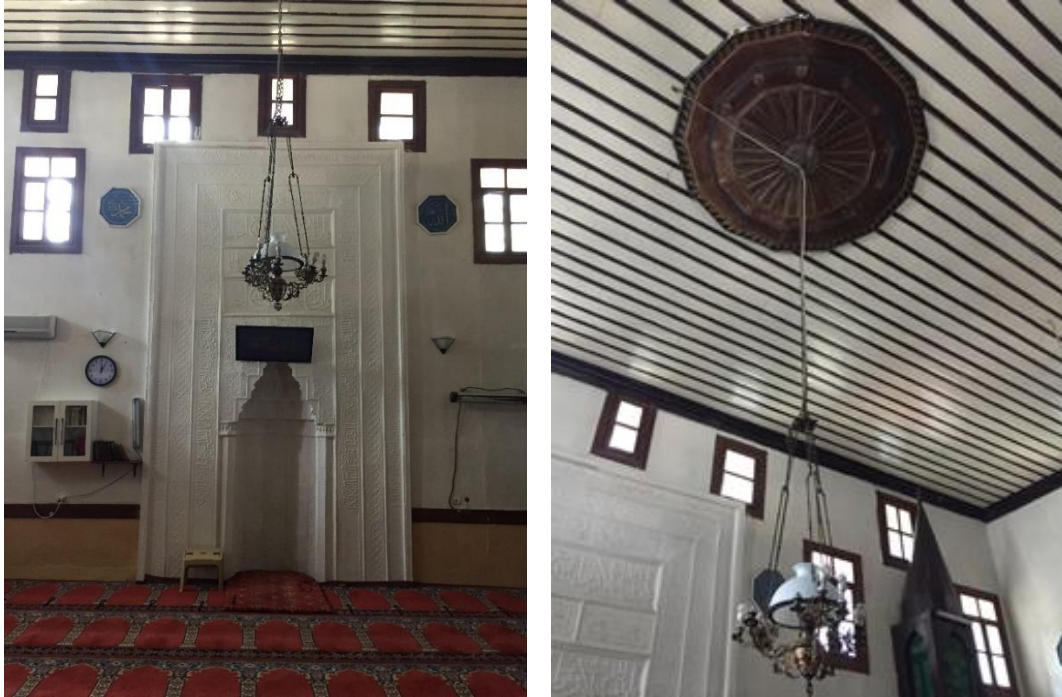
Figure 4. Plaster mihrab and wooden ceiling hub [7]

The mosque has a wooden ceiling and a low relief, geometric inserts, plaster mihrab (Figure 4) and a wooden minbar between the two windows [8]. On the slatted wooden ceiling, there is a ceiling hub which is found to be painted with ochre (Figure 4).

In the approved restoration project; It is envisaged that the paint layers applied in layers over time prevent the perception of the plaster mihrab motifs to a great extent, and therefore, paint cleaning is performed with suitable methods in order to reveal the original surface. In this direction, firstly mechanical cleaning has started in plaster mihrab. During the cleaning of the paint, different colors of ochre paint were found in the lower layers (Figure 16). For this reason, the cleaning activities were carried out more precisely, paint cleaning was continued with paint remover and scalpel and orche paint was determined in most of the mihrab. After the cleaning works were completed, the fractures and cavities in the mihrab were consolidated by injection (Figure 17). Afterwards, completion and revitalization was done with orche.

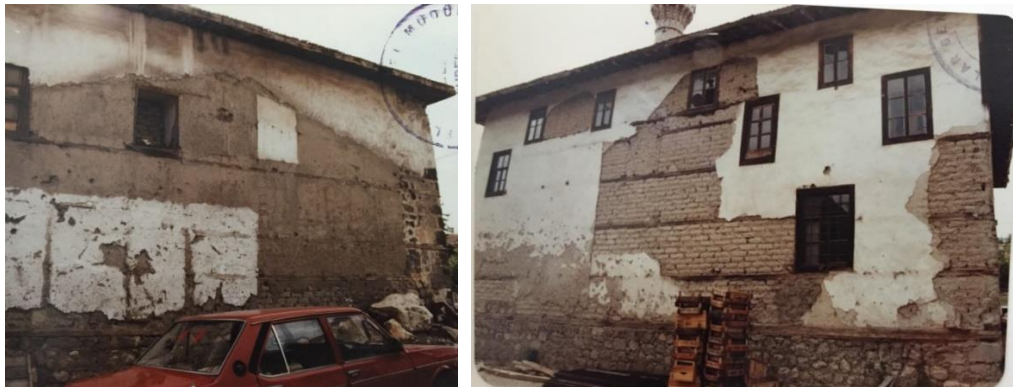
Figure 13. Old exterior photos [9]

Following the start of the restoration work, a research was conducted in the archives of the Conservation Regional Council and old photographs of the building were obtained (Figure 13). In line with the data obtained, the restoration project was revised and the revised restoration project was approved by the Ankara Regional Board of Conservation of Cultural Heritage with the decision dated 06/12/2018 and numbered 6218. According to this project, the wooden door on the left side of the entrance door on the north side of the mosque which was used for the entrance of the women's section was canceled and turned into a window. In line with the data and old photographs, the revision of the east and west facade window system was also carried out. However, an arrangement was not made in the southern facade window system where sufficient data could not be obtained.
