AGA KHAN CULTURAL SERVICES - AFGHANISTAN

FINAL NARRATIVE REPORT

RESTORATION OF DEHDADI MOSQUE, BALKH

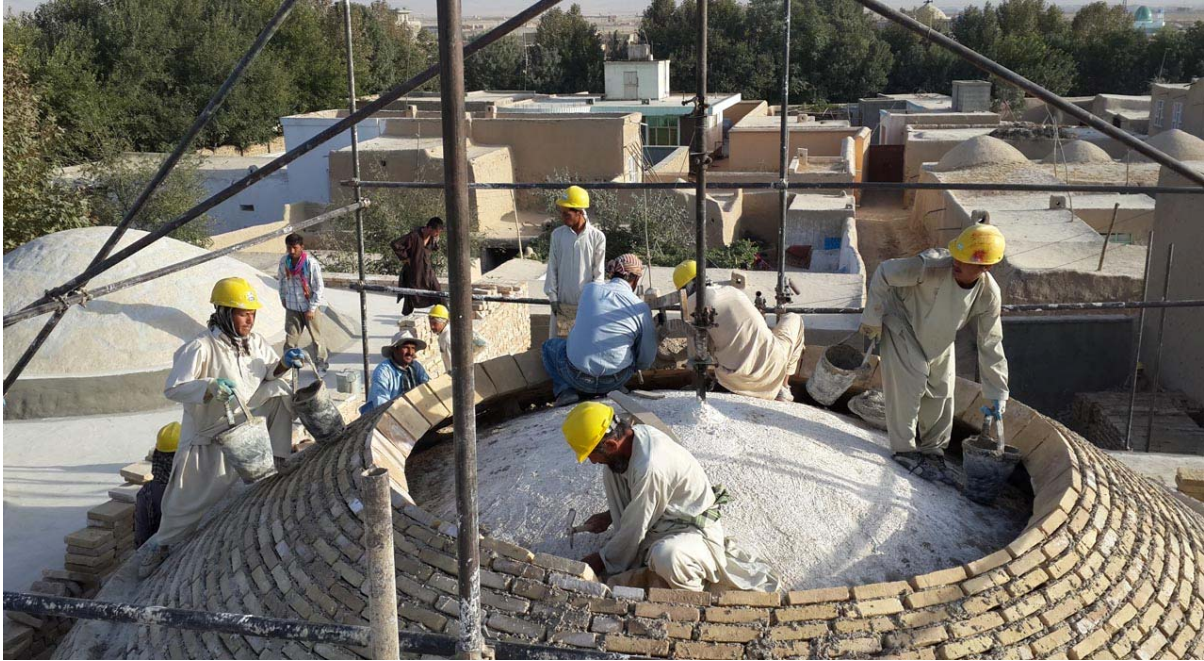
3.1.5 *Reconstruction of collapsed domes:*

Simultaneous to the construction of the baked brick masonry “shell” structure, teams of masons worked to reconstruct three large domes located at the western perimeter of the building. As the rooms beneath the domes were essential to the functioning of the mosque, the domes were rebuilt using backed brick masonry with a composite gypsum and mud mortar. In total more than 18.8 cubic meters of baked brick masonry was used to reconstruct these domes.

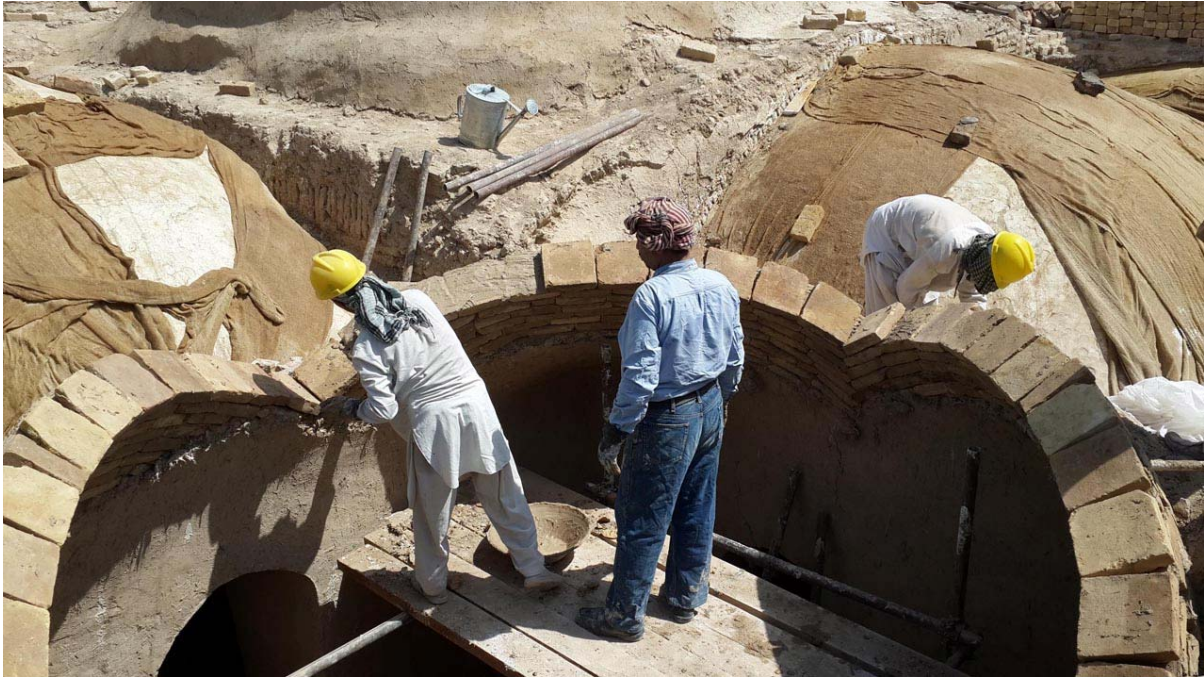
3.1.7 *Lime Concrete & Water Proofing:*

In order to ensure that rain water and snow melt did not seep into the newly restored roof; two separate treatments of water-proofing were applied to the surface of the roof. The first, involved the application of a 2.5 cm thick special lime concrete aggregate made of lime, sand, and brick powder. “Bulrush” fiber was also added to the mortar for its adhesive qualities and in order to reduce cracking of the lime concrete during the curing and drying process. The lime concrete was compacted using a plastic hammer for a period of three days and left to cure over a 2 week period, during which the materials was kept wet by a layer of damp straw sacks. Once the lime concrete had set and dried, a layer of water-proof polymer insulation paint was applied to the surface of the lime concrete. While sealing the surface of the lime concrete against the penetration of water, this flexible layer of polymer paint also serves the purpose of allowing water vapors to evaporate away from the masonry dome. In total an area of 1182 square meters on the roof was covered by lime concrete and received an application of the polymer paint.

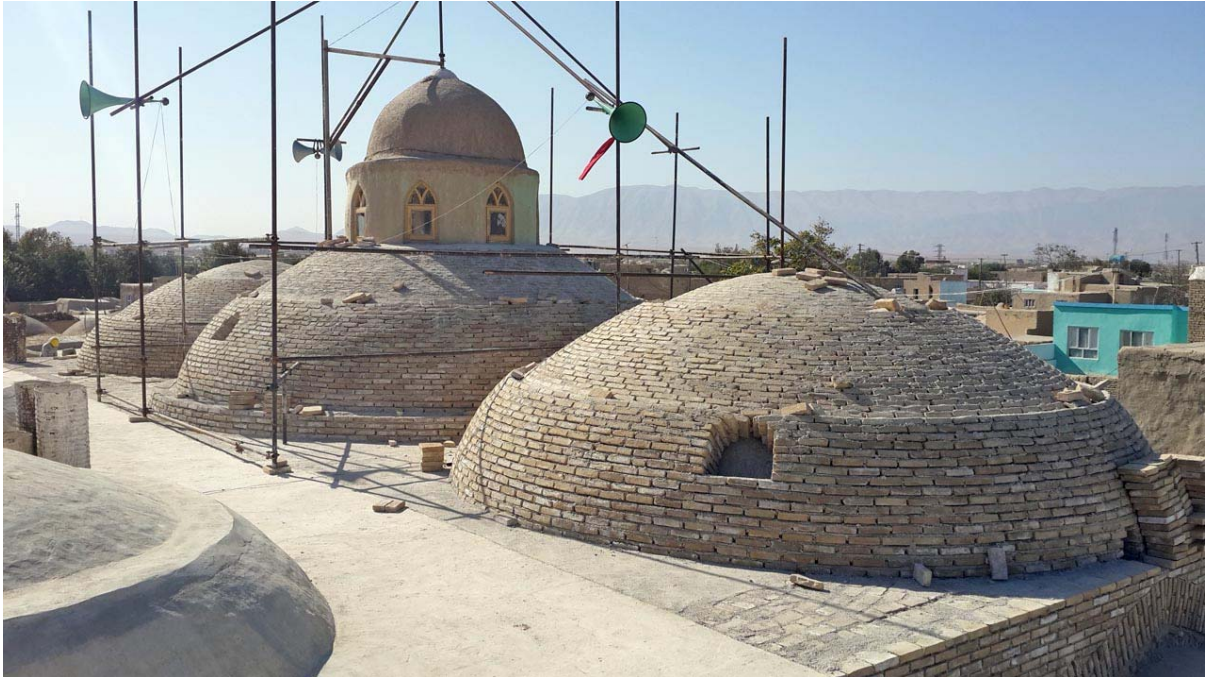
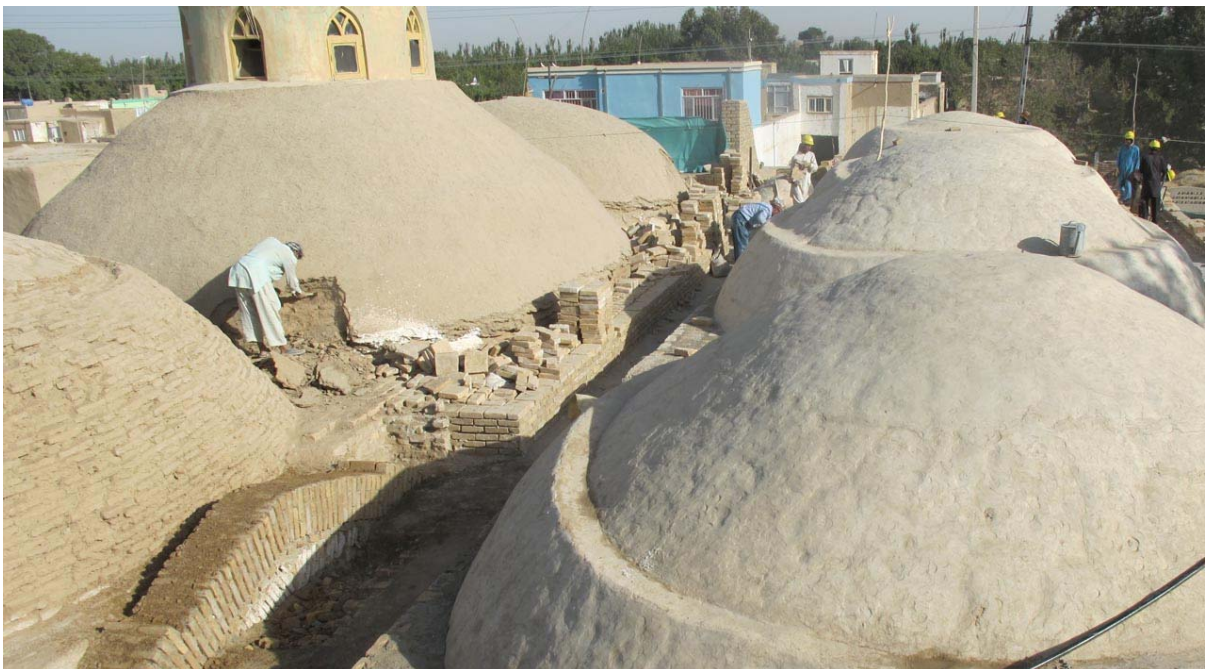
be re-directed away from the building quickly. The spouts were installed above the lime concrete and polymer paint and beneath the final layer of brick paving. The perimeter of the spouts was sealed against the penetration of water through the application of a thin layer of tar.

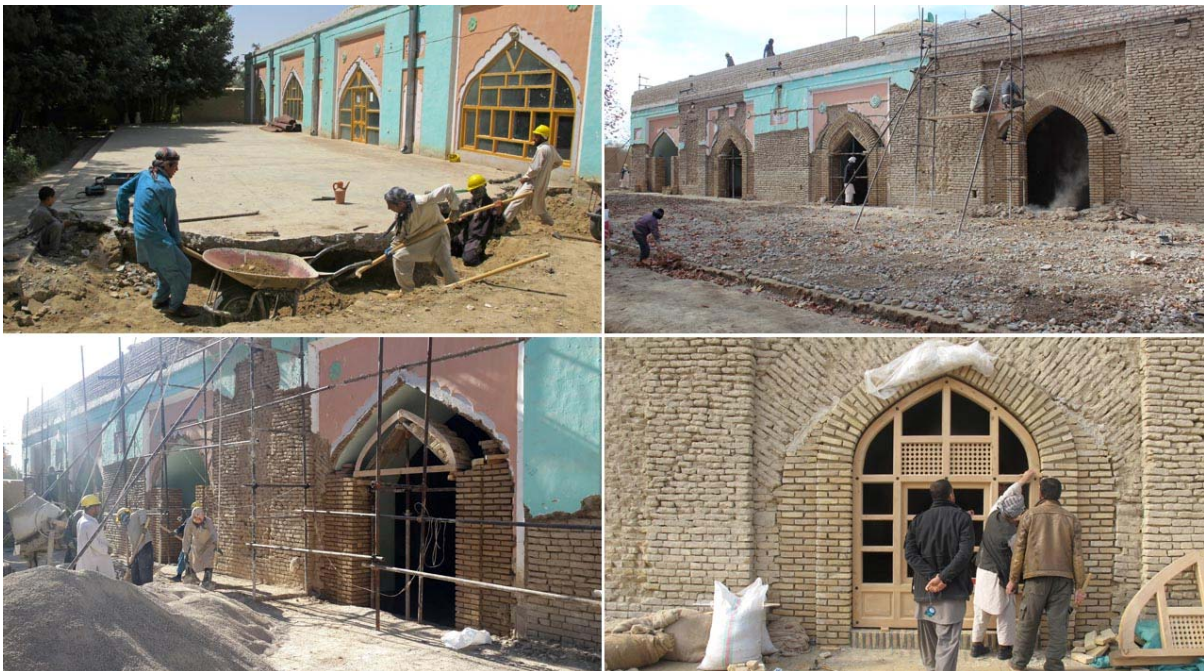
3.3 EXTERNAL ELEVATIONS

The 32 meter long western wall of the Mosque, behind the main *mihrab* niche, had been badly damaged due to settlement problems. In 2008, the Department of Historic Monuments had carried out remediate works to strengthen this wall yet settlement problems persisted. As part of consolidation works, the previous intervention was assessed and new designs for structural supports were prepared. The design called for the extension of an incomplete breast support wall built parallel to the original damaged wall. The work was carried out using more than 52 cubic meters of baked brick masonry applied with lime mortar. Following the construction of the breast wall, all exposed surfaces of the masonry were pointed using lime putty.

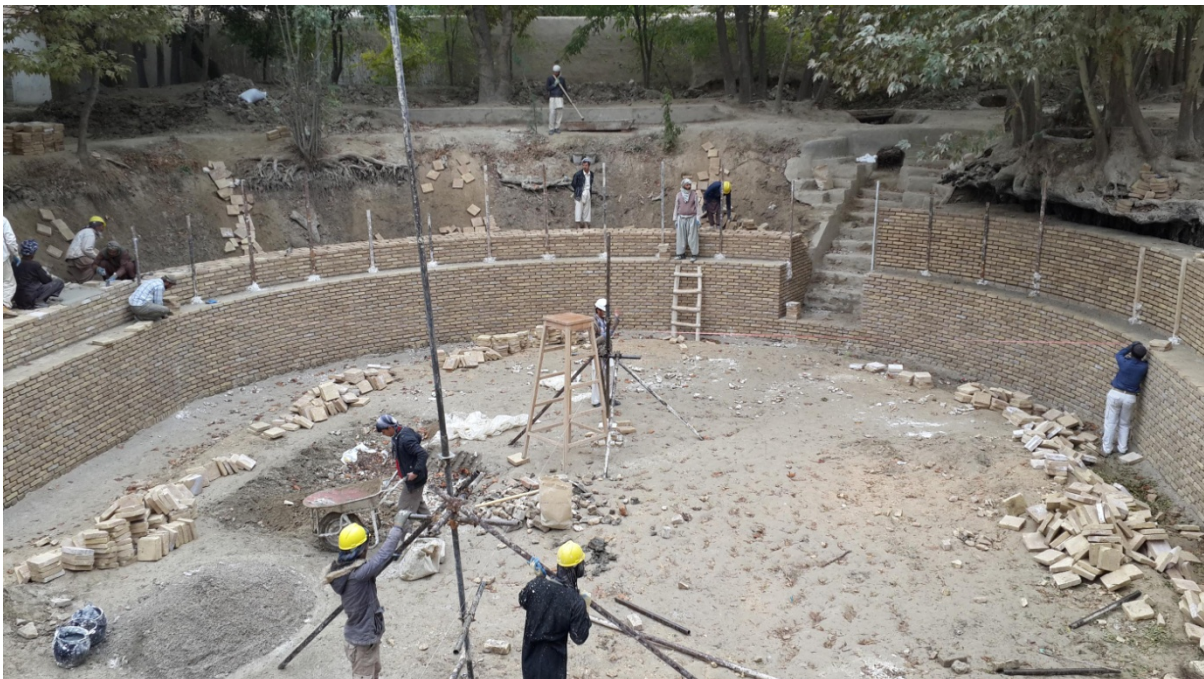
3.4 WATER RESERVOIR

The large oval water reservoir located approximately 13 meters to the east of the Mosque, has been the cause of many structural problems for the building. At the same time, the historic reservoir is one of the unique architectural elements of the site and supplied the community with potable water. As such, it was necessary to reconstruct the perimeter walls of the reservoir in order to prevent further eroding of the surrounding earth and reduce seepage of water towards the Dehdadi Mosque.

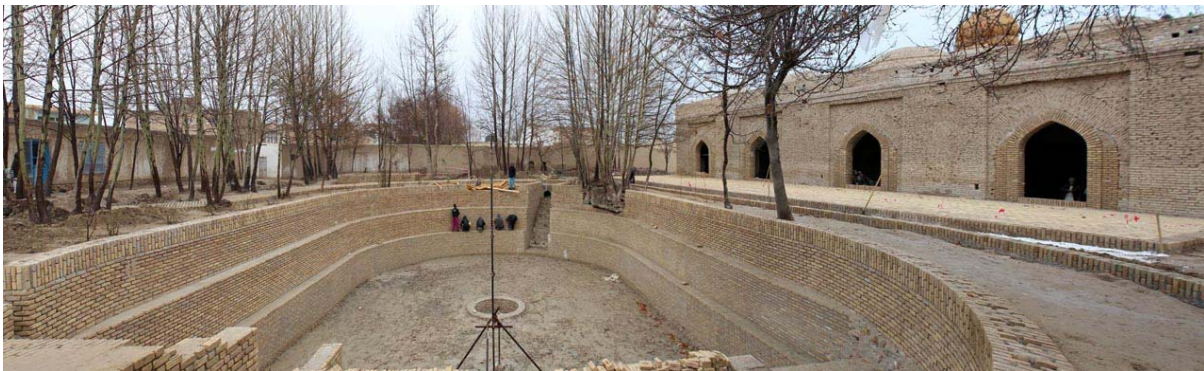
3.4.4 *Water filter:*

A historic man-made channel connects reservoir to its source at the Balkh River. Due to seasonal flooding of the river and the nature of top-soil in the area, the channel also carries fine river silt and deposits the material within the reservoir. Aside from polluting the water of the reservoir, this led to an increase in the level of the pool and decrease in its capacity. As part of the construction works, a simple water filtration tank was constructed on the southern edge of the reservoir and attached to the surface channel that brought water to the pool. The filter was designed to reduce the amount of silt deposited inside the reservoir by changing the speed of water flow. This results instead in the sedimentation of silt within specially designed tanks from where it can be easily cleaned.

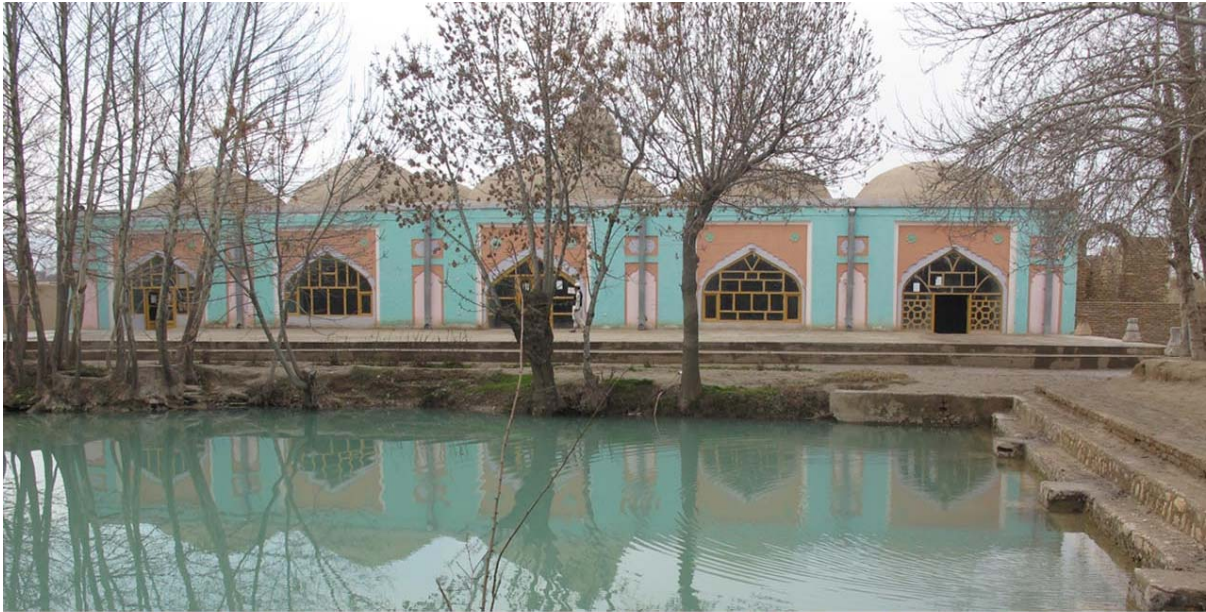
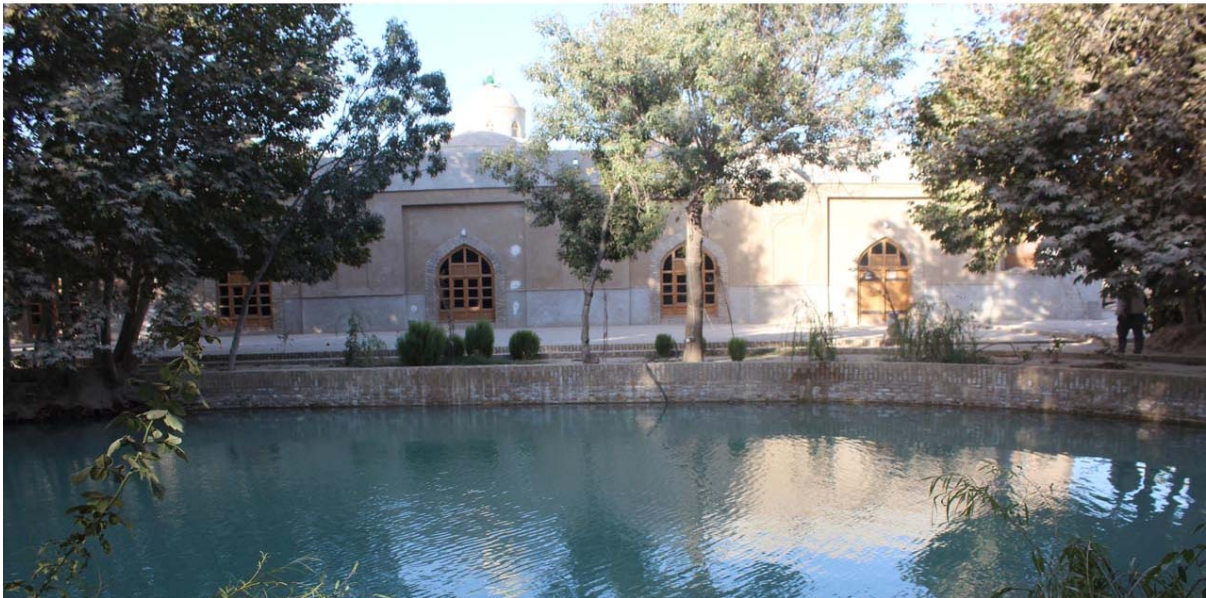
Upon the demolition of the large cement concrete platform, the area was paved with 278 square meters of baked square bricks above a lime concrete substructure. The newly constructed platform will serve as an important area for prayers.
