SHAHJAHANI MOSQUE CONSERVATION

Baghe Babur, Kabul

Completion Report

Ratish Nanda, Conservation Architect
January 2005

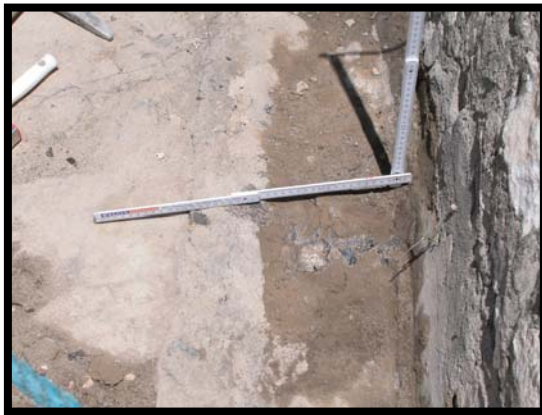
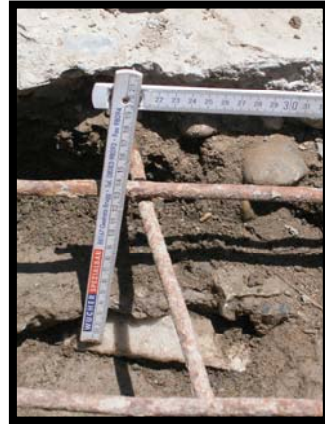
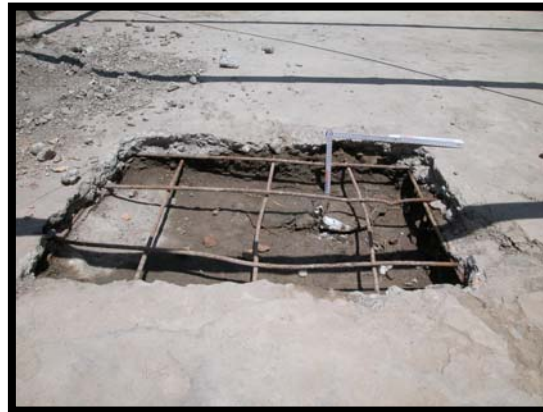
Slab. The slab was itself covered with a bituminous layer of waterproofing, as were the parapets; it seems that the bituminous coat melted from the vertical surfaces of the parapet and formed shallow depressions (see photo below) on the roof- thereby creating ‘pools’ that collected water that eventually seeped through to initiate the decay process. Modern grouting materials and waterproofing layers such as silica were also used, as were iron clamps to fix the marble to the cement masonry. Under the RCC roof an iron girder and posts have also been exposed, with no apparent structural function, these seem to have been used to serve as benchmarks during the reconstruction.

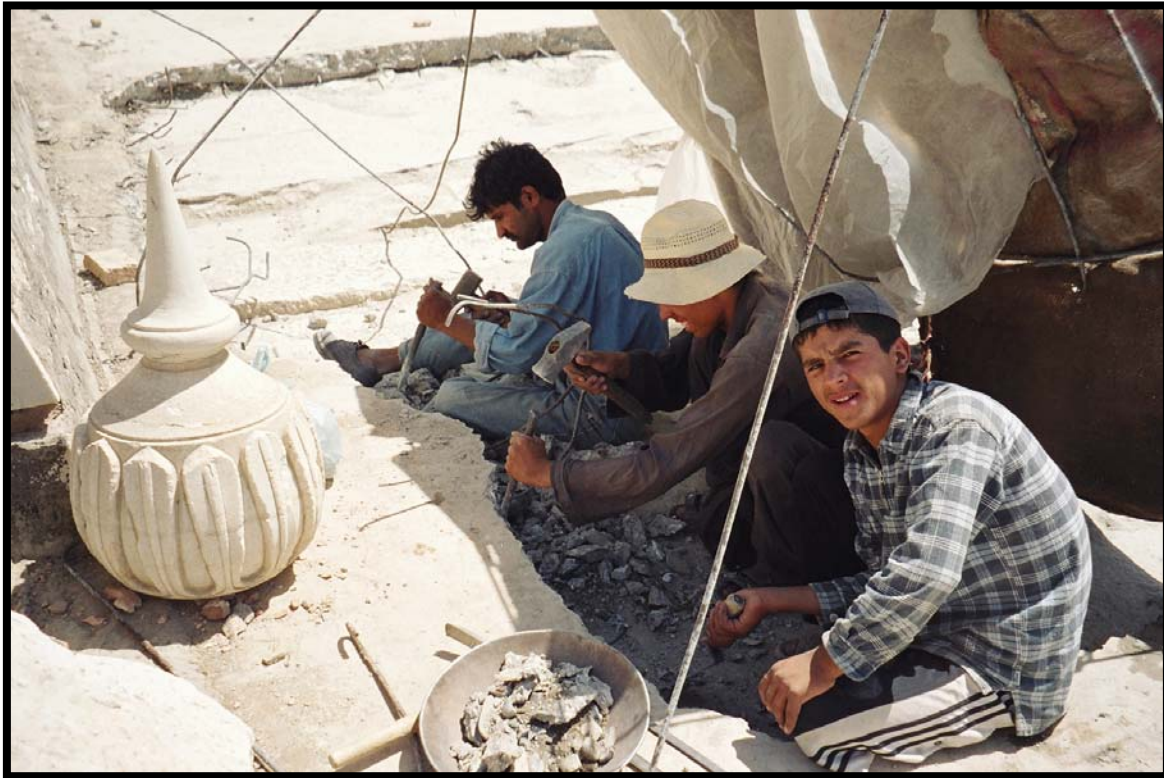
Concrete removal in progress, using hand tools and after the erection of shuttering to provide additional support to the roof.

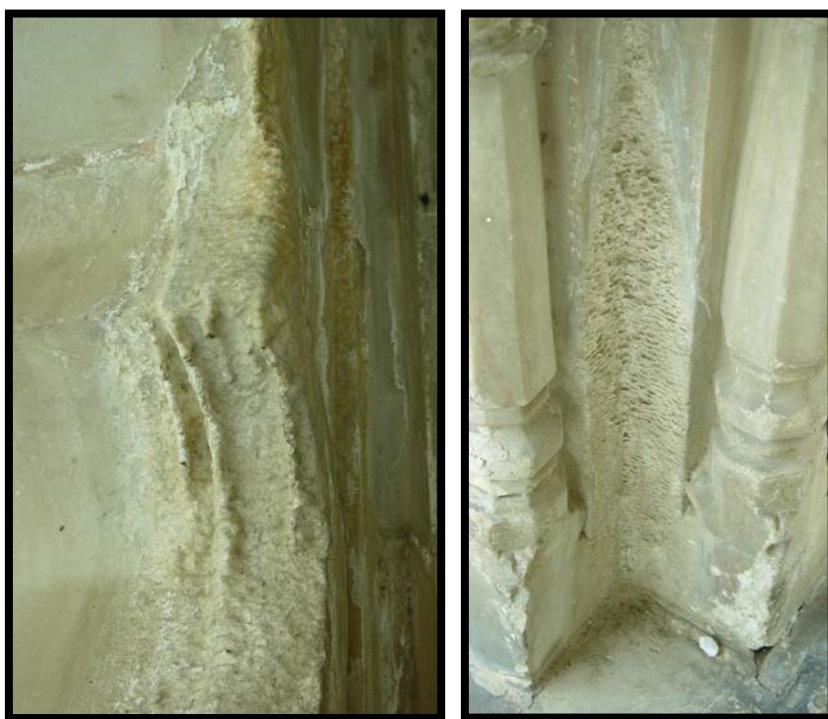
much deterioration in the historic marbles. The cement concrete in the RCC slab became loose from the reinforcement bars and the slab added considerable dead weight on the marble slabs; this occurred mainly due to the use of a high aggregate size (upto 100 mm) and inappropriate rounded river pebbles being used in the aggregate. The bitumen from the parapet melted in the heat causing pools of water to form during the rains thus leading to water seepage from the roof. The water seepage was accelerated as a result of cracks and cavities created due to a rocket attack.

Water seepage over the cement concrete and the iron bars caused severe calcification and accumulation of salts on the historic marbles causing severe damage that would require some stone replacement. Furthermore the roof slabs and the cornice stones have been stained with ferrous

run-off. In a situation seen rarely in marble, damp patches are visible on the roof slabs indicating the accumulation of a significant amount of water, over the years, in the cavity between the marble and the RCC slab.

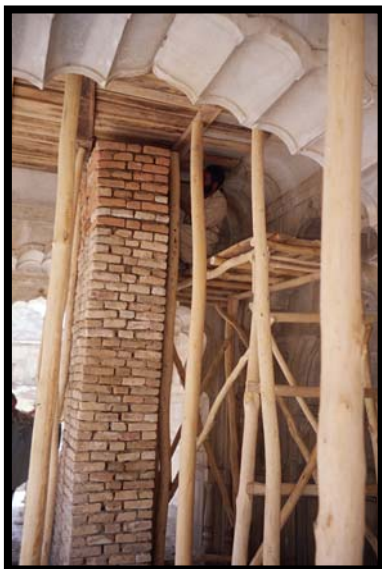
Water penetration from the roof and resulting dampness, ferrous run offs and salt formation on the marble causing irreversible deterioration was one of the prime concerns in the building. As a part of the analysis a small portion of RCC was removed from the location of the rocket damage; this revealed the condition of the roof slab described earlier in the report and led to the decision to dismantle the RCC to replace it with a traditional lime concrete slab.

In order to commence removal of the RCC slab, shuttering was erected within the mosque to cushion against the vibration caused during the removal process. Even though the RCC slab was chipped off over a month using hand tools, the shuttering, as a precautionary measure was still considered necessary; even more so in the central bay where the shuttering was further consolidated with the erection of brick piers in mud mortar as the west cornice had severe existing cracks. On the completion of the removal of the RCC a detailed inspection of the roof slab was carried out; this revealed the existence of vertical and horizontal 'T' sections, possibly used in the 1966 reconstruction to serve as benchmarks- some of the cornice stones were fixed to the horizontal section using iron rods. The fact that the three marble plates

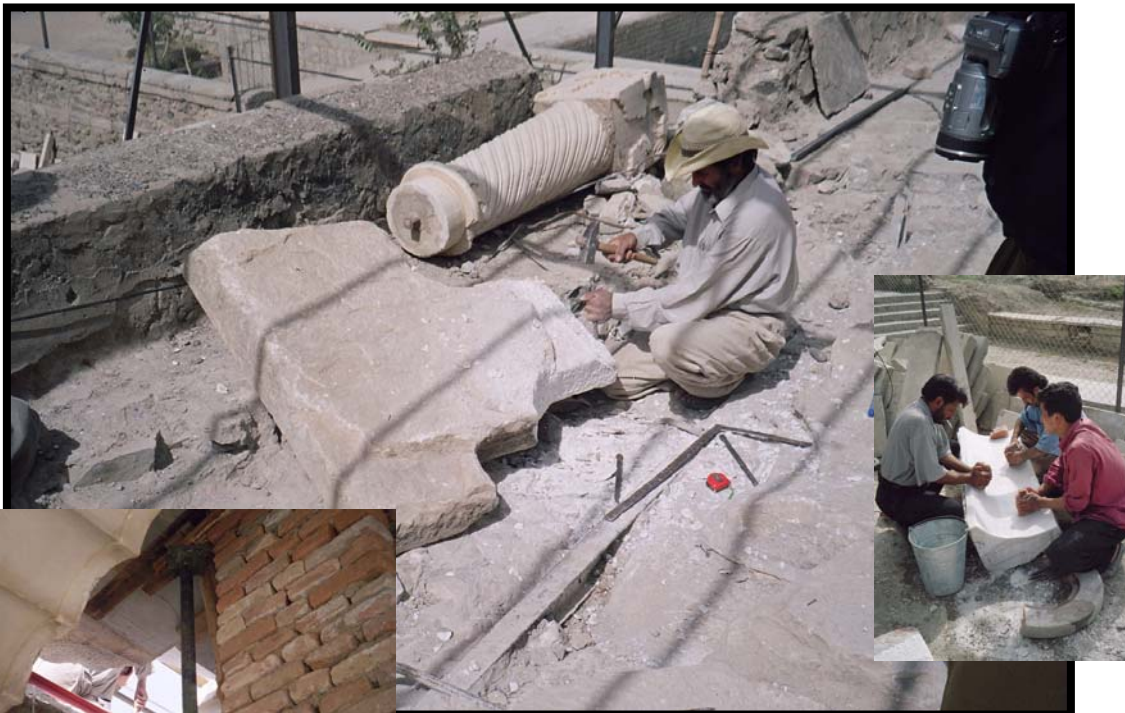
The support stone for the cornice being prepared (picture above) and the cavity in which it was to be fit (left).

Following documentation of the marble plates it became evident that replacing the damaged west cornice of the central bay would not be sufficient as with the limited overlap and high point load the new cornice was likely to crack in a similar fashion. The marble plate was temporarily supported using jacks and a brick masonry pier, 1m square in plan and built in mud mortar. This temporary support allowed the damaged cornice to be removed and be replaced with a new cornice stone 1.2 m long prepared in carefully selected marble from the quarries in the Wardak region and using only hand tools in order to encourage traditional craft techniques. Once the new cornice stone was in place, in order to avoid a recurrence of the damage and to provide extra support to the marble plate, an additional ‘T’ shaped marble stone was placed over it. Extending 100 + mm over the cornice with a chamfered edge, this stone was used to support the marble plate. Though visible from below, it is a repair meant to stabilise¹⁶ the roof structure with a minimal intervention¹⁷ and that too with the same material- marble, prepared using traditional tools and techniques¹⁸.

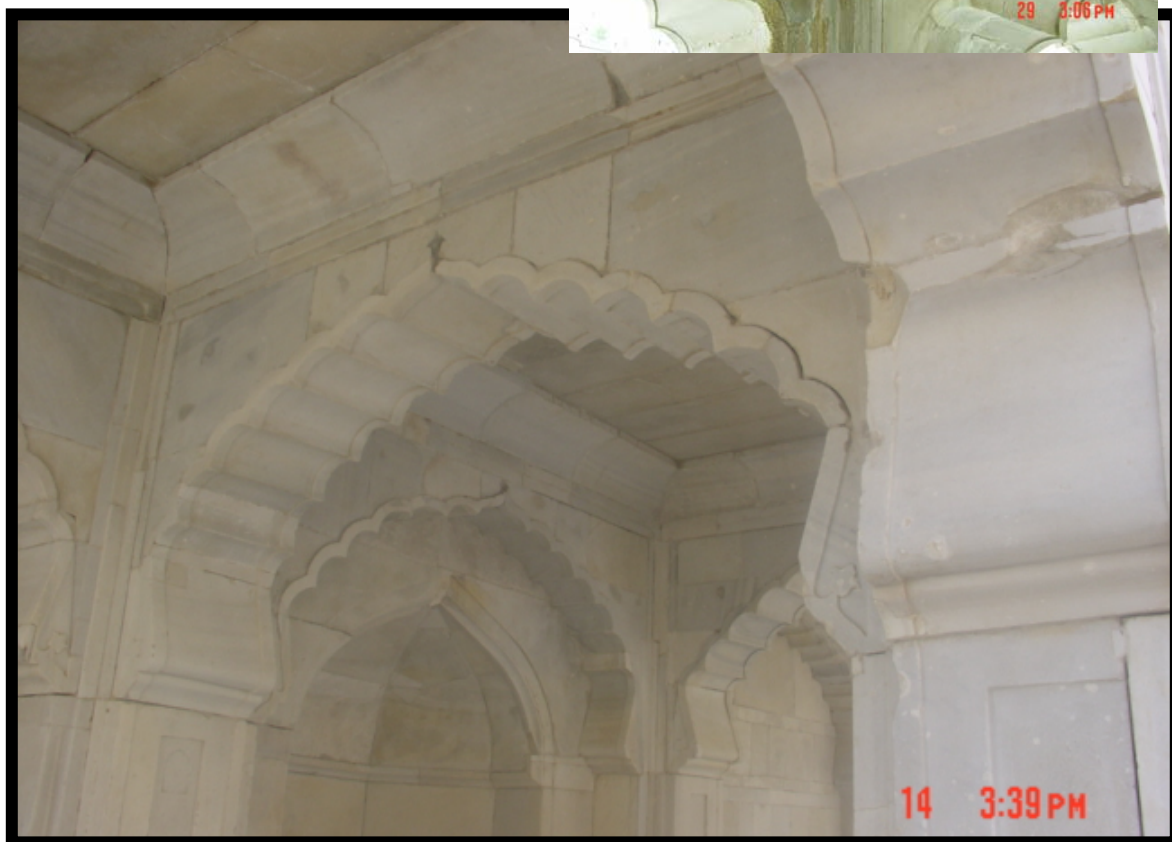
Salt analysis provided information suggesting that the salt formation was primarily due to water penetration in the cement roof. Prior to suggesting any replacement of stones it was decided to undertake a careful cleaning using soft brushes and moist cotton cloths. This was

extremely successful and almost 100% of the salt accumulations and ferrous stains. Some of the stones put in during the 1966 reconstruction that had heavy discoloration and scaling had to be replaced. In the process of removing these stones in the flooring it was discovered that during the 1966 restoration some stones from Rubbaiya Sultana Begum's tomb were reused in the mosque paving; no further removal of stones to ascertain extent of reuse was carried out. During August – October 2003, prior to the cleaning, all the joints in the stonework that were pointed with white cement were carefully opened up using a handsaw;

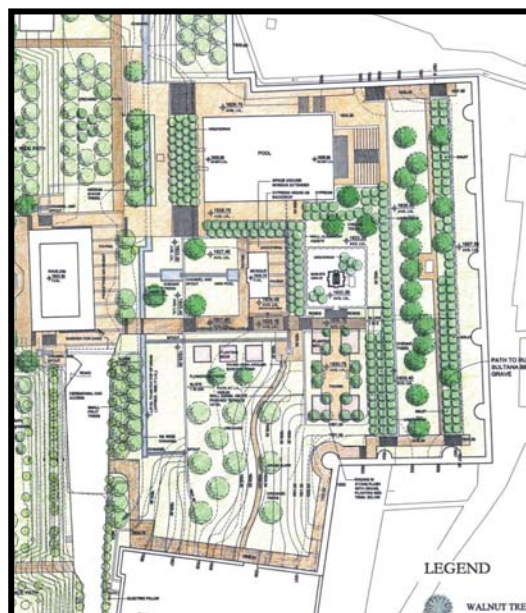
Along with ongoing conservation works on the mosque structure itself, ongoing works in the garden will result in the gradual enhancement of the setting of the Shahjahani building. The relationship with the Babur's tomb terrace on the east will be improved with the removal of the existing parapet followed by the construction of a masonry enclosure of the royal burial area²⁰. Repaving the existing pathway to the south together with sensitive landscaping including planting of large trees and arghwan plants and also regarding of earth will restore relationships with the surroundings and the Queens palace. Archaeological excavations to the west of the mosque have revealed underlying archaeology which means that these areas will be left largely open but the planting of Chenars on the western terrace and towards the northern portion would tie the mosque in with the rest of the garden while a double row of cypress to the north will provide a level of solitude, essential for a place occasionally used for prayers by visitors to the garden.
