The Application of UAV and CSP1 Matrix for Building Inspection at Mosques in Area of Pagoh – Muar, Johor

Abstract. Carrying out building inspection is very essential when it comes to conserving the condition of a building. The aim of performing building inspection on Pekan Pagoh mosque, Pekan Panchor mosque and Sultan Alaudin Riayat Syah 1 mosque is to evaluate their condition using Condition Survey Protocol 1 (CSP1) method. Condition Survey Protocol (CSP1) is used as an evaluation apparatus as it is appropriate for various structures to classify the data based on its condition and destruction evaluations. CSP1 Matrix has also been developed in order to reduce the process of interpreting the data which would then support shortening on-site inspection time. It would be difficult to determine a building existing condition without suitable inspection and that would result a possible failure of the building in the coming years. Therefore, an UAV is used to aid in the visual inspection and CSP1 Matrix is used to analyze the condition of all three mosques and identify the seriousness of each defect detected. Thus, the total score for all mosques were calculated whereby for Pekan Panchor

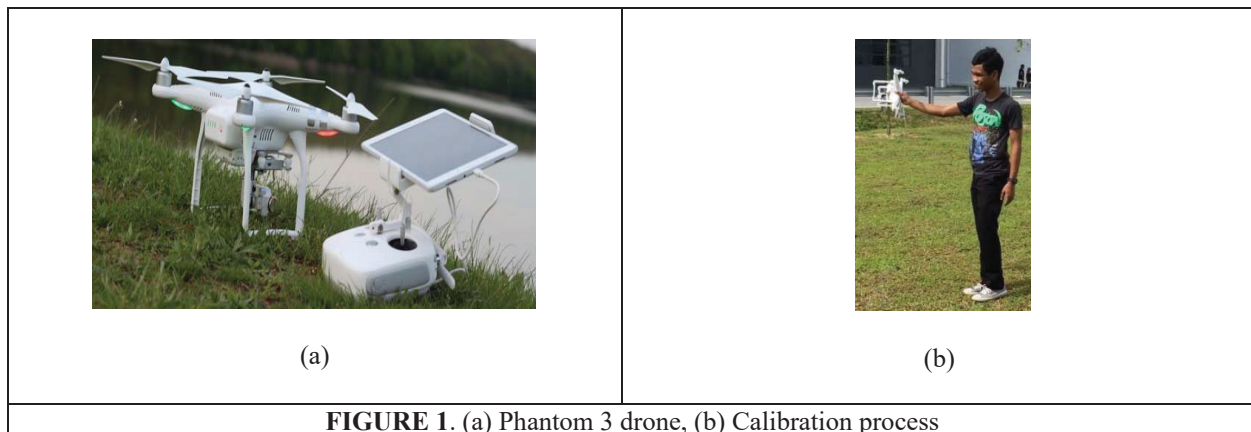
FIGURE 1. (a) Phantom 3 drone, (b) Calibration process

Visual inspection is the first step performed on structures of all the three mosques. It serves the purpose of acquiring and analyzing data which could then be proceeded with quality control. The gathering of data however was carried out by an UAV called Phantom 3 Advanced and with the help of its advance features, it was almost effortless. Phantom 3 has a core design that lifts the center of gravity closer to the Phantom's heart, improving balance, making it more agile and impressively precise. Furthermore, it could fly for as long as 23 minutes and has a range of 5km provided with a live 720p HD view of everything the camera sees. This significantly made it easier to reach both the roof and minaret easily. [2] Figure 1 shows the Phantom 3 drone and the process of calibration.

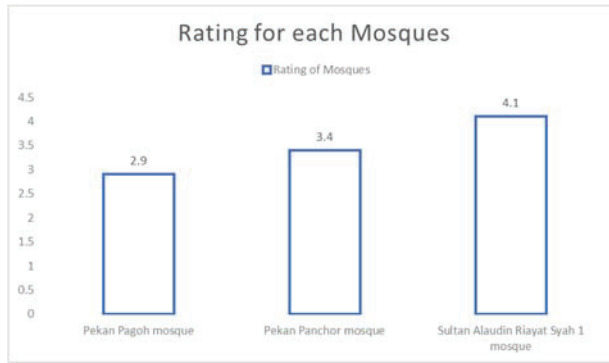
FIGURE 4. Ratings for all three mosques involved

building ratings [6-7]. All of the information gathered for the CSP1 Matrix is recorded in the Schedule of Building Condition form. For reporting purposes, the CSP1 Matrix comprises a photograph box, a defect plan tag and an executive summary, as shown in Figures 2 and 3. Figure 4 is the summary of defect finding on one of the mosques. As shows in Figure 5, in spite of being built around the 1970s, it shows that with proper care and maintenance can still be in a good condition such as the ones built in 2006 and 2017.

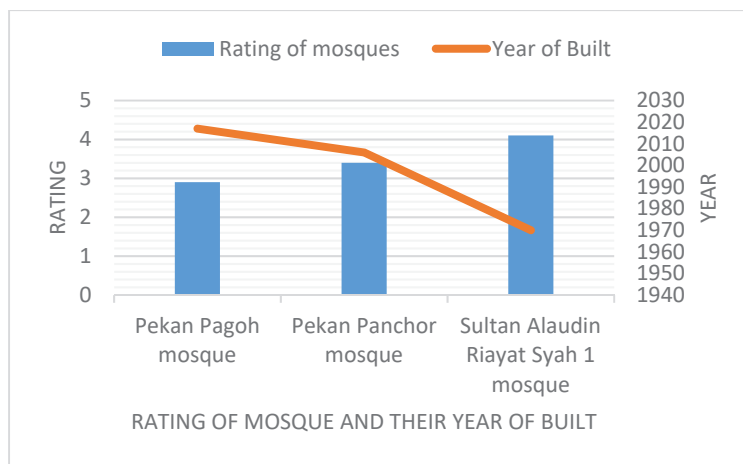
FIGURE 5. Rating of mosque (CSP1) vs year of built
